**NYC Department of Education**  
**Building Condition Assessment Survey 2023 - 2024**

Architectural Inspection

**K123**

**Asset:** P.S. 123 - BROOKLYN, 100 IRVING AVENUE, New York, 11237

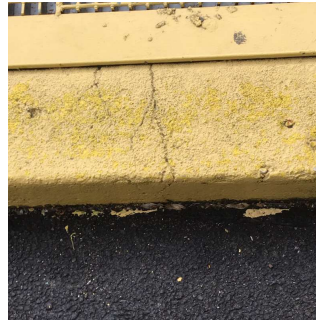
AW2

**AREAWAY WALLS: CRACKS AND SPALLING**

REPAIR

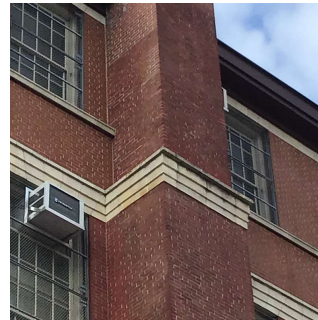
Chimney 1 Leak at Auditorium  
No violations recorded.

BRICK: DETERIORATED JOINTS

500  
S.F.  
REPOINT  
PRIORITY 3  
LEVEL 2

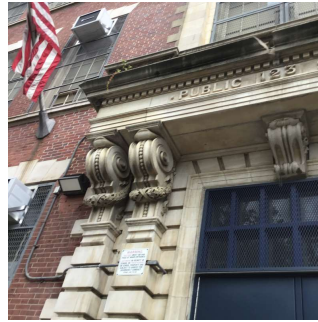
Facade A - Main Entrance

PRE-CAST CONCRETE: MAJOR CRACKS, SPALLING

10  
S.F.  
REPLACE  
PRIORITY 4  
LEVEL 2

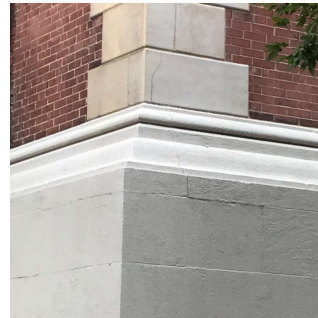
Facade A

**STONE: CRACKS AT BUILDING CORNERS**

REPLACE

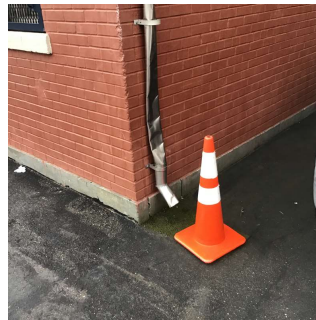
Facade H

DAMAGED/MISSING

REPLACE

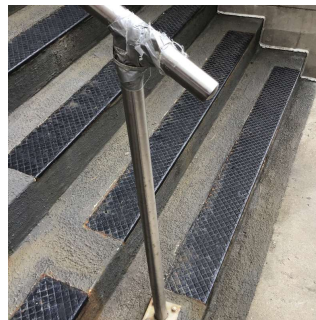
Facade B Exits 2 and 4

DAMAGED

REPLACE

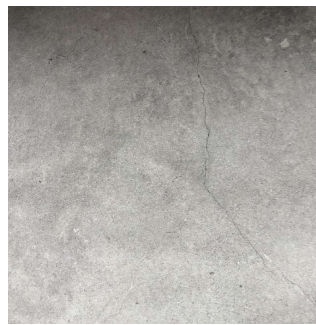
Facade B - Exit 2 and 4  
 No violations recorded.

CONCRETE: CRACKS/SPALLING - MINOR

30  
 S.F.  
 REPAIR  
 PRIORITY 3  
 LEVEL 2

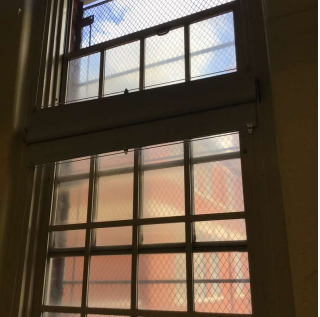
Violations	All Facades Basement Windows No violations recorded.
<b>LINTELS</b>	Inspected
Condition	2 - Between Good and Fair
Deficiency	No deficiencies recorded
<b>WINDOWS</b>	Inspected
Material Type(s)	Aluminum
Instance on Aluminum - Double Hung: All Facades	Inspected
Instance Condition	3 - Fair
Instance Quantity	10,000
Instance Quantity Uom	S.F.
Are these windows insulated	No
Installation Year	1999
Source of Installation	Custodial Staff
Deficiency	ALUMINUM - DOUBLE HUNG: INOPERABLE BALANCE

Deficiency Quantity Quantity Uom Potential Action Urgency of Action Purpose of Action Deficiency Photo1	140 EACH REPLACE BALANCES PRIORITY 3 LEVEL 2
Violations

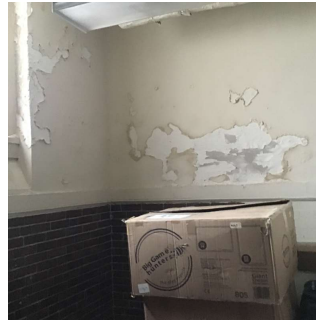
Basement Storage Room near Exit 13

**BRICK: WATER INFILTRATION IN NON- INSTRUCTIONAL SPACE**  
Basement - Space near Exit 13, Water Main Room, near Cafeteria TV Room, Stair F, Mechanical Room  
250  
S.F.  
INSTALL WATERPROOFING  
PRIORITY 5  
LEVEL 5

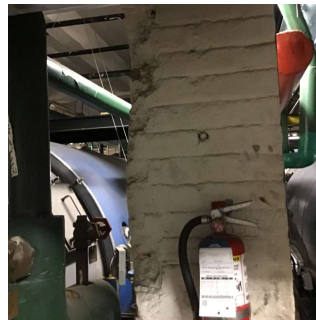
Boiler Room Vault Column

STEEL COLUMNS/BEAMS: DETERIORATED MASONRY FIREPROOFING

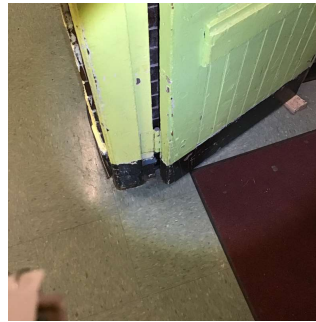
Instance on Basement	Inspected
Condition	4 - Between Fair and Poor
Deficiency	WOOD: DETERIORATED DOOR
Deficiency Location/Instance	Exit 7 Vestibule
Deficiency Quantity	2
Quantity Uom	EACH
Potential Action	MAINTENANCE
Urgency of Action	PRIORITY 3
Purpose of Action	LEVEL 2
Deficiency Photo1

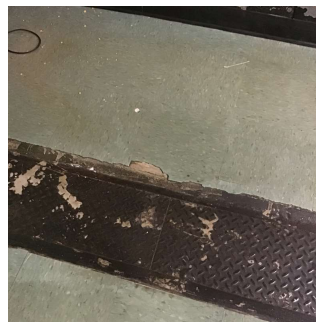
Near Kitchen

Instance on Basement	Inspected
Condition	2 - Between Good and Fair
Deficiency	VINYL TILES: BROKEN/DETERIORATED/MISSING TILES
Deficiency Location/Instance	Near Kitchen, near Drinking fountain
Deficiency Quantity	20
Quantity Uom	S.F.
Potential Action	REPLACE
Urgency of Action	PRIORITY 3
Purpose of Action	LEVEL 2
Deficiency Photo1

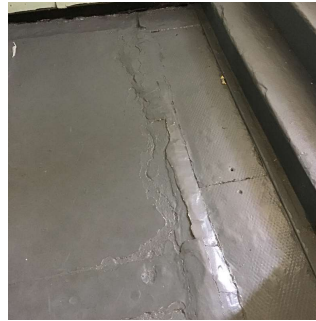
Stair GI/1
Violations	No violations recorded.
Deficiency	CONCRETE: CRACKS/SPALLING - MAJOR
Deficiency Location/Instance	Stair GI/Basement Vestibule
Deficiency Quantity	20
Quantity Uom	S.F.
Potential Action	REPLACE
Urgency of Action	PRIORITY 3
Purpose of Action	LEVEL 2
