NYC Department of Education
Building Condition Assessment Survey 2023 - 2024

Architectural Inspection

Asset: P.S. 124 - BROOKLYN, 515 4TH AVENUE, New York, 11215

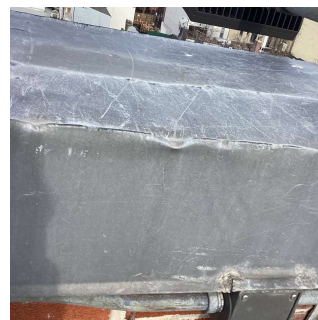
Roof 1 - Facade B

METAL: DETERIORATED

20
 L.F.
 REPLACE-IN-KIND
 PRIORITY 4
 LEVEL 2

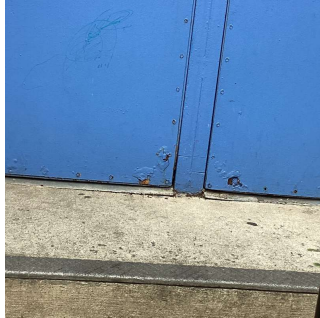
Question	Response
EXTERIOR	
DOORS	
DOORS AND FRAMES	
Urgency of Action	PRIORITY 4
Purpose of Action	LEVEL 2
Deficiency Photo1

Violations	Facade D - Exit 4 No violations recorded.
Deficiency	METAL: DETERIORATED DOOR - MINOR DETERIORATION
Roof Plan reference	K124

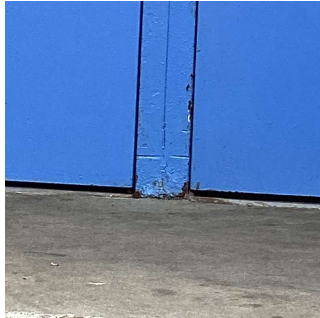
Deficiency Quantity	2
Quantity Uom	EACH
Potential Action	MAINTENANCE
Urgency of Action	PRIORITY 3
Purpose of Action	LEVEL 2
Deficiency Photo1

Violations	Facade A - Main Entrance No violations recorded.
DOOR HARDWARE	
Condition	Inspected
Deficiency	3 - Fair No deficiencies recorded
LINTELS	
Condition	Inspected
Deficiency	2 - Between Good and Fair No deficiencies recorded
TRANSOM/SIDE LIGHT	
Condition	Inspected

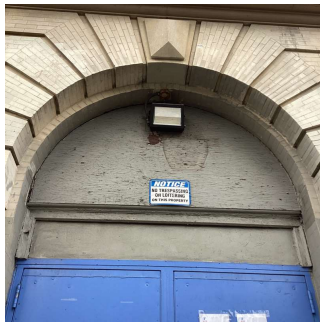
Question	Response
EXTERIOR	
DOORS	
TRANSOM/SIDE LIGHT	
Deficiency Photo1

Violations	Facade D - Exit 4 No violations recorded.
EXTERIOR WALLS	Inspected
Material Type(s)	Concrete, Masonry
Replacement Quantity	18,000
Replacement Uom	S.F.
Instance on All All Facades	Inspected
Instance Condition	3 - Fair
Instance Quantity	18,000
Instance Quantity Uom	S.F.
Deficiency	STONE: CRACKS AT BUILDING CORNERS
Roof Plan reference	<p align="center">K124</p>

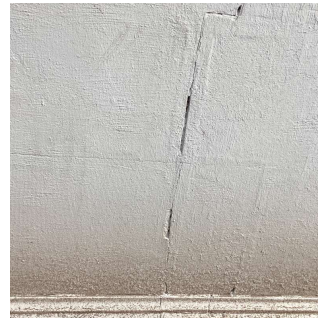
Facade A

CAST IN PLACE / PRE-CAST CONCRETE: DETERIORATED JOINTS

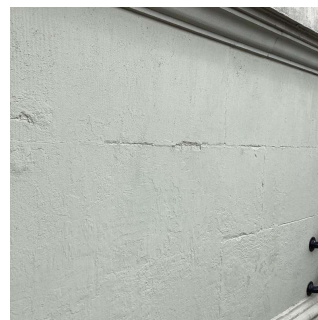
STONE: CHIPPED/SPALLED/BROKEN PIECES - MINOR

20
S.F.
REPAIR
PRIORITY 3
LEVEL 2

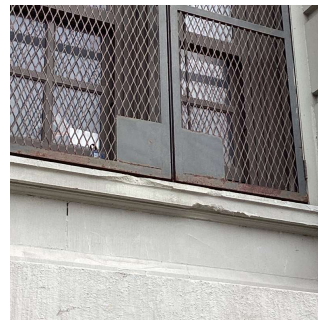
Facade A - Near Main Entrance

BRICK: DETERIORATED MASONRY SILLS - MAJOR

20
L.F.
REMOVE AND REPLACE
PRIORITY 4
LEVEL 2

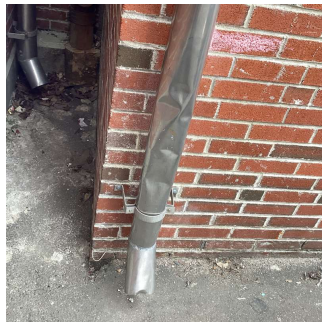
Question	Response
EXTERIOR	
PARAPETS	Inspected
Deficiency	No deficiencies recorded
PLAZA DECK	Does not Exist
ROOF	Inspected
Roofing	Inspected
Replacement Quantity	9,000
Replacement Uom	S.F.
ROOF HATCH/SMOKE HATCH	Does not Exist
LEADERS, GUTTERS, DOWNSPOUTS, SCUPPERS	Inspected
Condition	3 - Fair
Deficiency	DAMAGED/MISSING
Roof Plan reference	
Deficiency Quantity	10
Quantity Uom	L.F.
Potential Action	REPLACE
Urgency of Action	PRIORITY 4
Purpose of Action	LEVEL 2
Deficiency Photo1

Violations	Facade C - Roof 5 No violations recorded.
ROOF BARRIER/FENCE	Inspected
Condition	1 - Good
Deficiency	No deficiencies recorded
ROOF CAGE	Does not Exist
ROOFING	Inspected
Instance on Modified Bitumen: All Roofs	Inspected
Instance Condition	1 - Good

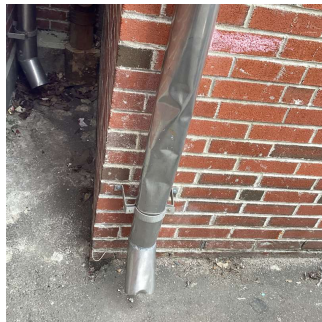
Facade C - Roof 5

K124
10
L.F.
REPLACE
PRIORITY 4
LEVEL 2

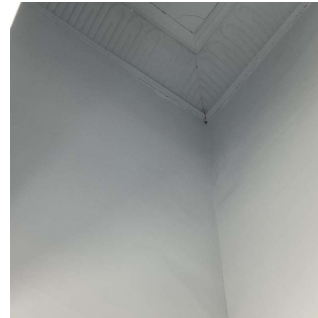
BH1 (Stair AB/Bulkhead)

Roof 1
Instance Quantity	9,000
Instance Quantity Uom	S.F.
Does the roof have major mechanical equipment sitting on Dunnage Steel less than 18" above the Roofing?	No
Does this roof instance have a Sustainable Roof System?	Yes
Sustainable Roof Type	White Roof
Sustainable Roof Location (Roof Number)	Roof 1
Do solar panels exist on these roofs?	No
Is/Are the roof(s) suitable for Solar Panel installation?	No
Installation Year	2020
Source of Installation	Custodial Staff
Deficiency	No deficiencies recorded
ROOFING DRAINS	Does not Exist
Specialties	Inspected
BULKHEAD/PENTHOUSE	Inspected
Condition	3 - Fair
Deficiency	BULKHEAD/PENTHOUSE WALLS/EXTERIOR: WATER INFILTRATION
Roof Plan reference

Deficiency Quantity	100
Quantity Uom	S.F.
Potential Action	REPAIR
Urgency of Action	PRIORITY 5
Purpose of Action	LEVEL 4

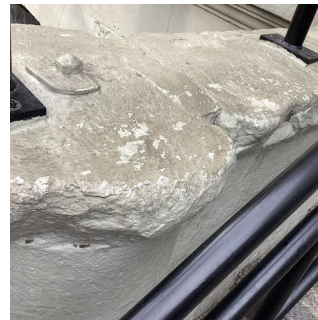
Facade D - Exit 4

STONE: CRACKS/SPALLING - MAJOR

REPLACE

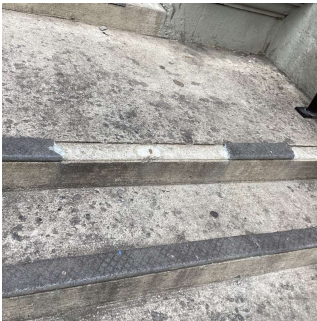
Question	Response
EXTERIOR	
STAIRS/RAMPS: EXTERIOR	
STAIRS/RAMPS	
Deficiency Photo1

Violations	Facade D - Exit 4 No violations recorded.
Deficiency	CONCRETE: WORN-OUT TREAD/RISER/NOSING
Roof Plan reference	K124

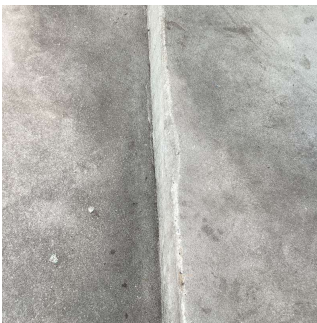
Deficiency Quantity	10
Quantity Uom	S.F.
Potential Action	REPLACE
Urgency of Action	PRIORITY 4
Purpose of Action	LEVEL 2
Deficiency Photo1

Violations	Facade A - Main Entrance No violations recorded.
WINDOWS	Inspected
Replacement Quantity	5,000
Replacement Uom	S.F.
EXTERIOR GUARDS	Inspected
Condition	2 - Between Good and Fair
Deficiency	No deficiencies recorded
LINTELS	Inspected
Condition	2 - Between Good and Fair
Deficiency	No deficiencies recorded

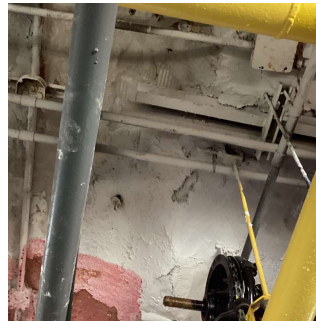
CINDER CONCRETE ARCH: METAL PAN DETERIORATED, SPALLED

Basement - Boiler Room
No violations recorded.

REPAIR

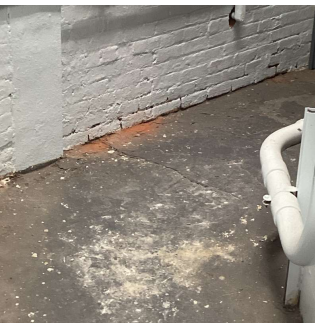
Question	Response
INTERIOR	
STRUCTURAL	
FLOOR STRUCTURE	
Deficiency Photo1 Violations

Basement - Electrical Room No violations recorded.
Deficiency Deficiency Location/Instance Deficiency Quantity Quantity Uom Potential Action Urgency of Action Purpose of Action Deficiency Photo1	CONCRETE: CRACKS/SPALLED/REINFORCEMENT EXPOSED Basement - Electrical Room 20 S.F. REPAIR PRIORITY 4 LEVEL 5
Violations

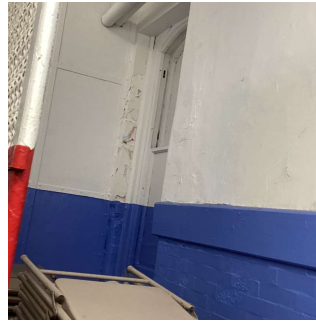
Stair B/Basement

CONCRETE: WATER INFILTRATION IN NON- INSTRUCTIONAL SPACE

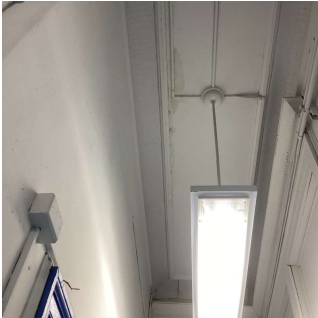
Question	Response
INTERIOR	
CLASSROOMS/CORRIDORS/ADMIN SPACES	
Ceiling	
Deficiency Quantity	10
Quantity Uom	S.F.
Potential Action	REPLACE
Urgency of Action	PRIORITY 3
Purpose of Action	LEVEL 2
Deficiency Photo1

Corridor near Exit 2/4
Violations	No violations recorded.
Deficiency	PLASTER: CRACKS/SPALLING - ACTIVE LEAK
Deficiency Location/Instance	Exit 2/4 Vestibule
Deficiency Quantity	50
Quantity Uom	S.F.
Potential Action	REPLACE
Urgency of Action	PRIORITY 5
Purpose of Action	LEVEL 2
Deficiency Photo1

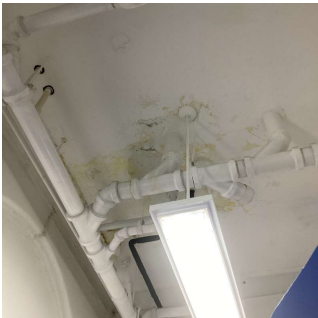
Exit 2/4 Vestibule
Violations	No violations recorded.
Door(s)	Inspected
Condition	5 - Poor
Deficiency	METAL CLAD WOOD: DETERIORATED DOOR
Deficiency Location/Instance	Room 101
Deficiency Quantity	1
Quantity Uom	EACH
Potential Action	MAINTENANCE
Urgency of Action	PRIORITY 3
Purpose of Action	LEVEL 2

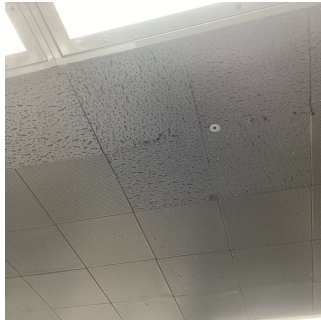
Question	Response
INTERIOR	
CLASSROOMS/CORRIDORS/ADMIN SPACES	Inspected
Walls	Inspected
Violations	Main Entrance Vestibule No violations recorded.
Specialties	Does not Exist
GYMNASIUM	Does not Exist
INTERIOR DOOR HARDWARE	Inspected
Condition	3 - Fair
Deficiency	No deficiencies recorded
INTERIOR GUARDS	Inspected
Condition	2 - Between Good and Fair
Deficiency	No deficiencies recorded
KITCHEN	Inspected
Instance on Basement (500 SF)	Inspected
Ceiling	
Instance on Basement (500 SF)	Inspected
Condition	5 - Poor
Deficiency	METAL PAN: DAMAGED/MISSING
Deficiency Location/Instance	Near Entrance, center
Deficiency Quantity	100
Quantity Uom	S.F.
Potential Action	REPLACE
Urgency of Action	PRIORITY 3
Purpose of Action	LEVEL 2
Deficiency Photo1

Violations	Near center No violations recorded.
Door(s)	
Instance on Basement (500 SF)	Inspected
Condition	3 - Fair
Deficiency	WOOD: DETERIORATED DOOR
Deficiency Location/Instance	Storage
Deficiency Quantity	1

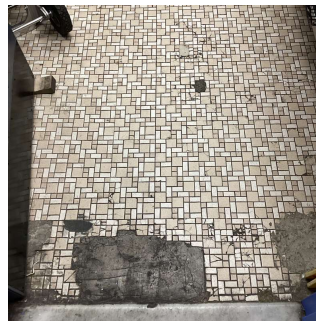
Near Entrance

Deficiency	CERAMIC TILE: BROKEN/MISSING TILES
Deficiency Location/Instance	Near Entrance, center
Deficiency Quantity	100
Quantity Uom	S.F.
Potential Action	REPLACE
Urgency of Action	PRIORITY 3
Purpose of Action	LEVEL 2
Deficiency Photo1

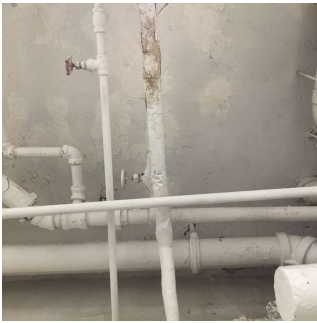
Question	Response
INTERIOR	
TOILET ROOMS - STAFF	
Ceiling	Inspected
Deficiency Photo1

Staff - Basement
Violations	No violations recorded.
Door(s)	Inspected
Condition	5 - Poor
Deficiency	WOOD: DETERIORATED DOOR
Deficiency Location/Instance	Room 306A, 206A
Deficiency Quantity	2
Quantity Uom	EACH
Potential Action	MAINTENANCE
Urgency of Action	PRIORITY 3
Purpose of Action	LEVEL 2
Deficiency Photo1

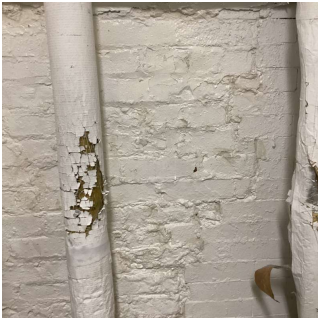
Question	Response
INTERIOR	
TOILET ROOMS - STAFF	
Walls	Inspected
	Basement - Staff Toilet
Violations	No violations recorded.
Deficiency	CERAMIC TILE: BROKEN/ MISSING - ACTIVE LEAK
Deficiency Location/Instance	Basement - Staff Toilet
Deficiency Quantity	20
Quantity Uom	S.F.
Potential Action	REPLACE
Urgency of Action	PRIORITY 5
Purpose of Action	LEVEL 2
Deficiency Photo1

Basement - Staff Toilet
Violations	No violations recorded.
TOILET ROOMS - STUDENTS	
Ceiling	Inspected
Condition	2 - Between Good and Fair
Deficiency	PLASTER: CRACKS/SPALLING
Deficiency Location/Instance	1st Floor - Boys
Deficiency Quantity	10
Quantity Uom	S.F.
Potential Action	REPLACE
Urgency of Action	PRIORITY 3
Purpose of Action	LEVEL 2
Deficiency Photo1

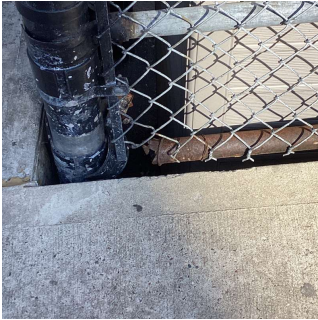
Question	Response
SITE	
FENCES	
Violations	No violations recorded.
Deficiency	CHAIN LINK: DAMAGED POST/RAIL
Deficiency Location/Instance	Along 14th Street, 13th a street, Schoolyard
Deficiency Quantity	60
Quantity Uom	L.F.
Potential Action	REPLACE
Urgency of Action	PRIORITY 3
Purpose of Action	LEVEL 2
Deficiency Photo1

Violations	Along 14th Street No violations recorded.
Deficiency	CHAIN LINK: RUST - MAJOR
Deficiency Location/Instance	Along 14th Street
Deficiency Quantity	1,050
Quantity Uom	S.F.
Potential Action	REPLACE
Urgency of Action	PRIORITY 3
Purpose of Action	LEVEL 2
Deficiency Photo1

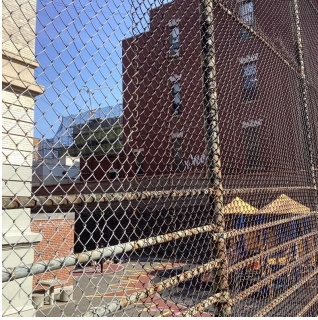
Violations	Along 14th Street No violations recorded.
Deficiency	WROUGHT IRON: DAMAGED/DETERIORATED
Deficiency Location/Instance	Along 14th Street, 4th Avenue
Deficiency Quantity	120
Quantity Uom	S.F.
Potential Action	REPLACE
Urgency of Action	PRIORITY 3
Purpose of Action	LEVEL 2

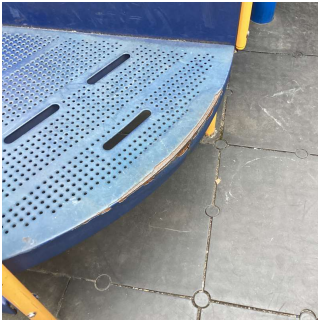
Question	Response
SITE	
PAVING	Inspected
DOT Sidewalk	
Concrete	Inspected
Violations	Along 4th Avenue No violations recorded.
Pavers	Does not Exist
PLAYGROUNDS	Inspected
Instance on Schoolyard	Inspected
Benches	
Instance on Schoolyard	Does not Exist
Fence	
Instance on Schoolyard	Does not Exist
Pavement	
Instance on Schoolyard	Does not Exist
Play Equipment	
Instance on Schoolyard	Inspected
Condition	5 - Poor
Deficiency	BROKEN/DETERIORATED/MISSING
Deficiency Location/Instance	Schoolyard
Deficiency Quantity	1
Quantity Uom	EACH
Potential Action	REPLACE
Urgency of Action	PRIORITY 3
Purpose of Action	LEVEL 2
Deficiency Photo1

Violations	Schoolyard No violations recorded.
Safety Surfacing	
Instance on Schoolyard	Inspected
Condition	2 - Between Good and Fair
Deficiency	DETERIORATED/MISSING
Deficiency Location/Instance	Schoolyard
Deficiency Quantity	10
Quantity Uom	S.F.
Potential Action	MAINTENANCE
Urgency of Action	PRIORITY 3

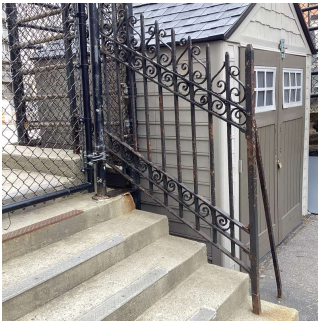
Question	Response
SITE	
SITE WALLS (NOT RETAINING WALLS)	Inspected
Violations	No violations recorded.
STAIRS/RAMPS: EXTERIOR	
Railings	Inspected
Condition	4 - Between Fair and Poor
Deficiency	MISSING
Deficiency Location/Instance	Near exit 3/5
Deficiency Quantity	20
Quantity Uom	L.F.
Potential Action	REPLACE
Urgency of Action	PRIORITY 5
Purpose of Action	LEVEL 6
Deficiency Photo1

Violations	Near exit 3/5 No violations recorded.
Site Cheek/flank Walls	Inspected
Condition	2 - Between Good and Fair
Deficiency	No deficiencies recorded
Stairs/ramps	Inspected
Condition	2 - Between Good and Fair
Deficiency	CAST IN PLACE CONCRETE: CRACKS/SPALLING - MAJOR
Deficiency Location/Instance	Schoolyard
Deficiency Quantity	25
Quantity Uom	S.F.
Potential Action	REPLACE
Urgency of Action	PRIORITY 3
Purpose of Action	LEVEL 2
Deficiency Photo1
