**NYC Department of Education**  
**Building Condition Assessment Survey 2023 - 2024**

Architectural Inspection

**K126**

**Asset: J.H.S. 126 - BROOKLYN, 424 LEONARD STREET, New York, 11222**

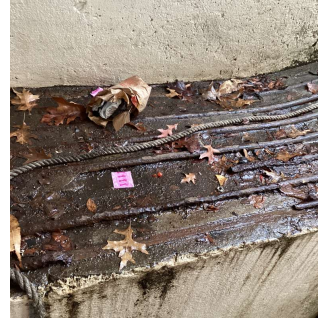
Facade M - AW2

AREAWAY STAIRS: DETERIORATED TREADS/RISERS/NOSINGS

REPAIR

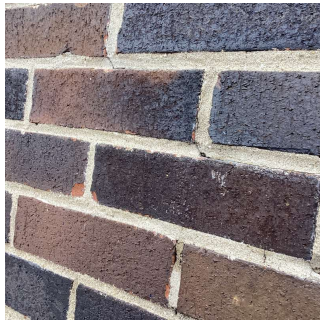
Violations	Roof 1 - CH No violations recorded.
Deficiency	BRICK: MAJOR / THRU CRACKS

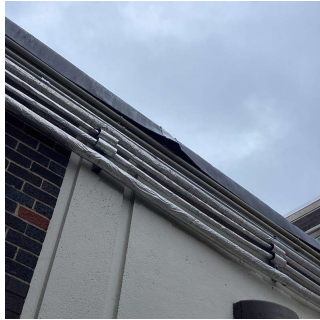
Violations	Facade D - Near Exit 6 No violations recorded.
<b>CORNICE</b>	Does not Exist
<b>DOORS</b>	Inspected
<b>DOORS AND FRAMES</b>	Inspected
Condition	3 - Fair
Deficiency	METAL CLAD: DETERIORATED DOOR AND FRAME - MINOR DETERIORATION
Roof Plan reference	K126

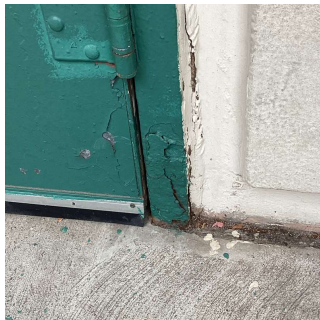
Violations	Facade C - Exit 5 No violations recorded.
<b>DOOR HARDWARE</b>	Inspected
Condition	3 - Fair
Deficiency	No deficiencies recorded
<b>LINTELS</b>	Inspected
Condition	2 - Between Good and Fair

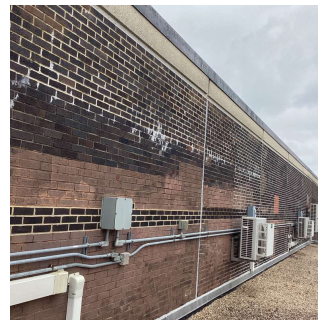
Roof 2 - Near Auditorium Fan Room

BRICK: MAJOR / THRU CRACKS

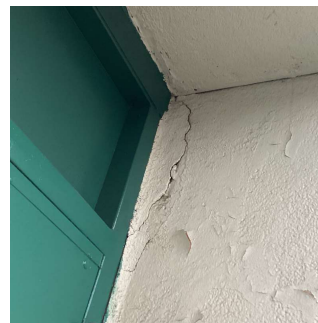
Facade A - Main Entrance

**CAST IN PLACE / PRE-CAST CONCRETE: MINOR  
CRACKS/SPALLING**

REPAIR

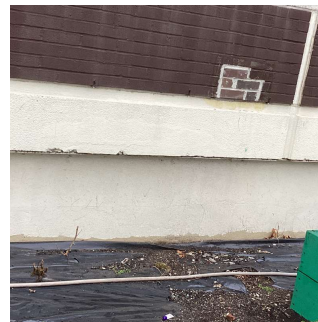
Facade A - Near Exit 3

BRICK: DETERIORATED JOINTS

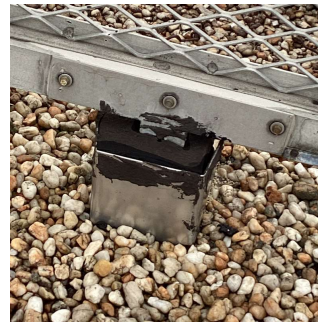
Roof 1 - Near BH2

BUILT-UP: ROOFING: MAJOR ACTIVE ROOF LEAKS IN INSTRUCTIONAL SPACE

REPLACE ROOFING WITHOUT MAJOR EQUIPMENT REMOVAL

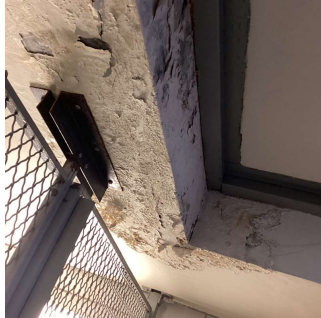
Violations	Roof 1 - BH1 No violations recorded.
Deficiency	BULKHEAD/PENTHOUSE WALLS/EXTERIOR: WATER INFILTRATION
Roof Plan reference

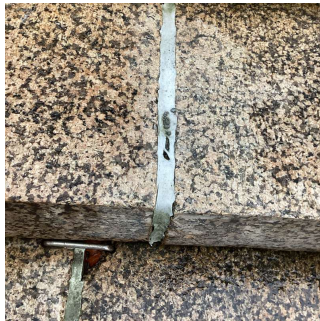
Violations	Facade G - Exit 8 (Terrazzo) No violations recorded.
Deficiency	<b>STONE: CRACKS/SPALLING - MAJOR</b>
Roof Plan reference

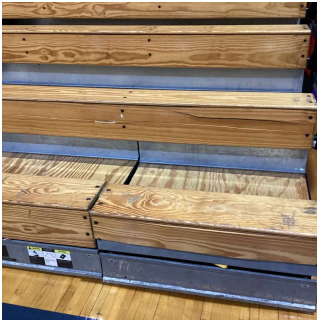
Violations	Storage No violations recorded.
<b>Seating</b>	
Instance on 1st Floor	Inspected
Condition	3 - Fair
Deficiency	DAMAGED BLEACHERS
Deficiency Location/Instance	Near center
Deficiency Quantity	50
Quantity Uom	S.F.
Potential Action	REPLACE
Urgency of Action	PRIORITY 3
Purpose of Action	LEVEL 2
Deficiency Photo1

Violations	Near center No violations recorded.
<b>Sliding-folding Partition</b>	
Instance on 1st Floor	Inspected
Condition	2 - Between Good and Fair
Deficiency	No deficiencies recorded
<b>Stage</b>	
Instance on 1st Floor	Does not Exist
<b>Walls</b>	
Instance on 1st Floor	Inspected
Condition	2 - Between Good and Fair
Deficiency	GLAZED BLOCK: CRACKS/SPALLING
Deficiency Location/Instance	Near water fountain
Deficiency Quantity	20
Quantity Uom	S.F.
Potential Action	REPLACE
Urgency of Action	PRIORITY 3

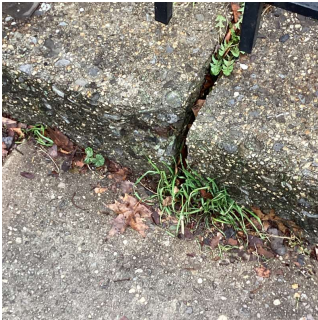
Question	Response
<b>SITE</b>	
<b>FENCES</b>	
Violations	No violations recorded.
Deficiency	CONCRETE CURB: DAMAGED/DETERIORATED
Deficiency Location/Instance	Along Manhattan Avenue, Bayard Street, Leonard Street
Deficiency Quantity	90
Quantity Uom	S.F.
Potential Action	REPLACE
Urgency of Action	PRIORITY 3
Purpose of Action	LEVEL 2
Deficiency Photo1

Along Manhattan Avenue
Violations	No violations recorded.
<b>IRRIGATION SYSTEM</b>	Does not Exist
<b>PAVING</b>	Inspected
<b>Student Non-Use</b>	Inspected
Gravel Exists?	No
<b>Asphalt</b>	Does not Exist
<b>Concrete</b>	Inspected
Condition	3 - Fair
Deficiency	DAMAGED/DETERIORATED/MISSING SECTIONS
Deficiency Location/Instance	Near exit 11
Deficiency Quantity	450
Quantity Uom	S.F.
Potential Action	REPLACE
Urgency of Action	PRIORITY 3
Purpose of Action	LEVEL 2
Deficiency Photo1

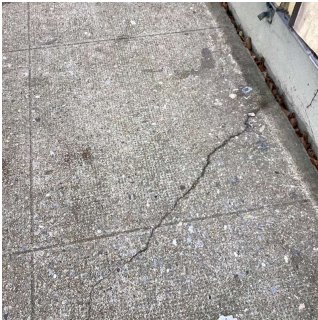
Violations	Walkway along Parks Department No violations recorded.
Deficiency	DAMAGED/DETERIORATED/MISSING SECTIONS
Deficiency Location/Instance	Walkway along Parks Department
Deficiency Quantity	25
Quantity Uom	S.F.
Potential Action	REPLACE
Urgency of Action	PRIORITY 5
Purpose of Action	LEVEL 6
Deficiency Photo1
