**NYC Department of Education**  
**Building Condition Assessment Survey 2023 - 2024**

Architectural Inspection

**K127**

**Asset: P.S. 127 - BROOKLYN, 7805 7 AVENUE, New York, 11209**

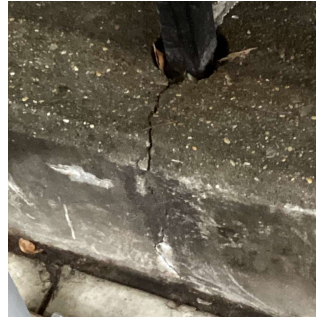
AW1

| Question | Response |
|---|---|
| Instance Condition | 3 - Fair |
| Deficiency | AREAWAY WALLS: CRACKS AND SPALLING |

Potential Action  
Urgency of Action  
Purpose of Action  
Deficiency Photo1

REPAIR  
PRIORITY 3  
LEVEL 2

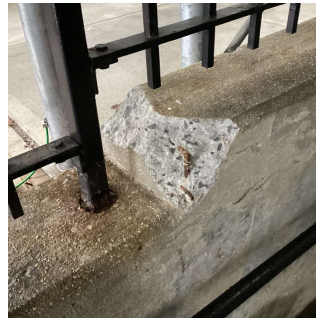
AW1

AREAWAY WALLS: CRACKS AND SPALLING

Deficiency Quantity  
Quantity Uom  
Potential Action  
Urgency of Action  
Purpose of Action  
Deficiency Photo1

10  
S.F.  
REPLACE  
PRIORITY 4  
LEVEL 2

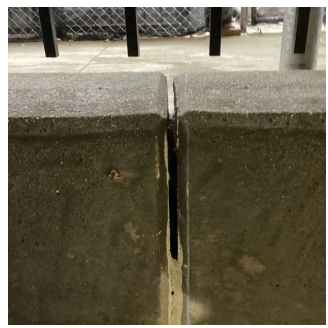
AREAWAY WALLS: DETERIORATED JOINTS

| Question | Response |
|---|--|
| Potential Action | REPAIR |
| Urgency of Action | PRIORITY 3 |

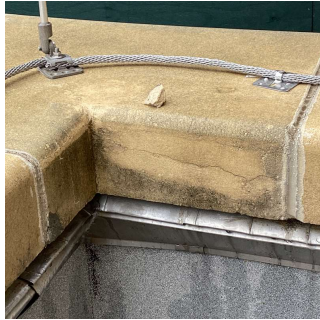
| Question | Response |
|---|--|
| Violations | Roof 7<br>No violations recorded. |

| Question | Response |
|---|--|
| Condition | 3 - Fair |
| Deficiency | CAST STONE: DISINTEGRATING / FREEZE THAW |

| Question | Response |
|---|--|
| Potential Action | REPLACE-IN-KIND |

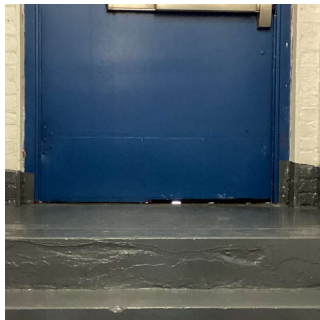
| Question | Response |
|---|--|
| Violations | Facade D - Exit 8<br>No violations recorded. |

| Question | Response |
|---|--|
| Condition | 5 - Poor |
| Deficiency | METAL CLAD: DETERIORATED DOOR - MAJOR DETERIORATION |

| Question | Response |
|---|--|
| Potential Action | REPLACE |
| Urgency of Action | PRIORITY 4 |

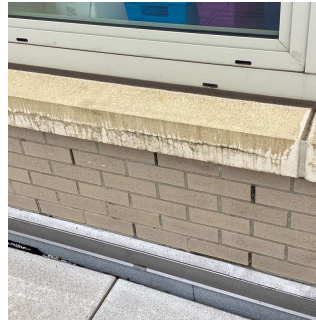
Facade C - Roof 7

| Question | Response |
|---|--|
| Instance Condition | 2 - Between Good and Fair |
| Deficiency | BRICK: DETERIORATED MASONRY SILLS - MINOR |

| Question | Response |
|---|--|
| Potential Action | REPAIR |

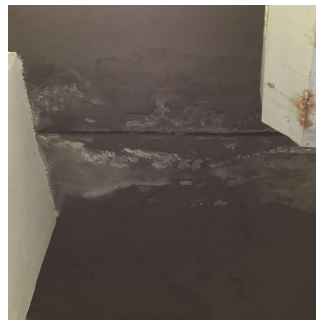
Facade E

CONCRETE: WATER PENETRATION

REPLACE

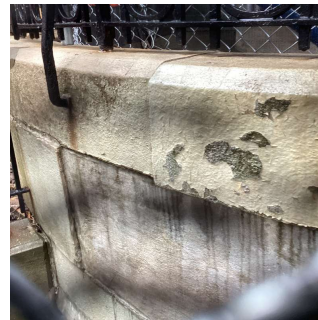
Facade E

| Question | Response |
|---|--|
| Condition | 5 - Poor |

STONE: BULGING/DISPLACED

REPLACE

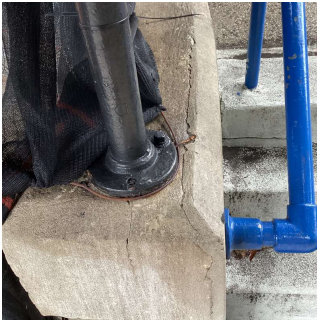
| Question | Response |
|---|--|
| Violations | Facade E<br>No violations recorded. |

STONE: CRACKS/SPALLING - MAJOR

REPLACE

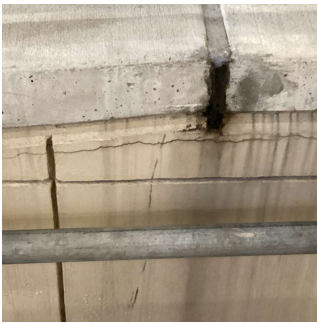
| Question | Response |
|---|--|
| Violations | Exit 13<br>No violations recorded. |

| Question | Response |
|---|--|
| Deficiency | CAST IN PLACE CONCRETE: CRACKS/SPALLING - MINOR |

| Question | Response |
|---|--|
| Potential Action | REPAIR |
| Urgency of Action | PRIORITY 3 |

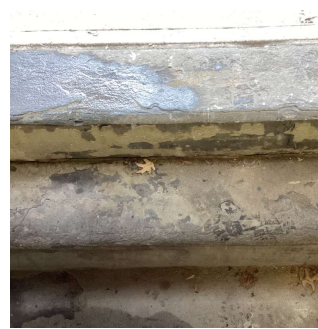
Facade E

| Question | Response |
|---|--|
| Condition | 5 - Poor |
| Deficiency | STONE: WORN-OUT TREAD/RISER/NOSING |

Deficiency Quantity  
Quantity Uom  
Potential Action  
Urgency of Action  
Purpose of Action  
Deficiency Photo1

50  
S.F.  
REPLACE  
PRIORITY 4  
LEVEL 2

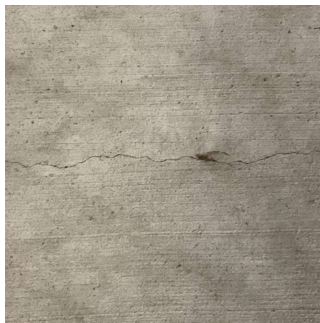
| Question | Response |
|---|--|
| Violations | Exit 13<br>No violations recorded. |

**CONCRETE: CRACKS/SPALLING - MINOR**

Deficiency Quantity  
Quantity Uom  
Potential Action  
Urgency of Action  
Purpose of Action

85  
S.F.  
REPAIR  
PRIORITY 3  
LEVEL 2

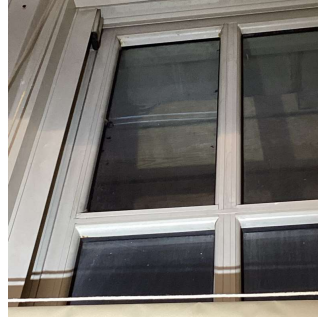
Facade G - Room 202

| Question | Response |
|---|--|
| Deficiency | ALUMINUM - DOUBLE HUNG: BROKEN PANE |

Quantity Uom  
Potential Action  
Urgency of Action  
Purpose of Action  
Deficiency Photo1

S.F.  
MAINTENANCE  
PRIORITY 3  
LEVEL 2

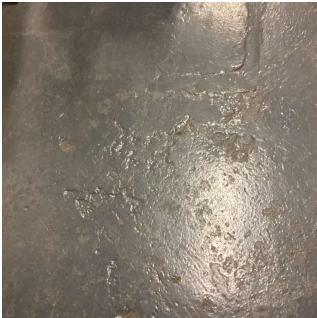
| Question | Response |
|---|--|
| | Electrical Panel Room (Boiler Room, 2021 Electrical Panel Room similar) |

| Question | Response |
|---|--|
| Condition | 3 - Fair |
| Deficiency | CONCRETE SLAB ON GRADE: THRU CRACKS |

| Question | Response |
|---|--|
| Potential Action | REPAIR |
| Urgency of Action | PRIORITY 3 |

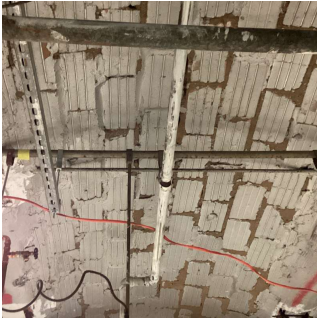
| Question | Response |
|---|--|
| | Boiler Room |

| Question | Response |
|---|--|
| Deficiency | CLAY TILE: PLASTER MISSING |

| Question | Response |
|---|--|
| Potential Action | REPLACE |
| Urgency of Action | PRIORITY 3 |

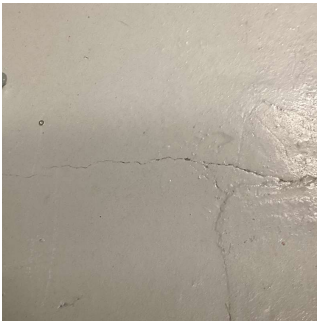
| Question | Response |
|---|--|
| Violations | Elevator Machine Room<br>No violations recorded. |

| Question | Response |
|---|--|
| Deficiency | CONCRETE: CRACKS/SPALLED/REINFORCEMENT EXPOSED |

| Question | Response |
|---|--|
| Potential Action | REPAIR |

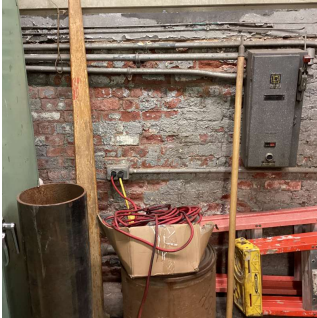
| Question | Response |
|---|--|
| Violations | Boiler Room<br>No violations recorded. |

| Question | Response |
|---|--|
| Condition | 3 - Fair |
| Deficiency | BRICK: CRACKED/SPALLED |

| Question | Response |
|---|--|
| Urgency of Action | PRIORITY 3 |

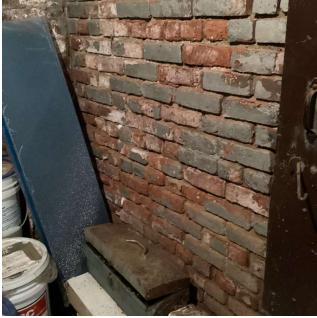
| Question | Response |
|---|--|
| Violations | Vault<br>No violations recorded. |

| Question | Response |
|---|--|
| Condition | 3 - Fair |
| Deficiency | DETERIORATED JOINTS |

| Question | Response |
|---|--|
| Urgency of Action | PRIORITY 4 |

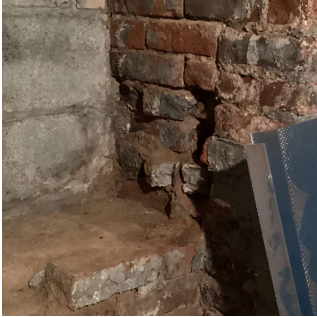
| Question | Response |
|--|--|
| Violations | Vault<br>No violations recorded. |

| Question | Response |
|---|--|
| Deficiency | CRACKS, SPALLING |

| Question | Response |
|---|--|
| Potential Action | REPAIR |

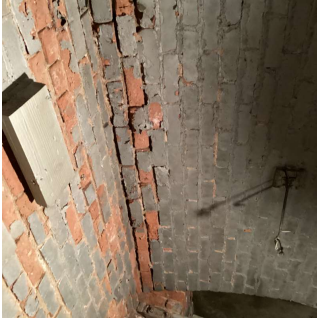
| Question | Response |
|--|--|
| Violations | Vault (Brick - Deteriorated Joints)<br>No violations recorded. |

| Question | Response |
|--|--|
| Condition | 3 - Fair |
| Deficiency | CLAY TILE: PLASTER MISSING |

| Question | Response |
|--|--|
| Potential Action | REPLACE |
| Urgency of Action | PRIORITY 4 |

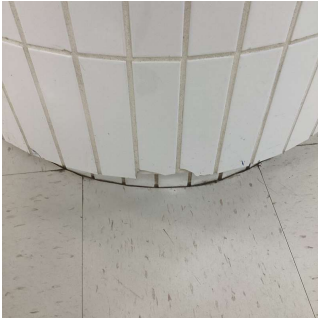
| Question | Response |
|--|---|
| | 4 Columns |

| Question | Response |
|--|---|
| Condition | 2 - Between Good and Fair |
| Deficiency | CERAMIC TILE: BROKEN/ MISSING |

| Question | Response |
|--|---|
| Potential Action | REPLACE |
| Urgency of Action | PRIORITY 3 |

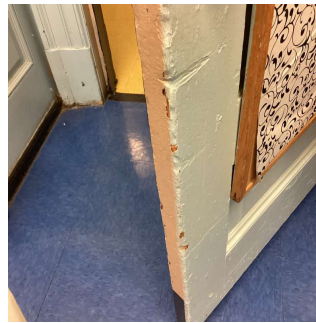
Room 205

| Question | Response |
|--|---|
| Condition | 5 - Poor |
| Deficiency | WOOD: DETERIORATED DOOR |
| Deficiency Location/Instance | Rooms 103, 205, 207, 208, 209, and others |

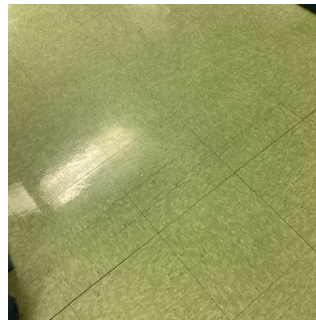
Corridor

VINYL TILES: DETERIORATED SUBSTRATE

REPLACE

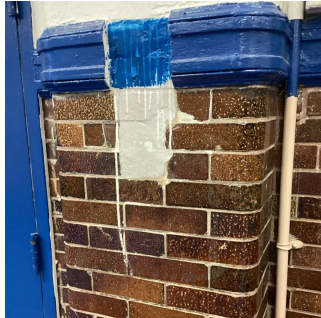
| Question | Response |
|---|--|
| | Right Side |

| Question | Response |
|---|--|
| Condition | 2 - Between Good and Fair |
| Deficiency | BRICK: CRACKS/SPALLING |

| Question | Response |
|---|--|
| Potential Action | REPLACE |
| Urgency of Action | PRIORITY 3 |

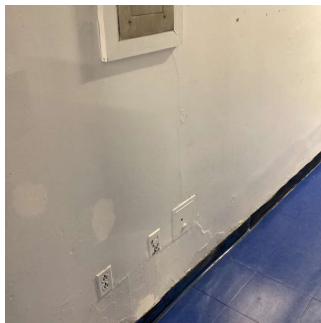
| Question | Response |
|---|--|
| | Near Stair B |

| Question | Response |
|---|--|
| Condition | 2 - Between Good and Fair |
| Deficiency | PLASTER: CRACKS/SPALLING |

| Question | Response |
|---|--|
| Potential Action | REPLACE |

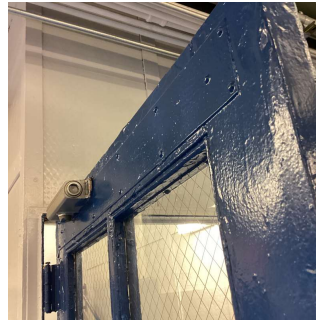
Stair AC/Basement

| Question | Response |
|---|--|
| Condition | 3 - Fair |
| Deficiency | METAL CLAD WOOD: DETERIORATED DOOR |

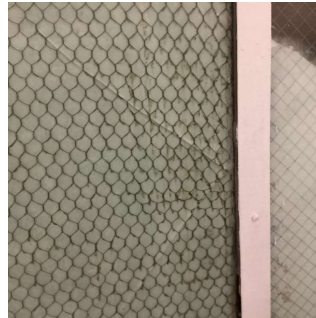
Stair BD/Basement

GLASS PANEL: DAMAGED/DETERIORATED

REPLACE
