NYC Department of Education
Building Condition Assessment Survey 2023 - 2024

Architectural Inspection

K131

Asset: P.S. 131 - BROOKLYN, 4305 FT HAMILTON PKWY, New York, 11219

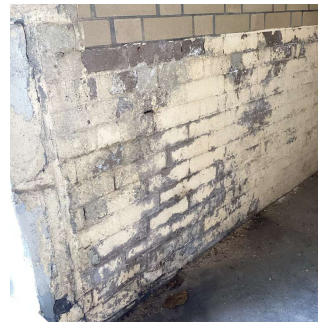
AW6

AREAWAY WALLS: CRACKS AND SPALLING

REPAIR

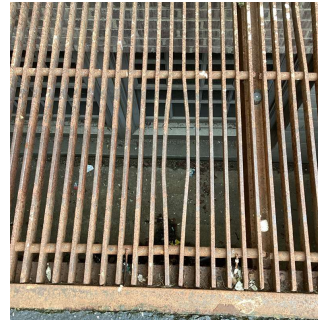
AW4

AREAWAY GRATINGS: MAJOR RUSTING / OR BROKEN

REPLACE

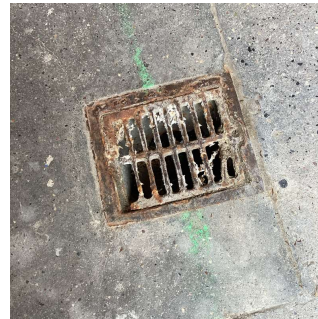
AW1

AREAWAY DRAINS: DETERIORATED

REPLACE

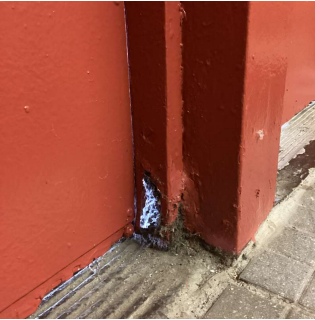
Question	Response
EXTERIOR	
CORNICE	Inspected
Deficiency	No deficiencies recorded
DOORS	Inspected
DOORS AND FRAMES	Inspected
Condition	4 - Between Fair and Poor
Deficiency	METAL CLAD: DETERIORATED DOOR AND FRAME - MAJOR DETERIORATION
Roof Plan reference

Deficiency Quantity	4
Quantity Uom	EACH
Potential Action	REPLACE
Urgency of Action	PRIORITY 4
Purpose of Action	LEVEL 2
Deficiency Photo1

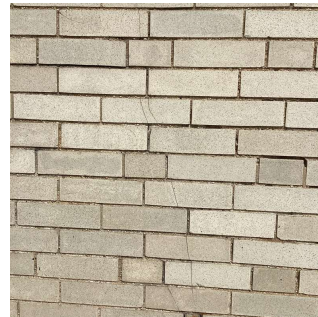
Facade H

BRICK: MINOR CRACKS AND SPALLING

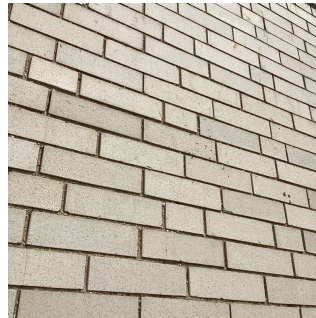
Facade H

BRICK: DETERIORATED JOINTS

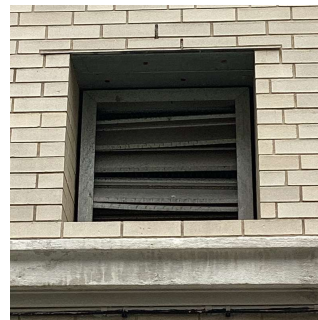
Facade C

BROKEN/ DENTED BLADES

REPLACE

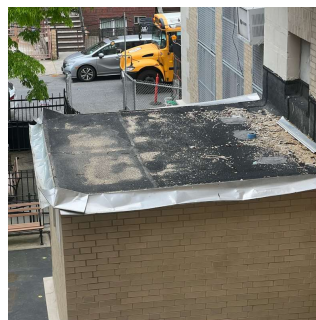
Roof 10

Installation Year	1994
Source of Installation	Inspector Estimate
Deficiency	MODIFIED BITUMEN: FLASHING: DRIP EDGE/GRAVEL STOP DAMAGED

Deficiency Quantity	80
Quantity Uom	L.F.
Potential Action	REPLACE
Urgency of Action	PRIORITY 4
Purpose of Action	LEVEL 2
Deficiency Photo1

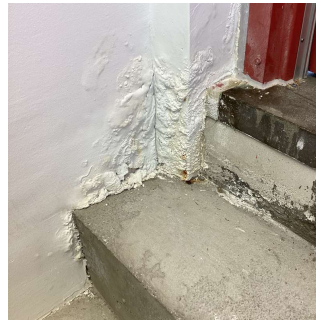
BH1

**BULKHEAD/PENTHOUSE WALLS/INTERIOR: PLASTER
CRACKS/SPALLING**

REPLACE

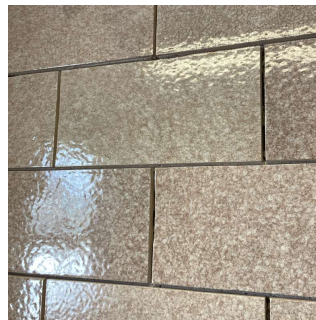
BH2

Deficiency	BULKHEAD/PENTHOUSE WALLS/INTERIOR: GLASS BLOCK DETERIORATED JOINTS
------------	--

Deficiency Quantity	80
Quantity Uom	S.F.
Potential Action	REPOINT
Urgency of Action	PRIORITY 3
Purpose of Action	LEVEL 2
Deficiency Photo1

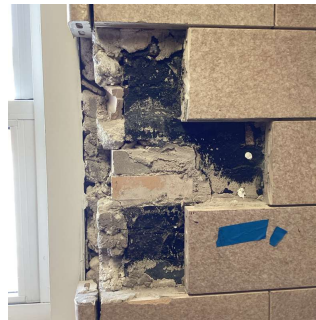
BH2
 No violations recorded.

Deficiency	BULKHEAD/PENTHOUSE WALLS/INTERIOR: GLASS BLOCK CRACKS/SPALLING
------------	--

20
 S.F.
 REPLACE
 PRIORITY 4
 LEVEL 2

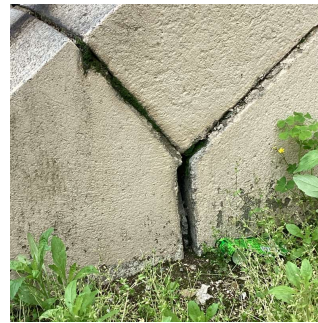
Facade G

STONE: DETERIORATED JOINTS

10
S.F.
REPOINT
PRIORITY 4
LEVEL 2

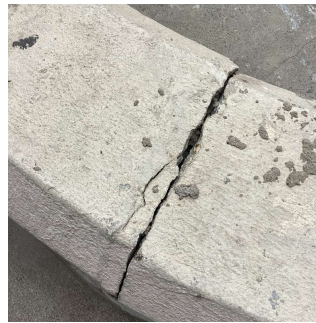
Facade B

CAST IN PLACE CONCRETE: DETERIORATED COPING STONE

10
S.F.
REPAIR
PRIORITY 3
LEVEL 2

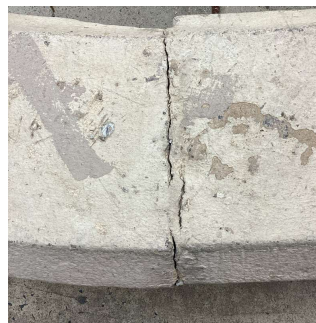
Facade B

STONE: DETERIORATED JOINTS AT COPING STONES

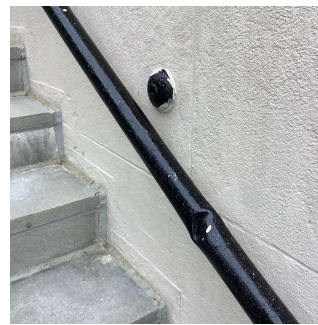
Facade A

BROKEN BRACKET

1
EACH
REPLACE
PRIORITY 4
LEVEL 2

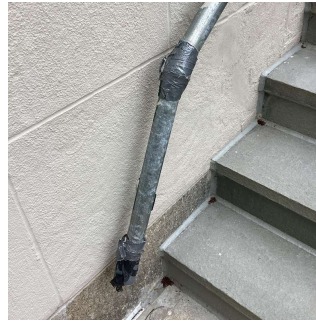
Facade B

DAMAGED

20
L.F.
REPLACE
PRIORITY 4
LEVEL 2

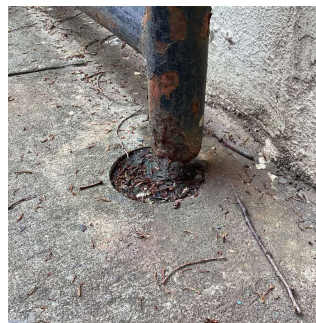
Facade C1

RUST - MAJOR

REPLACE

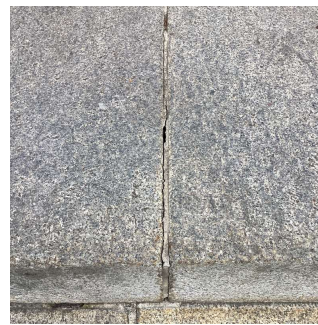
Facade L

STONE: DETERIORATED JOINTS

20
L.F.
REPOINT
PRIORITY 3
LEVEL 2

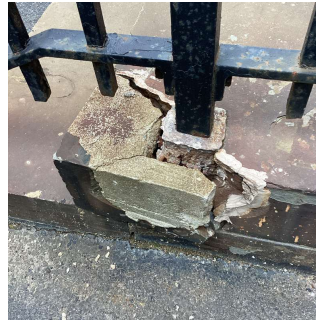
Facade K

STONE: CRACKS/SPALLING - MAJOR

20
S.F.
REPLACE
PRIORITY 4
LEVEL 2

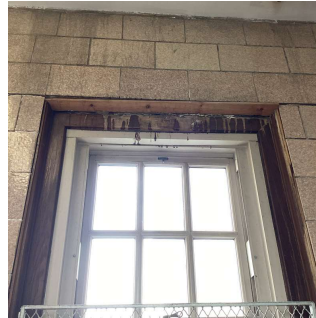
Facade E - 2nd Floor Bridge (Facade K - MDF Room 129, similar)

ALUMINUM - DOUBLE HUNG: AIR/WATER INFILTRATION, DETERIORATED JOINTS WITH DAMAGED CAULKING

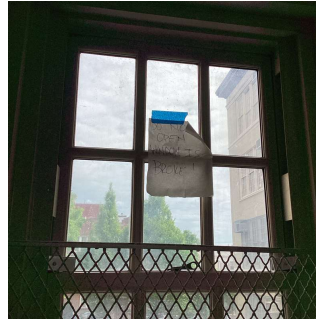
Facade E - 1st Floor Bridge (Facade A - Cafeteria similar)

ALUMINUM - DOUBLE HUNG: DETERIORATED

S.F.
REPLACE WINDOW
PRIORITY 4
LEVEL 2

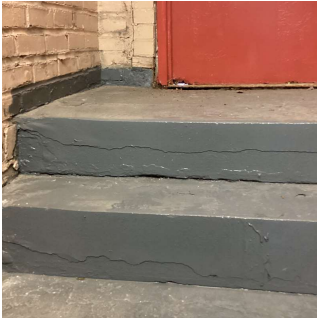
Question	Response
INTERIOR	
STAIRS/RAMPS: INTERIOR	
Stairs and Landings	
Deficiency	CONCRETE: CRACKS/SPALLING - MAJOR
Deficiency Location/Instance	Exit 13 Vestibule
Deficiency Quantity	10
Quantity Uom	S.F.
Potential Action	REPLACE
Urgency of Action	PRIORITY 3
Purpose of Action	LEVEL 2
Deficiency Photo1

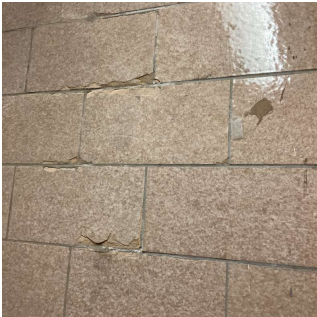
Violations	Exit 13 Vestibule No violations recorded.
Walls	Inspected
Condition	2 - Between Good and Fair
Deficiency	GLAZED BLOCK: CRACKS/SPALLING
Deficiency Location/Instance	Stair by Auditorium/Exit 9
Deficiency Quantity	20
Quantity Uom	S.F.
Potential Action	REPLACE
Urgency of Action	PRIORITY 3
Purpose of Action	LEVEL 2
Deficiency Photo1

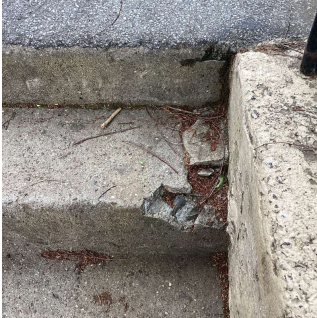
Violations	43rd Street - Leading up to the Schoolyard No violations recorded.

Violations	44th Street - Leading up to the Schoolyard No violations recorded.
Deficiency	CAST IN PLACE CONCRETE: CRACKS/SPALLING - MAJOR
Deficiency Location/Instance	43rd Street - Leading up to the Schoolyard
Deficiency Quantity	30
Quantity Uom	S.F.
Potential Action	REPLACE
Urgency of Action	PRIORITY 5
Purpose of Action	LEVEL 6
Deficiency Photo1
