NYC Department of Education
Building Condition Assessment Survey 2023 - 2024

Architectural Inspection

Asset: P.S. 135 - BROOKLYN, 684 LINDEN BLVD, New York, 11203

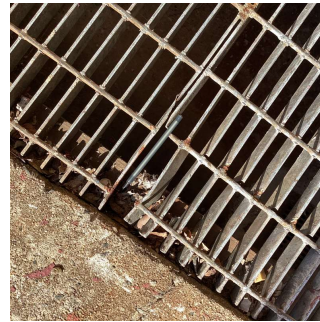
Question	Response
Architectural	
EXTERIOR	Inspected
AREAWAY	Inspected
Instance on AW1	Inspected
Instance Condition	3 - Fair
Instance Quantity	1
Instance Quantity Uom	EACH
Deficiency	AREAWAY GRATINGS: MAJOR RUSTING / OR BROKEN

REPLACE

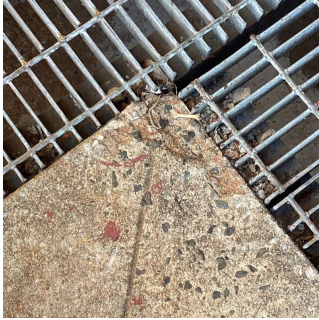
AREAWAY WALLS: CRACKS AND SPALLING

REPAIR

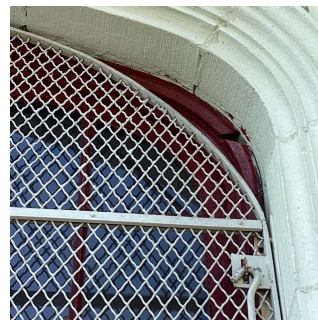
Facade A
No violations recorded.

WOOD: EXCESSIVELY WEATHERED

40
S.F.
REPLACE
PRIORITY 4
LEVEL 2

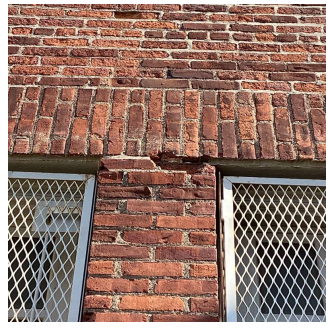
Question	Response
EXTERIOR	
EXTERIOR WALLS	
Replacement Uom	S.F.
Instance on All Facades	Inspected
Instance Condition	3 - Fair
Instance Quantity	34,000
Instance Quantity Uom	S.F.
Deficiency	BRICK: MAJOR / THRU CRACKS
Roof Plan reference

Deficiency Quantity	10
Quantity Uom	S.F.
Potential Action	REMOVE AND REBUILD
Urgency of Action	PRIORITY 4
Purpose of Action	LEVEL 2
Deficiency Photo1

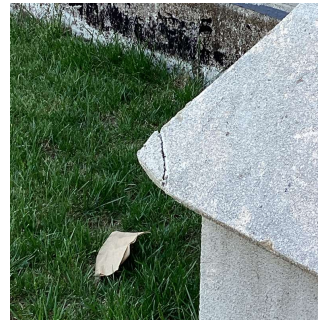
Facade H

Violations	Facade G No violations recorded.
Deficiency	STONE: CHIPPED/SPALLED/BROKEN PIECES - MINOR

REPAIR

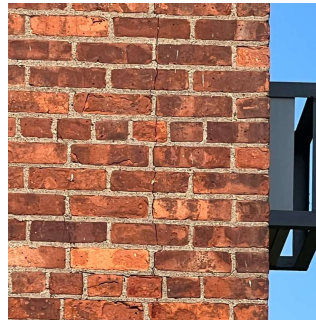
Facade B

BRICK: CRACKS/DISPLACED/SPALLED BRICK AT BUILDING CORNERS

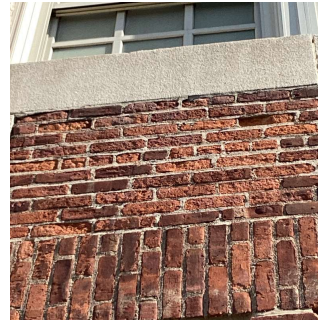
Facade G

BRICK: MINOR CRACKS AND SPALLING

PRIORITY 3
LEVEL 2

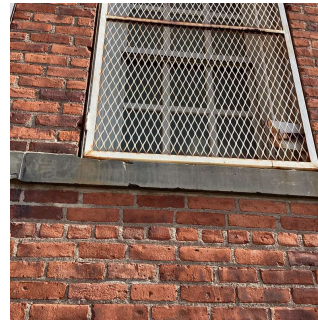
Facade C

BRICK: DETERIORATED MASONRY SILLS - MINOR

REPAIR

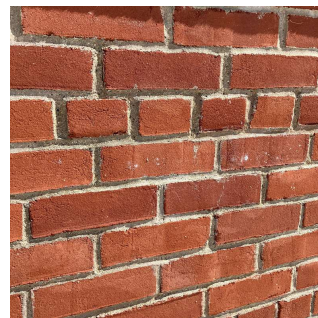
Roof 1

BRICK: DETERIORATED JOINTS

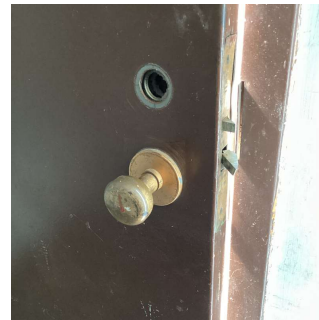
BH1 (does not close)
 No violations recorded.

Deficiency	BULKHEAD/PENTHOUSE DOORS: DETERIORATED DOOR AND FRAME
------------	---

Deficiency Quantity	1
Quantity Uom	EACH
Potential Action	REPLACE DOOR AND FRAME
Urgency of Action	PRIORITY 4
Purpose of Action	LEVEL 2
Deficiency Photo1

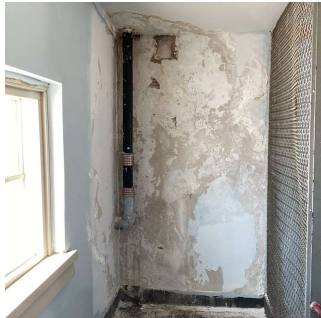
Deficiency	BULKHEAD/PENTHOUSE WALLS/INTERIOR: PLASTER CRACKS/SPALLING
------------	--

BH2
Violations	No violations recorded.
Deficiency	BULKHEAD/PENTHOUSE WALLS/EXTERIOR: DETERIORATED JOINTS
Roof Plan reference

Question	Response
EXTERIOR	
ROOF	
Specialties	
BULKHEAD/PENTHOUSE	
Quantity Uom	S.F.
Potential Action	REPLACE
Urgency of Action	PRIORITY 4
Purpose of Action	LEVEL 2
Deficiency Photo1

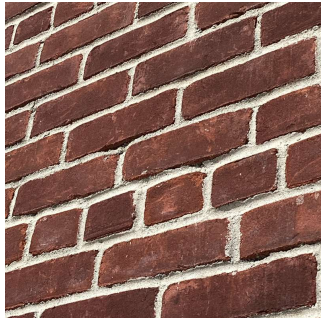
BH2
Violations	No violations recorded.
CUPOLA/ SPIRES/ TOWERS	Does not Exist
DORMER	Does not Exist
DUNNAGE STEEL	Does not Exist

Deficiency Quantity	20
Quantity Uom	S.F.
Potential Action	REPOINT
Urgency of Action	PRIORITY 3
Purpose of Action	LEVEL 2
Deficiency Photo1

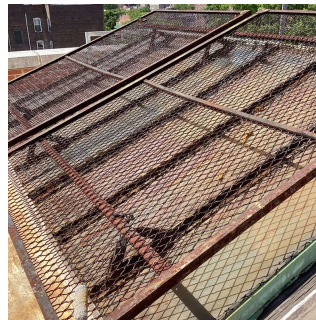
SK3
No violations recorded.

DAMAGED GUARDS

50
S.F.
MAINTENANCE
PRIORITY 3
LEVEL 2

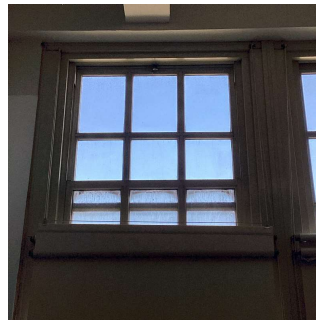
Facade A - Room 207 (Custodians Office, Room 506 similar)
No violations recorded.

Source of Installation	Custodial Staff
Deficiency	ALUMINUM - DOUBLE HUNG: INOPERABLE BALANCE

70
EACH
REPLACE BALANCES
PRIORITY 3
LEVEL 2

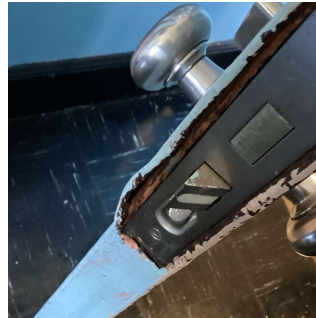
Room 506

METAL: DETERIORATED DOOR

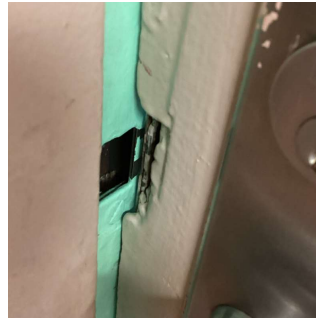
Room 506

WOOD: DETERIORATED DOOR

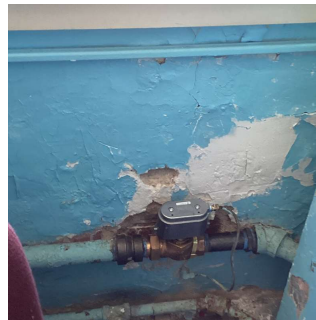
Room 307

PLASTER: CRACKS/SPALLING

REPLACE

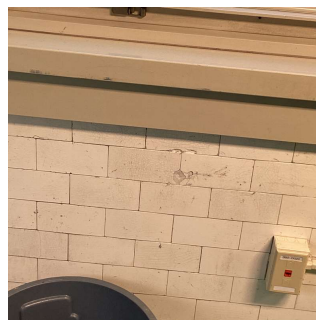
CERAMIC TILE: BROKEN/ MISSING

REPLACE

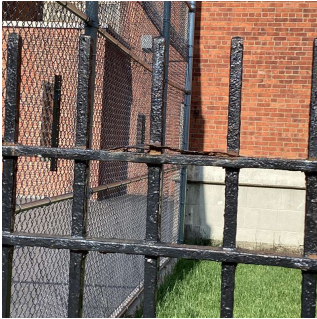
Schoolyard
Violations	No violations recorded.
Deficiency	WROUGHT IRON: RUST - MAJOR
Deficiency Location/Instance	E.48th Street
Deficiency Quantity	40
Quantity Uom	S.F.
Potential Action	REPLACE
Urgency of Action	PRIORITY 3
Purpose of Action	LEVEL 2
Deficiency Photo1

E.48th Street
Violations	No violations recorded.
Deficiency	WROUGHT IRON: DAMAGED/DETERIORATED
Deficiency Location/Instance	E.48th Street, Linden Boulevard, Schenectady Avenue
Deficiency Quantity	280
Quantity Uom	S.F.
Potential Action	REPLACE
Urgency of Action	PRIORITY 3
Purpose of Action	LEVEL 2
Deficiency Photo1	 
	Linden Boulevard
