NYC Department of Education
Building Condition Assessment Survey 2023 - 2024

Architectural Inspection

K145

Asset: P.S. 145 - BROOKLYN, 100 NOLL STREET, New York, 11206

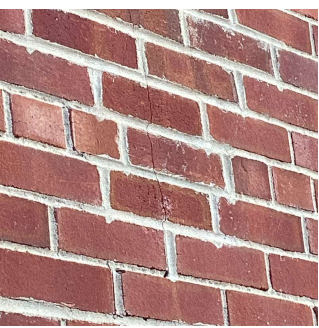
Question	Response
Architectural	
EXTERIOR	Inspected
AREAWAY	Inspected
Instance on AW1-AW2	Inspected
Instance Condition	2 - Between Good and Fair
Instance Quantity	2
Instance Quantity Uom	EACH
Deficiency	No deficiencies recorded
AWNINGS AND CANOPIES	Does not Exist
CHIMNEY	Inspected
Material Type(s)	Masonry
Condition	3 - Fair
Deficiency	BRICK: MAJOR / THRU CRACKS
Roof Plan reference	<p>K145</p>

Deficiency Quantity	20
Quantity Uom	S.F.
Potential Action	REMOVE AND REBUILD
Urgency of Action	PRIORITY 4
Purpose of Action	LEVEL 2
Deficiency Photo1

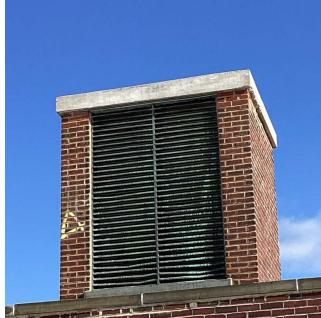
Question	Response
EXTERIOR	
LOUVER	
Deficiency Quantity	80
Quantity Uom	S.F.
Potential Action	REPLACE
Urgency of Action	PRIORITY 4
Purpose of Action	LEVEL 2
Deficiency Photo1

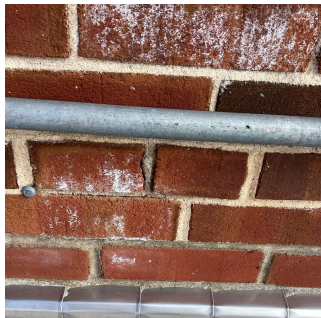
Roof 1	Roof 1
Violations	No violations recorded.

PH	PH
Violations	No violations recorded.
PARAPETS	
Material Type(s)	Inspected Masonry
Replacement Quantity	6,700
Replacement Uom	C.F.
Instance on All Facades	Inspected
Instance Condition	3 - Fair
Instance Quantity	6,700
Instance Quantity Uom	C.F.
Deficiency	BRICK: DETERIORATED JOINTS
Roof Plan reference	K145

Deficiency Quantity	10
Quantity Uom	S.F.
Potential Action	REPOINT
Urgency of Action	PRIORITY 4
Purpose of Action	LEVEL 2
Deficiency Photo1

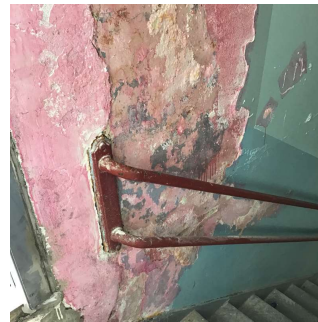
Roof 2 BH
35651093P

Does this roof instance have a Sustainable Roof System?	No
Do solar panels exist on these roofs?	No
Is/Are the roof(s) suitable for Solar Panel installation?	No
Installation Year	1989
Source of Installation	Inspector Estimate
Deficiency	No deficiencies recorded
ROOFING DRAINS	Inspected
Condition	2 - Between Good and Fair
Deficiency	No deficiencies recorded
Specialties	Inspected
BULKHEAD/PENTHOUSE	Inspected
Condition	3 - Fair
Deficiency	BULKHEAD/PENTHOUSE WALLS/INTERIOR: PLASTER CRACKS/SPALLING

80
S.F.
REPLACE
PRIORITY 4
LEVEL 4

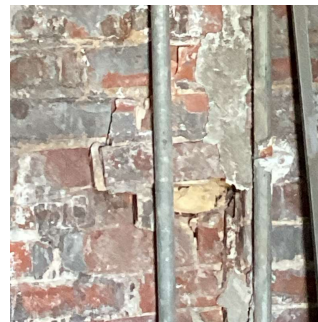
PH

**BULKHEAD/PENTHOUSE WALLS/INTERIOR: BRICK
CRACKS/SPALLING**

50
S.F.
REPLACE
PRIORITY 4
LEVEL 2

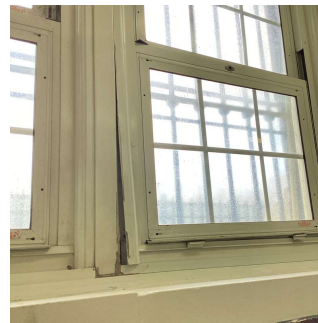
Facade A - Cafeteria

ALUMINUM - DOUBLE HUNG: DETERIORATED

REPLACE WINDOW

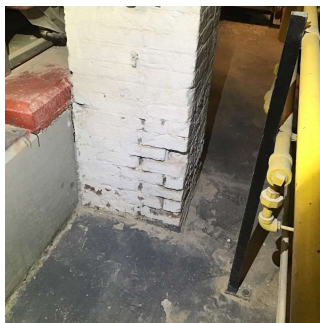
Question	Response
INTERIOR	
STRUCTURAL	
COLUMNS/BEAMS/BEARING WALLS	
Violations	Boiler Room No violations recorded.
Deficiency	STEEL COLUMNS/BEAMS: DETERIORATED MASONRY FIREPROOFING
Deficiency Location/Instance	Basement
Deficiency Quantity	50
Quantity Uom	S.F.
Potential Action	REPLACE
Urgency of Action	PRIORITY 3
Purpose of Action	LEVEL 5
Deficiency Photo1

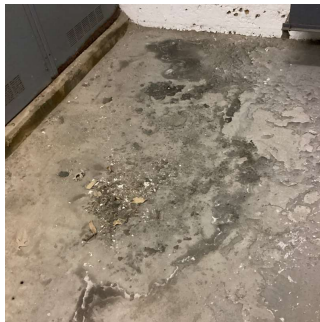
Violations	Boiler Room No violations recorded.
FLOOR STRUCTURE	
Condition	Inspected 4 - Between Fair and Poor
Deficiency	CONCRETE SLAB ON GRADE: WATER INFILTRATION IN ELECTRICAL PANEL ROOM
Deficiency Location/Instance	Basement - Electrical Room
Deficiency Quantity	50
Quantity Uom	S.F.
Potential Action	INSTALL WATERPROOFING
Urgency of Action	PRIORITY 5
Purpose of Action	LEVEL 6
Deficiency Photo1

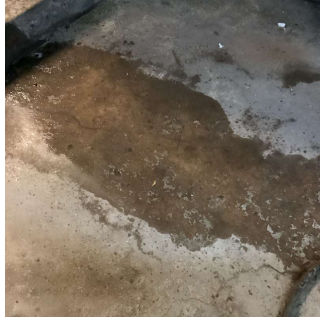
Violations	Basement - Electrical Room No violations recorded.
Deficiency	CONCRETE SLAB ON GRADE: WATER INFILTRATION IN NON- INSTRUCTIONAL SPACE
Deficiency Location/Instance	Basement - Boiler Room near Auditorium exhaust

Deficiency Quantity	100
Quantity Uom	S.F.
Potential Action	INSTALL WATERPROOFING

Question	Response
INTERIOR	
STRUCTURAL	
FLOOR STRUCTURE	
Urgency of Action	PRIORITY 5
Purpose of Action	LEVEL 5
Deficiency Photo1

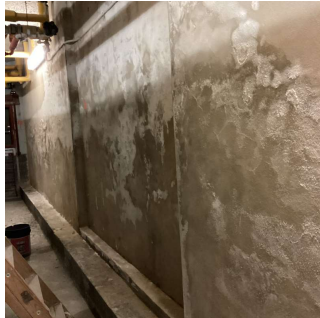
Violations	Basement - Boiler Room near Auditorium exhaust No violations recorded.
FOUNDATION WALLS	
Material Type(s)	Inspected Concrete
Condition	4 - Between Fair and Poor
Deficiency	CONCRETE: WATER INFILTRATION IN NON- INSTRUCTIONAL SPACE
Deficiency Location/Instance	Basement - Gas meter, Boiler room, Oil Tank room
Deficiency Quantity	300
Quantity Uom	S.F.
Potential Action	INSTALL WATERPROOFING
Urgency of Action	PRIORITY 5
Purpose of Action	LEVEL 5
Deficiency Photo1

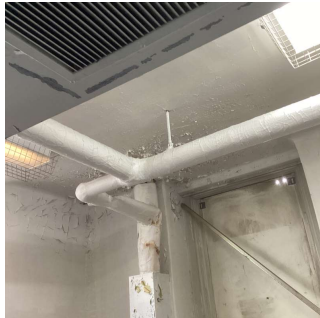
Deficiency	PLASTER: CRACKS/SPALLING - ACTIVE LEAK
Deficiency Location/Instance	Near Stair FG/Basement
Deficiency Quantity	20
Quantity Uom	S.F.
Potential Action	REPLACE
Urgency of Action	PRIORITY 5
Purpose of Action	LEVEL 2
Deficiency Photo1

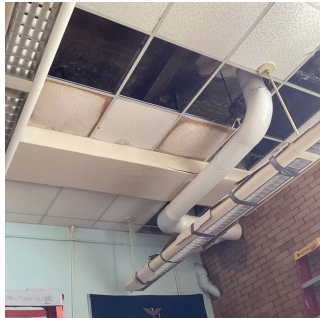
Question	Response
INTERIOR	
CAFETERIA	Inspected
Walls	
Violations	No violations recorded.
Window Curtains/Shades/Blinds	
Instance on Basement	Does not Exist
CLASSROOMS/CORRIDORS/ADMIN SPACES	Inspected
Ceiling	Inspected
Condition	2 - Between Good and Fair
Deficiency	PLASTER: CRACKS/SPALLING
Deficiency Location/Instance	Rooms 409A, 417, 419, 426, Corridor near Stair D/4 and others
Deficiency Quantity	180
Quantity Uom	S.F.
Potential Action	REPLACE
Urgency of Action	PRIORITY 3
Purpose of Action	LEVEL 2
Deficiency Photo1

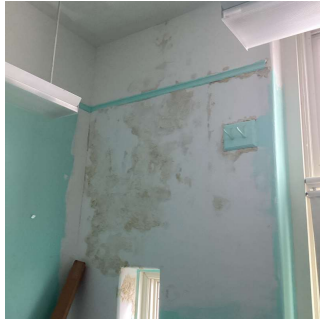
Question	Response
INTERIOR	
CLASSROOMS/CORRIDORS/ADMIN SPACES	
Floor Finish	Inspected
Violations	No violations recorded.
Walls	Inspected
Condition	2 - Between Good and Fair
Deficiency	PLASTER: CRACKS/SPALLING - ACTIVE LEAK
Deficiency Location/Instance	Room 301, 401, 409A
Deficiency Quantity	250
Quantity Uom	S.F.
Potential Action	REPLACE
Urgency of Action	PRIORITY 5
Purpose of Action	LEVEL 2
Deficiency Photo1

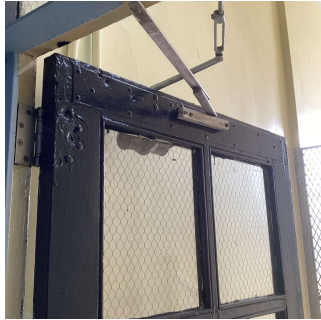
Deficiency	METAL CLAD WOOD: DETERIORATED DOOR
Deficiency Location/Instance	Stair D/4
Deficiency Quantity	2
Quantity Uom	EACH
Potential Action	MAINTENANCE
Urgency of Action	PRIORITY 3
Purpose of Action	LEVEL 2
Deficiency Photo1

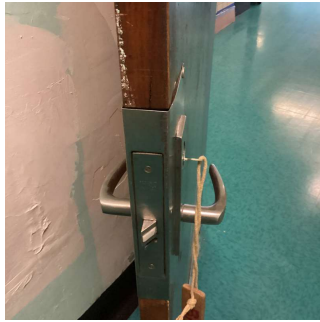
Question	Response
INTERIOR	
TOILET ROOMS - STAFF	
Ceiling	Inspected
Deficiency Photo1	 
Violations	Men Toilet Room - 3rd Floor No violations recorded.
Door(s)	Inspected
Condition	5 - Poor
Deficiency	WOOD: DETERIORATED DOOR
Deficiency Location/Instance	In Women Kitchen Locker Room, Women Toilet Room - 3rd Floor, Men Toilet Room - 3rd, 2nd Floor
Deficiency Quantity	4
Quantity Uom	EACH
Potential Action	MAINTENANCE
Urgency of Action	PRIORITY 3
Purpose of Action	LEVEL 2
Deficiency Photo1
