**NYC Department of Education
Building Condition Assessment Survey 2023 - 2024**

Architectural Inspection

Asset: P.S. 373 (OLD P148) - BROOKLYN, 185 ELLERY STREET, New York, 11206

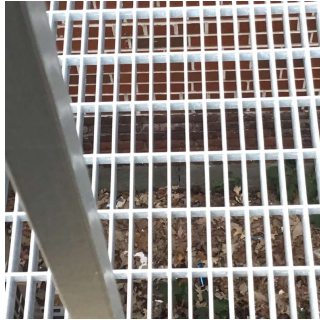
AREAWAY WALLS: DETERIORATED JOINTS

REPAIR

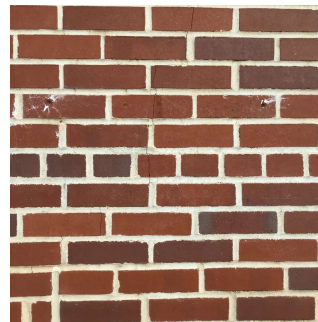
Violations	Chimney 2 No violations recorded.
Deficiency	BRICK: MINOR CRACKS AND SPALLING

10
S.F.
RESTITCH
PRIORITY 3
LEVEL 2

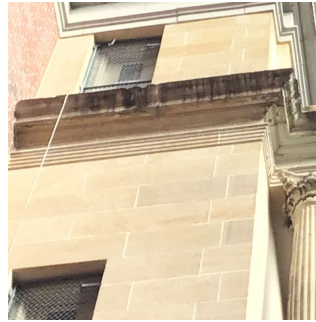
Facade A - Main Entry
No violations recorded.

PRE-CAST CONCRETE: MINOR CRACKS, SPALLING

100
S.F.
REPAIR
PRIORITY 3
LEVEL 2

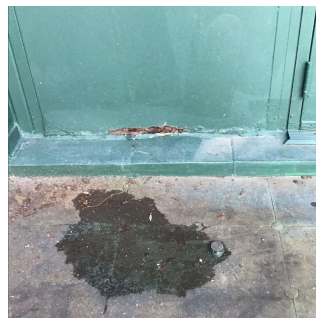
METAL: DENTED, MAJOR RUSTING

REPLACE

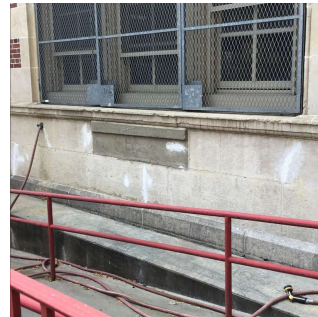
Facade B - Near Ramp

BRICK: DETERIORATED MASONRY SILLS - MINOR

REPAIR

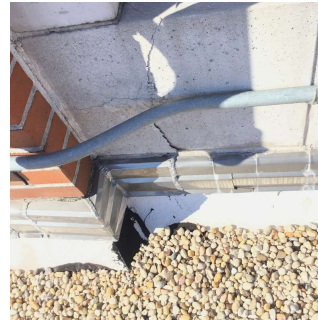
Roof 1 Facade H

Deficiency **CONCRETE: MAJOR DETERIORATION/CRACKS**

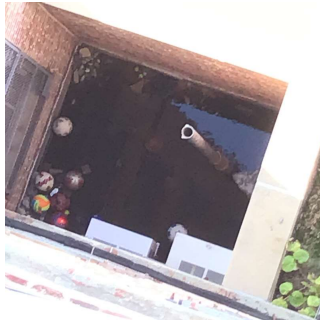
ROOFING DRAINS	Inspected
Condition	3 - Fair
Deficiency	CLOGGED
Roof Plan reference

Deficiency Quantity	1
Quantity Uom	EACH
Potential Action	MAINTENANCE
Urgency of Action	PRIORITY 5
Purpose of Action	LEVEL 2

Violations	Roof 2A No violations recorded.
Specialties	Inspected
BULKHEAD/PENTHOUSE	Inspected
Condition	2 - Between Good and Fair
Deficiency	No deficiencies recorded
CUPOLA/ SPIRES/ TOWERS	Does not Exist
DORMER	Does not Exist
DUNNAGE STEEL	Does not Exist
SKYLIGHT/ROOF VENT	Does not Exist
ROOF/GRAVITY TANK	Does not Exist
STAIRS/RAMPS: EXTERIOR	Inspected
BUILDING CHEEK/FLANK WALLS	Inspected
Condition	2 - Between Good and Fair
Deficiency	No deficiencies recorded
RAILINGS	Inspected
Condition	2 - Between Good and Fair
Deficiency	No deficiencies recorded
STAIRS/RAMPS	Inspected
Condition	5 - Poor
Deficiency	STONE: DETERIORATED JOINTS
Roof Plan reference

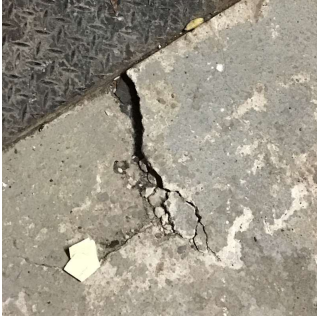
Urgency of Action	PRIORITY 3
Purpose of Action	LEVEL 5
Deficiency Photo1	 
	Basement Electrical Room
Violations	No violations recorded.
FLOOR STRUCTURE	Inspected
Condition	3 - Fair
Deficiency	CONCRETE SLAB ON GRADE: THRU CRACKS
Deficiency Location/Instance	Basement Fan Room South
Deficiency Quantity	10
Quantity Uom	S.F.

Question	Response
INTERIOR	
STRUCTURAL	
FLOOR STRUCTURE	
Potential Action	REPLACE
Urgency of Action	PRIORITY 4
Purpose of Action	LEVEL 5
Deficiency Photo1

Basement Fan Room South
Violations	No violations recorded.
Deficiency	CINDER CONCRETE ARCH: METAL PAN DETERIORATED, SPALLED
Deficiency Location/Instance	Basement Fan Room North, South
Deficiency Quantity	20
Quantity Uom	S.F.
Potential Action	REPAIR
Urgency of Action	PRIORITY 5
Purpose of Action	LEVEL 6
Deficiency Photo1

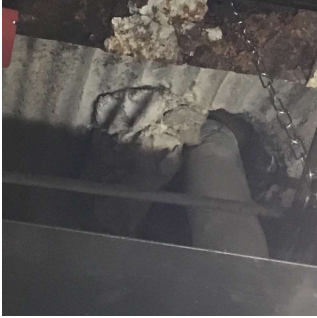
Basement Fan Room South
Violations	No violations recorded.
Deficiency	WOOD: DETERIORATED/DAMAGED
Deficiency Location/Instance	Rooms 208, 210, 310
Deficiency Quantity	100
Quantity Uom	S.F.
Potential Action	REPLACE
Urgency of Action	PRIORITY 3
Purpose of Action	LEVEL 5

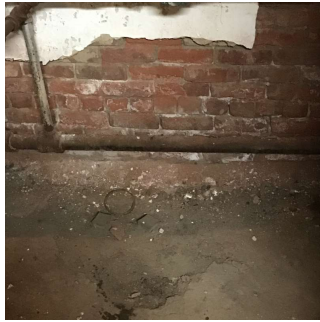
Electric Electrical Panel Room
Violations	No violations recorded.
Deficiency	BRICK: CRACKED/SPALLED
Deficiency Location/Instance	Basement Fan Room North, Boiler Room
Deficiency Quantity	200
Quantity Uom	S.F.
Potential Action	RESTITCH
Urgency of Action	PRIORITY 3
Purpose of Action	LEVEL 5
Deficiency Photo1

Basement Fan Room North
Violations	No violations recorded.
ROOF STRUCTURE	
	Inspected
Condition	4 - Between Fair and Poor
Deficiency	CINDER CONCRETE, FLAT SLAB: CRACKED/SPALLED/REINFORCEMENT EXPOSED
Deficiency Location/Instance	Basement Fan Room - North, Fan Room - South, Auditorium Storage Room
Deficiency Quantity	200
Quantity Uom	S.F.
Potential Action	REPAIR
Urgency of Action	PRIORITY 5
Purpose of Action	LEVEL 6

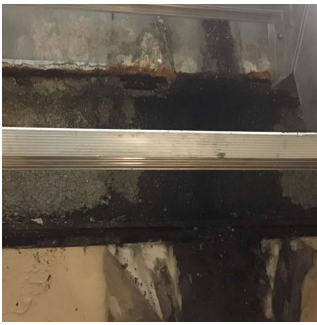
Basement Fan Room - South
Violations	No violations recorded.
VAULTS-BUNKERS	
Foundation Walls	Inspected
Condition	2 - Between Good and Fair
Deficiency	No deficiencies recorded
Slab Structure	Inspected
Condition	3 - Fair
Deficiency	CONCRETE SLAB ON GRADE: THRU CRACKS
Deficiency Location/Instance	Boiler Room
Deficiency Quantity	200
Quantity Uom	S.F.
Potential Action	REPAIR
Urgency of Action	PRIORITY 3
Purpose of Action	LEVEL 5
Deficiency Photo1

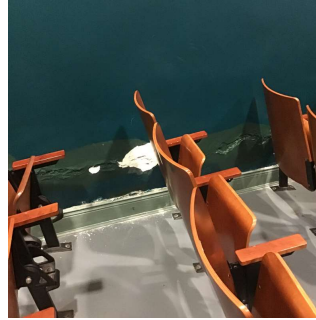
Deficiency	PLASTER: CRACKS/SPALLING
------------	--------------------------

Deficiency Location/Instance	Right Side
------------------------------	------------

Deficiency Quantity	100
---------------------	-----

Potential Action	REPLACE
------------------	---------

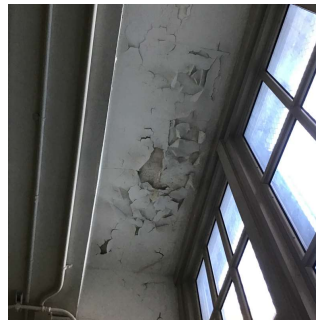
Deficiency	PLASTER: CRACKS/SPALLING
------------	--------------------------

Deficiency Location/Instance	Near Exit 6
------------------------------	-------------

Deficiency Quantity	10
---------------------	----

Potential Action	REPLACE
------------------	---------

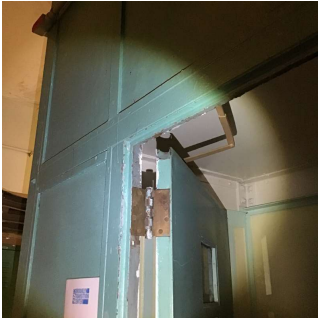
Stair F/1
Violations	No violations recorded.
Door(s)	Inspected
Condition	5 - Poor
Deficiency	METAL: DETERIORATED DOOR
Deficiency Location/Instance	Stair GH/Basement
Deficiency Quantity	1
Quantity Uom	EACH
Potential Action	MAINTENANCE
Urgency of Action	PRIORITY 3
Purpose of Action	LEVEL 2
Deficiency Photo1

Stair GH/Basement
Violations	No violations recorded.
Deficiency	METAL CLAD WOOD: DETERIORATED DOOR
Deficiency Location/Instance	Stairs AB/2,3, CD/3, JK/3
Deficiency Quantity	8
Quantity Uom	EACH
Potential Action	MAINTENANCE
Urgency of Action	PRIORITY 3
Purpose of Action	LEVEL 2

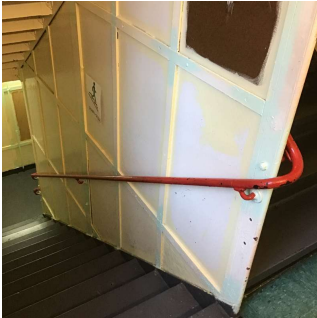
Violations	Stair GH/Basement No violations recorded.
Railings	
Condition	Inspected 5 - Poor
Deficiency	METAL: DAMAGED
Deficiency Location/Instance	Stair GH/1
Deficiency Quantity	32
Quantity Uom	L.F.
Potential Action	REPLACE
Urgency of Action	PRIORITY 3
Purpose of Action	LEVEL 2
Deficiency Photo1

Violations	Stair GH/1 No violations recorded.
Deficiency	METAL: MISSING
Deficiency Location/Instance	Stairs AB/4, CD/3,4, GH/4, JK/4, Basement Near Stair C
Deficiency Quantity	100
Quantity Uom	L.F.
Potential Action	REPLACE
Urgency of Action	PRIORITY 5

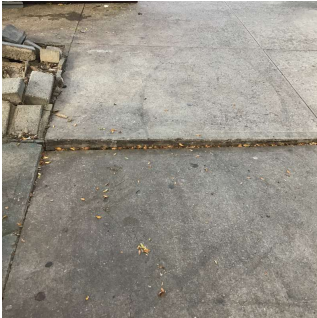
Violations	Ellery Street No violations recorded.
Deficiency	HEAVING
Deficiency Location/Instance	Ellery Street
Deficiency Quantity	225
Quantity Uom	S.F.

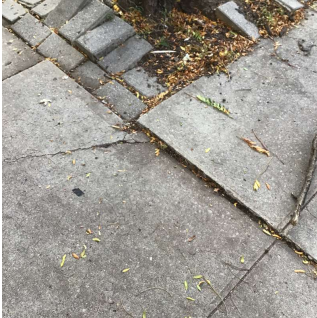
Ellery Street
Violations	No violations recorded.
Deficiency	DAMAGED CURBS
Deficiency Location/Instance	Ellery Street, Hopkins Street
Deficiency Quantity	55
Quantity Uom	L.F.
Potential Action	REPLACE
Urgency of Action	PRIORITY 3
Purpose of Action	LEVEL 2
Deficiency Photo1

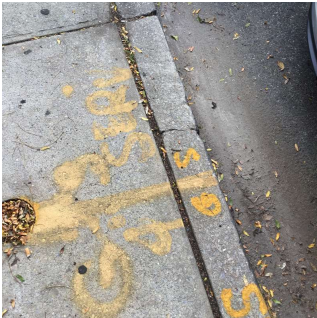
Ellery Street
Violations	No violations recorded.
Deficiency	DAMAGED/DETERIORATED/MISSING SECTIONS
Deficiency Location/Instance	Ellery Street
Deficiency Quantity	175
Quantity Uom	S.F.
Potential Action	REPLACE
Urgency of Action	PRIORITY 3
Purpose of Action	LEVEL 2
