**NYC Department of Education**  
**Building Condition Assessment Survey 2023 - 2024**

Architectural Inspection

**K151**

**Asset:** P.S. 151 - BROOKLYN, 763 KNICKERBOCKER AVENUE, New York, 11207

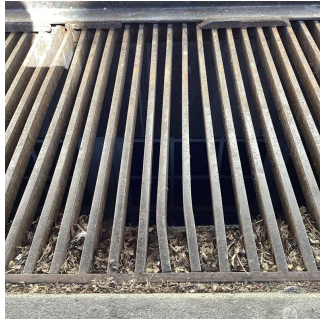
AREAWAY GRATINGS: MAJOR RUSTING / OR BROKEN

REPLACE

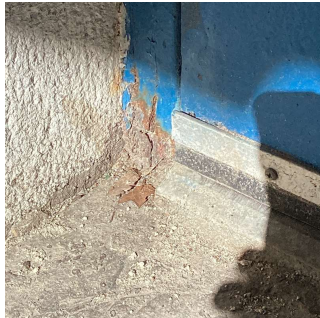
Violations	Facade M No violations recorded.

Violations	AW7 No violations recorded.
<b>AWNINGS AND CANOPIES</b>	Does not Exist
<b>CHIMNEY</b>	Under Construction
<b>COPING</b>	Under Construction
<b>CORNICE</b>	Inspected
Condition	2 - Between Good and Fair
Deficiency	No deficiencies recorded
<b>DOORS</b>	Inspected
<b>DOORS AND FRAMES</b>	Inspected
Condition	5 - Poor
Deficiency	METAL: DETERIORATED DOOR AND FRAME - MAJOR DETERIORATION
Roof Plan reference

Deficiency Quantity	8
Quantity Uom	EACH
Potential Action	REPLACE
Urgency of Action	PRIORITY 4
Purpose of Action	LEVEL 2
Deficiency Photo1

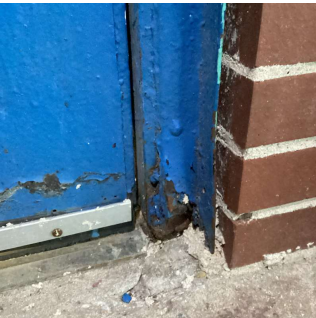
Question	Response
<b>EXTERIOR</b>	
<b>DOORS</b>	
<b>DOORS AND FRAMES</b>	
Deficiency	METAL CLAD: DETERIORATED DOOR AND FRAME - MAJOR DETERIORATION
Roof Plan reference

<p align="center">K151</p> <p align="center">Knickerbocker Avenue</p>
Deficiency Quantity	3
Quantity Uom	EACH
Potential Action	REPLACE
Urgency of Action	PRIORITY 4
Purpose of Action	LEVEL 2
Deficiency Photo1

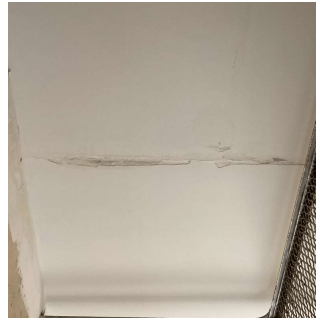
BH

Question	Response
<b>EXTERIOR</b>	
<b>PARAPETS</b>	Inspected
Material Type(s)	Masonry
Replacement Quantity	4,500
Replacement Uom	C.F.
Instance on All Facades	Under Construction
Instance Quantity	4,500
Instance Quantity Uom	C.F.
<b>PLAZA DECK</b>	Does not Exist
<b>ROOF</b>	Inspected
<b>Roofing</b>	Inspected
Replacement Quantity	15,000
Replacement Uom	S.F.
<b>ROOF HATCH/SMOKE HATCH</b>	Does not Exist
<b>LEADERS, GUTTERS, DOWNSPOUTS, SCUPPERS</b>	Inspected
Condition	2 - Between Good and Fair
Deficiency	No deficiencies recorded
<b>ROOF BARRIER/FENCE</b>	Under Construction
<b>ROOF CAGE</b>	Does not Exist
<b>ROOFING</b>	Inspected
Instance on Built-Up: All Roofs	Under Construction
Instance Quantity	15,000
Instance Quantity Uom	S.F.
<b>ROOFING DRAINS</b>	Under Construction
<b>Specialties</b>	Inspected
<b>BULKHEAD/PENTHOUSE</b>	Inspected
Condition	3 - Fair
Deficiency	BULKHEAD/PENTHOUSE CEILING: PLASTER DAMAGED/DETERIORATED
Roof Plan reference

Deficiency Quantity	20
Quantity Uom	S.F.
Potential Action	REPLACE
Urgency of Action	PRIORITY 3
Purpose of Action	LEVEL 2

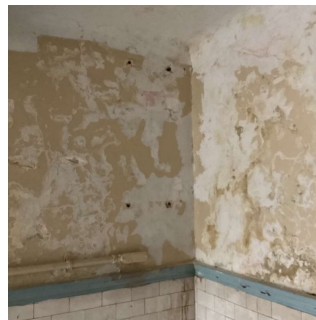
BH

**BULKHEAD/PENTHOUSE WALLS/INTERIOR: PLASTER  
CRACKS/SPALLING**

REPLACE

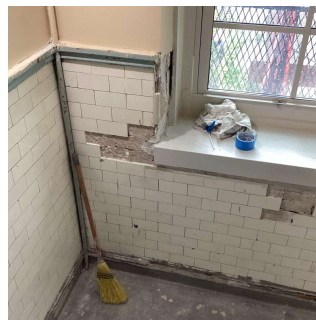
BH  
No violations recorded.

**BULKHEAD/PENTHOUSE WALLS/INTERIOR: GLAZED BLOCK  
CRACKS/SPALLING**

30  
S.F.  
REPLACE  
PRIORITY 4  
LEVEL 2

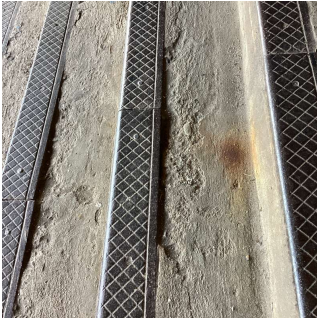
Violations	Facade A No violations recorded.

Violations	Facade C No violations recorded.
<b>RAILINGS</b>	Inspected
Condition	2 - Between Good and Fair
Deficiency	No deficiencies recorded
<b>STAIRS/RAMPS</b>	Inspected
Condition	5 - Poor
Deficiency	CONCRETE: WORN-OUT TREAD/RISER/NOSING
Roof Plan reference

Deficiency Quantity	20
Quantity Uom	S.F.
Potential Action	REPLACE
Urgency of Action	PRIORITY 5
Purpose of Action	LEVEL 6
Deficiency Photo1

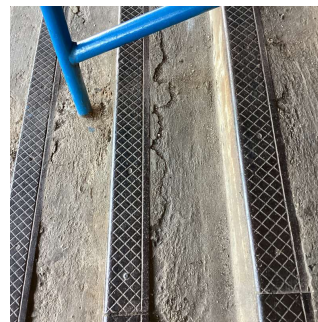
Facade A

CONCRETE: WORN-OUT TREAD/RISER/NOSING

60  
 S.F.  
 REPLACE  
 PRIORITY 4  
 LEVEL 2

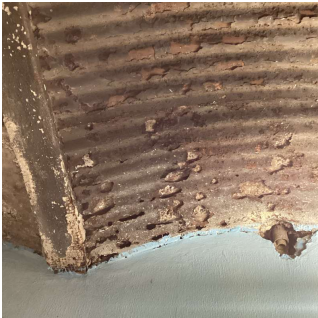
Violations	Oil Tank Room No violations recorded.
Deficiency	CINDER CONCRETE ARCH: METAL PAN DETERIORATED, SPALLED
Deficiency Location/Instance	Sub-basement - Oil Tank Room, Custodians Shop, Sprinkler Main, Boiler Room
Deficiency Quantity	200
Quantity Uom	S.F.
Potential Action	REPAIR
Urgency of Action	PRIORITY 4
Purpose of Action	LEVEL 5
Deficiency Photo1

Violations	Sub-basement - Oil Tank Room, Custodians Shop No violations recorded.

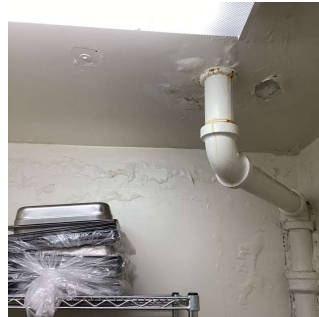
Question	Response
<b>INTERIOR</b>	
<b>STRUCTURAL</b>	
<b>FOUNDATION WALLS</b>	
Deficiency Location/Instance Deficiency Quantity Quantity Uom Potential Action Urgency of Action Purpose of Action Deficiency Photo1	Basement - Servery Storage, Servery 200 S.F. INSTALL WATERPROOFING PRIORITY 5 LEVEL 5

Violations	Basement - Servery Storage No violations recorded.
Deficiency  Deficiency Location/Instance Deficiency Quantity Quantity Uom Potential Action Urgency of Action Purpose of Action Deficiency Photo1	CONCRETE: WATER INFILTRATION IN NON- INSTRUCTIONAL SPACE  Sub-basement - Oil Tank Room, Boiler Room, Fan Areas 400 S.F. INSTALL WATERPROOFING PRIORITY 5 LEVEL 5

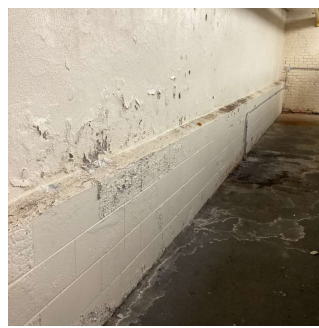
Violations	Sub-basement - Oil Tank Room No violations recorded.
Deficiency  Deficiency Location/Instance Deficiency Quantity Quantity Uom Potential Action Urgency of Action Purpose of Action	BRICK: DETERIORATED JOINTS  Sub-basement - Oil Tank Room, Gas Meter Room 200 S.F. REPOINT PRIORITY 4 LEVEL 5

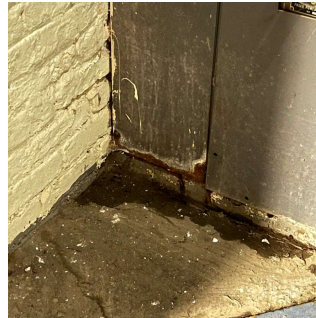
Sub-basement - Electrical Panel Room

**BRICK: WATER INFILTRATION IN ELECTRICAL PANEL ROOM**

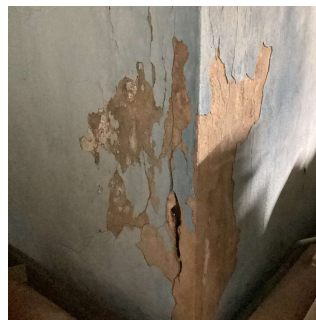
Sub-basement - Fan Area

**CONCRETE: CRACKED/SPALLED/REINFORCEMENT EXPOSED**

REPAIR

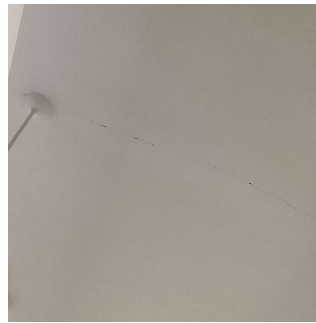
Room 201

Deficiency	PLASTER: CRACKS/SPALLING
Deficiency Location/Instance	Room 201, Corridor near Stair E/2
Deficiency Quantity	40
Quantity Uom	S.F.
Potential Action	REPLACE
Urgency of Action	PRIORITY 3
Purpose of Action	LEVEL 2

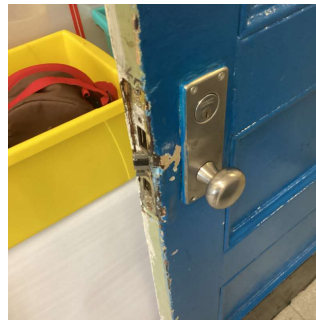
Room 306

METAL CLAD WOOD: DETERIORATED DOOR

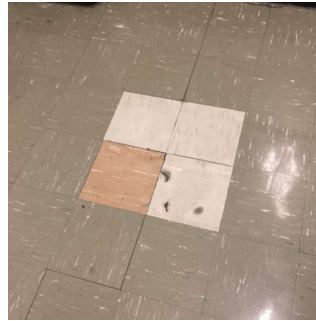
Corridor near room 303

Room 303
Violations	No violations recorded.
Deficiency	VINYL TILES: BROKEN/DETERIORATED/MISSING TILES
Deficiency Location/Instance	Corridor near room 303, Room 108A, 302
Deficiency Quantity	200
Quantity Uom	S.F.
Potential Action	REPLACE

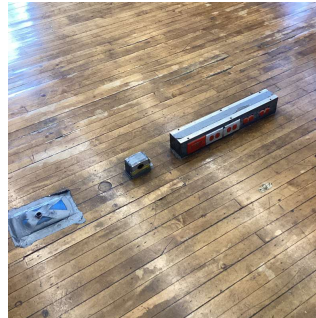
Room 311

WOOD: TRIPPING HAZARD - ELECTRICAL OUTLET

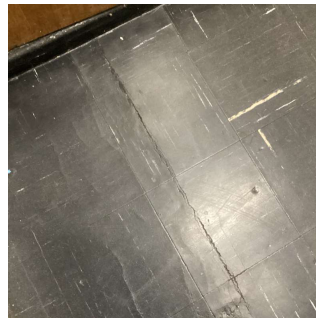
Room B06

VINYL TILES: DETERIORATED SUBSTRATE

REPLACE

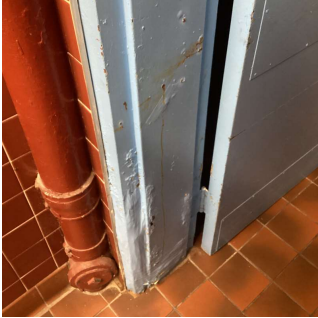
Storage Room
Violations	No violations recorded.
<b>Door(s)</b>	
Instance on Basement	Inspected
Condition	5 - Poor
Deficiency	METAL: DETERIORATED DOOR AND FRAME
Deficiency Location/Instance	Servery
Deficiency Quantity	1
Quantity Uom	EACH
Potential Action	MAINTENANCE
Urgency of Action	PRIORITY 3
Purpose of Action	LEVEL 2
Deficiency Photo1

Servery
Violations	No violations recorded.
Deficiency	WOOD: DETERIORATED DOOR
Deficiency Location/Instance	Entrance, Kitchen Staff Locker Room, Storage Room
Deficiency Quantity	3
Quantity Uom	EACH
Potential Action	MAINTENANCE

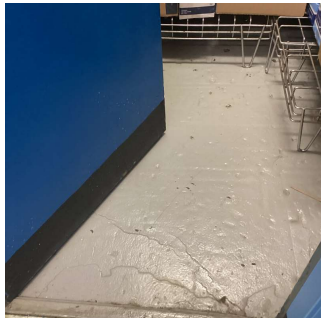
<b>Floor Finish</b>	
Instance on Basement	Inspected
Condition	3 - Fair
Deficiency	CONCRETE: CRACKS
Deficiency Location/Instance	Storage Room
Deficiency Quantity	15
Quantity Uom	S.F.
Potential Action	REPLACE
Urgency of Action	PRIORITY 3
Purpose of Action	LEVEL 2
Deficiency Photo1

Storage Room
Violations	No violations recorded.

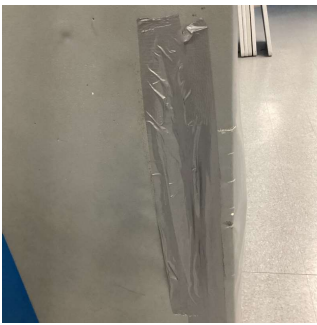
Condition	3 - Fair
Deficiency	WALL PADDING: DETERIORATED
Deficiency Location/Instance	Perimeter
Deficiency Quantity	180
Quantity Uom	S.F.
Potential Action	REPLACE
Urgency of Action	PRIORITY 3
Purpose of Action	LEVEL 2

Violations	Perimeter No violations recorded.
<b>Window Curtains/Shades/Blinds</b>	
Instance on 2nd Floor	Inspected
Condition	2 - Between Good and Fair
Deficiency	No deficiencies recorded
Instance on Basement	Does not Exist
<b>SCIENCE DEMO ROOM</b>	Does not Exist
<b>SCIENCE LAB</b>	Does not Exist
<b>SCIENCE PREP ROOM</b>	Does not Exist
<b>SHOWER ROOM</b>	Does not Exist
<b>STAIRS/RAMPS: INTERIOR</b>	
Do Letter Stair Signs Exist?	Inspected Partially
<b>Ceiling</b>	
Condition	Inspected 2 - Between Good and Fair
Deficiency	No deficiencies recorded
<b>Door(s)</b>	
Condition	Inspected 4 - Between Fair and Poor
Deficiency	METAL CLAD WOOD: DETERIORATED DOOR
Deficiency Location/Instance	Stair C/3 (2 Doors) E/Basement
Deficiency Quantity	3
Quantity Uom	EACH
Potential Action	MAINTENANCE
Urgency of Action	PRIORITY 3
Purpose of Action	LEVEL 2

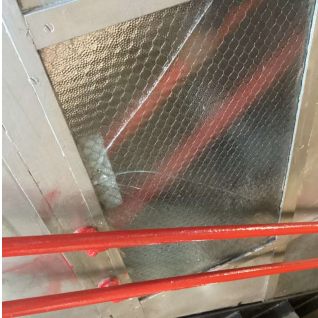
Question	Response
<b>INTERIOR</b>	
<b>STAIRS/RAMPS: INTERIOR</b>	
<b>Partition</b>	
Condition	3 - Fair
Deficiency	GLASS PANEL: DAMAGED/DETERIORATED
Deficiency Location/Instance	Stairs BC/Basement,2, D/Basement, FG/1,
Deficiency Quantity	50
Quantity Uom	S.F.
Potential Action	REPLACE
Urgency of Action	PRIORITY 3
Purpose of Action	LEVEL 2
Deficiency Photo1

Violations	Stair G/1 No violations recorded.
<b>Railings</b>	
Condition	Inspected 3 - Fair
Deficiency	METAL: DAMAGED
Deficiency Location/Instance	Stair F/Basement
Deficiency Quantity	15
Quantity Uom	L.F.
Potential Action	REPLACE
Urgency of Action	PRIORITY 3
Purpose of Action	LEVEL 2
Deficiency Photo1

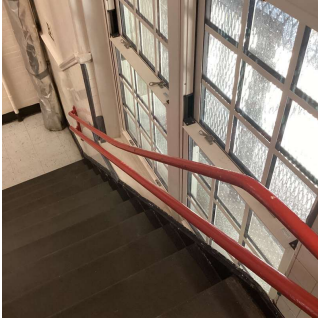
Violations	Stair F/Basement No violations recorded.
<b>Stairs and Landings</b>	
Condition	Inspected 3 - Fair
Deficiency	ROLLED ASPHALT: CRACKS
Deficiency Location/Instance	Stair E/Bulkhead
Deficiency Quantity	50
Quantity Uom	S.F.
Potential Action	REPLACE
Urgency of Action	PRIORITY 3

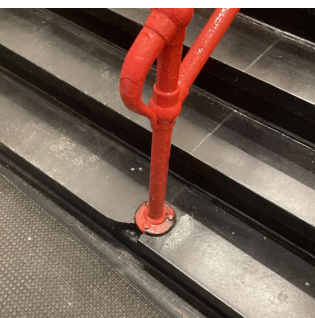
Violations	Stair E/Bulkhead No violations recorded.
Deficiency	STONE: BROKEN/MISSING
Deficiency Location/Instance	Stair A/Basement, E/ Basement, F/ Basement
Deficiency Quantity	50
Quantity Uom	S.F.
Potential Action	REPLACE
Urgency of Action	PRIORITY 3
Purpose of Action	LEVEL 2
Deficiency Photo1

Violations	Stair A/Basement No violations recorded.
Deficiency	CERAMIC TILE: BROKEN/MISSING
Deficiency Location/Instance	Stair A/Basement
Deficiency Quantity	20
Quantity Uom	S.F.
Potential Action	REPLACE
Urgency of Action	PRIORITY 3
Purpose of Action	LEVEL 2
Deficiency Photo1

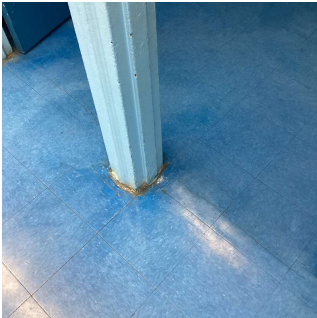
Question	Response
<b>INTERIOR</b>	
<b>STAIRS/RAMPS: INTERIOR</b>	
<b>Stairs and Landings</b>	
Violations	No violations recorded.
Deficiency	VINYL TILES: DETERIORATED SUBSTRATE
Deficiency Location/Instance	Stairs BC/ Basement, D/Basement, F/ Basement
Deficiency Quantity	80
Quantity Uom	S.F.
Potential Action	REPLACE
Urgency of Action	PRIORITY 3
Purpose of Action	LEVEL 2
Deficiency Photo1

Violations	D/Basement No violations recorded.
<b>Walls</b>	Inspected
Condition	2 - Between Good and Fair
Deficiency	CERAMIC TILE: BROKEN/ MISSING
Deficiency Location/Instance	Stairs BC/2,3, D/Basement, F/Basement , G/3, and others
Deficiency Quantity	70
Quantity Uom	S.F.
Potential Action	REPLACE
Urgency of Action	PRIORITY 3
Purpose of Action	LEVEL 2
Deficiency Photo1

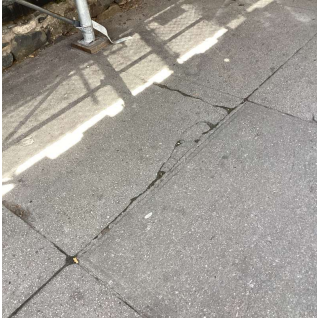
Weirfield Street
Violations	94619
Deficiency	DAMAGED/DETERIORATED/MISSING SECTIONS
Deficiency Location/Instance	Weirfield Street, Knickerbocker Avenue, Hancock Street
Deficiency Quantity	900
Quantity Uom	S.F.
Potential Action	REPLACE
Urgency of Action	PRIORITY 4
Purpose of Action	LEVEL 4
Deficiency Photo1

Weirfield Street
Violations	94619
<b>Pavers</b>	Does not Exist
<b>PLAYGROUNDS</b>	Inspected
Instance on Schoolyard	Inaccessible
<b>PLAYING SURFACE</b>	Does not Exist
<b>RETAINING WALLS</b>	Inspected
Are there any Retaining Walls 6' OR higher facing public street/sidewalk?	No
