NYC Department of Education
Building Condition Assessment Survey 2023 - 2024

Architectural Inspection

Asset: P.S. 154 - BROOKLYN, 1625 11TH AVENUE, New York, 11215

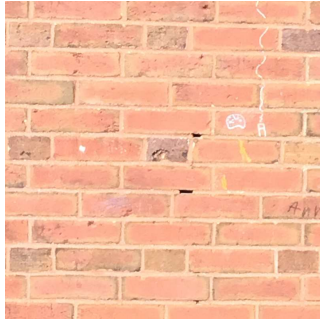
Deficiency
 Roof Plan reference
 BRICK: DETERIORATED JOINTS

Deficiency Quantity	20
Quantity Uom	S.F.
Potential Action	REPOINT
Urgency of Action	PRIORITY 4
Purpose of Action	LEVEL 2

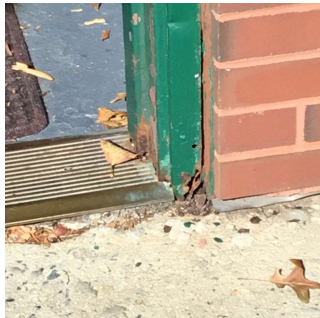
Violations	Facade C No violations recorded.

Violations	CH No violations recorded.
COPING	
Condition	Inspected
Deficiency	2 - Between Good and Fair No deficiencies recorded
CORNICE	
Condition	Inspected
Deficiency	2 - Between Good and Fair No deficiencies recorded
DOORS	
DOORS AND FRAMES	
Condition	Inspected
Deficiency	4 - Between Fair and Poor METAL: DETERIORATED DOOR AND FRAME - MAJOR DETERIORATION
Roof Plan reference

Deficiency Quantity	2
Quantity Uom	EACH
Potential Action	REPLACE
Urgency of Action	PRIORITY 4
Purpose of Action	LEVEL 2
Deficiency Photo1

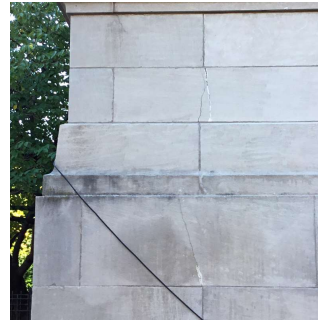
Facade A

Question	Response
EXTERIOR	
DOORS	
DOOR HARDWARE	Inspected
Condition	3 - Fair
Deficiency	No deficiencies recorded
LINTELS	Inspected
Condition	2 - Between Good and Fair
Deficiency	No deficiencies recorded
TRANSOM/SIDE LIGHT	Does not Exist
EXTERIOR WALLS	Inspected
Material Type(s)	Masonry, Steel
Replacement Quantity	18,000
Replacement Uom	S.F.
Instance on All Facades	Inspected
Instance Condition	3 - Fair
Instance Quantity	18,000
Instance Quantity Uom	S.F.
Deficiency	STONE: CRACKS AT BUILDING CORNERS
Roof Plan reference

35
S.F.
REPLACE
PRIORITY 4
LEVEL 2

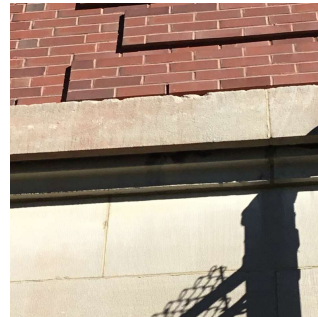
Facade D

STONE: CHIPPED/SPALLED/BROKEN PIECES - MINOR

REPAIR

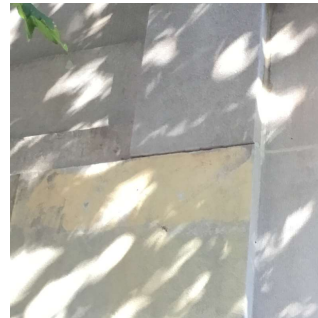
Facade D

STONE: DETERIORATED JOINTS

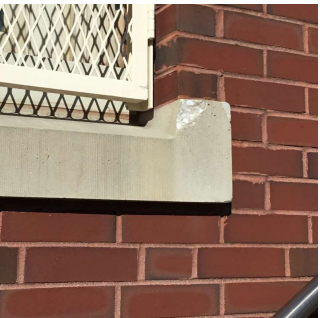
BRICK: DETERIORATED MASONRY SILLS - MINOR

Violations	Facade C No violations recorded.
EXTERIOR SOFFITS	Inspected
Condition	2 - Between Good and Fair
Deficiency	No deficiencies recorded
LOADING DOCK	Does not Exist
LOUVER	Inspected
Condition	2 - Between Good and Fair
Deficiency	No deficiencies recorded
PARAPETS	Inspected
Material Type(s)	Masonry
Replacement Quantity	5,000
Replacement Uom	C.F.
Instance on All Roofs	Inspected
Instance Condition	2 - Between Good and Fair
Instance Quantity	5,000
Instance Quantity Uom	C.F.
Deficiency	No deficiencies recorded
PLAZA DECK	Inspected
Instance on Concrete: Roofs 5, 6	Inspected
Instance Condition	5 - Poor
Instance Quantity	200
Instance Quantity Uom	S.F.
Installation Year	2015

Deficiency Quantity	10
Quantity Uom	L.F.
Potential Action	REPAIR
Urgency of Action	PRIORITY 3
Purpose of Action	LEVEL 2
Deficiency Photo1

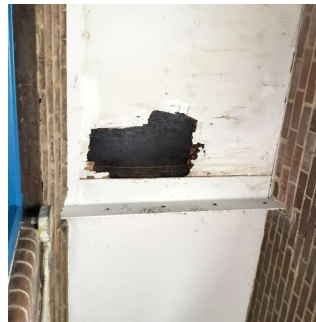
Roof 6 - Exit 6 Vestibule

CONCRETE: MAJOR ACTIVE PLAZA DECK LEAKS IN INSTRUCTIONAL SPACE

REPLACE

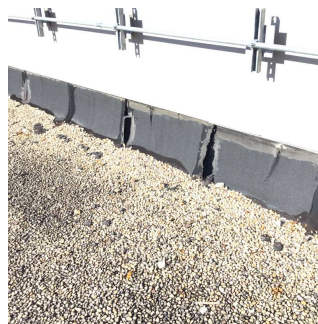
Roof 1
 No violations recorded.

Question	Response
EXTERIOR	
ROOF	
Roofing	
LEADERS, GUTTERS, DOWNSPOUTS, SCUPPERS	
Potential Action	REPLACE
Urgency of Action	PRIORITY 4
Purpose of Action	LEVEL 2
Deficiency Photo1	 
Violations	Facade C No violations recorded.
ROOF BARRIER/FENCE	Inspected
Condition	2 - Between Good and Fair
Deficiency	No deficiencies recorded
ROOF CAGE	Does not Exist
ROOFING	Inspected
Instance on Built-Up: All Roofs	Inspected
Instance Condition	3 - Fair
Instance Photo	 
	Roof 1
Instance Quantity	14,000
Instance Quantity Uom	S.F.
Does the roof have major mechanical equipment sitting on Dunnage Steel less than 18" above the Roofing?	No
Does this roof instance have a Sustainable Roof System?	No
Do solar panels exist on these roofs?	No
Is/Are the roof(s) suitable for Solar Panel installation?	Yes
Installation Year	2015
Source of Installation	Custodial Staff
Deficiency	BUILT-UP: FLASHING: BASE FLASHING DETERIORATED

80
 S.F.
 REMOVE AND REPLACE
 PRIORITY 4
 LEVEL 2

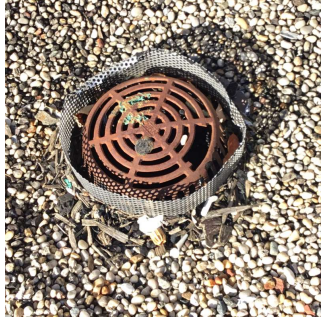
DETERIORATED

Violations	Roof 1 No violations recorded.
Specialties	Inspected
BULKHEAD/PENTHOUSE	Inspected
Condition	3 - Fair
Deficiency	BULKHEAD/PENTHOUSE WALLS/INTERIOR: PLASTER CRACKS/SPALLING
Roof Plan reference

1
 EACH
 REPLACE
 PRIORITY 4
 LEVEL 2

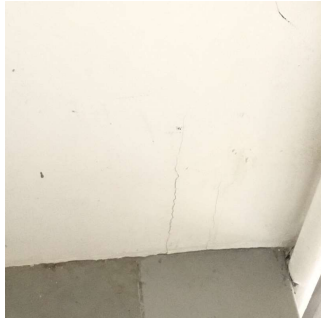
Violations	BH No violations recorded.
Deficiency	BULKHEAD/PENTHOUSE WALLS/INTERIOR: PLASTER CRACKS/SPALLING

Deficiency Quantity	15
Quantity Uom	S.F.
Potential Action	REPLACE
Urgency of Action	PRIORITY 3
Purpose of Action	LEVEL 2
Deficiency Photo1

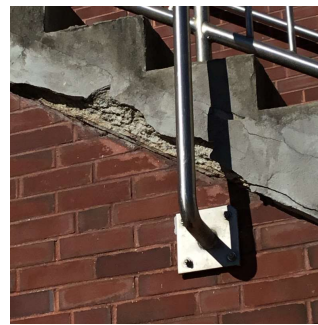
Facade C

Question	Response
EXTERIOR	
ROOF	
Specialties	
BULKHEAD/PENTHOUSE	
Roof Plan reference	
Deficiency Quantity	25
Quantity Uom	S.F.
Potential Action	REPLACE
Urgency of Action	PRIORITY 4
Purpose of Action	LEVEL 2
Deficiency Photo1	
Violations	BH No violations recorded.
CUPOLA/ SPIRES/ TOWERS	Does not Exist
DORMER	Does not Exist
DUNNAGE STEEL	Does not Exist
SKYLIGHT/ROOF VENT	Inspected
Material Type(s)	Glass
Condition	2 - Between Good and Fair
Deficiency	No deficiencies recorded
ROOF/GRAVITY TANK	Does not Exist
STAIRS/RAMPS: EXTERIOR	Inspected
BUILDING CHEEK/FLANK WALLS	Inspected
Condition	2 - Between Good and Fair
Deficiency	No deficiencies recorded
RAILINGS	Inspected
Condition	2 - Between Good and Fair
Deficiency	No deficiencies recorded
STAIRS/RAMPS	Inspected
Condition	5 - Poor
Deficiency	CONCRETE: CRACKS/SPALLING - MAJOR

30
S.F.
REPLACE
PRIORITY 4
LEVEL 2

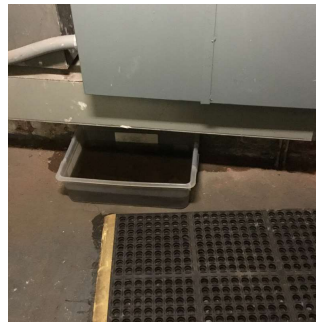
Electrical Panel Room

STONE: WATER INFILTRATION IN ELECTRICAL PANEL ROOM BELOW

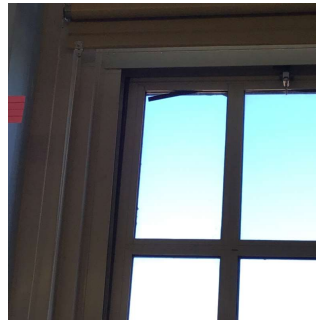
Facade A - Room 310

ALUMINUM - DOUBLE HUNG: DETERIORATED

30
S.F.
REPLACE WINDOW
PRIORITY 4
LEVEL 2

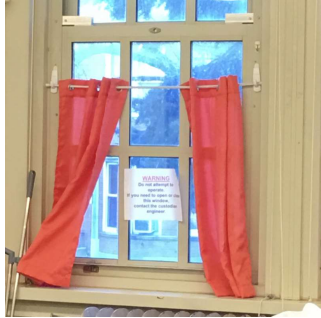
Facade A - Room 107
Violations	No violations recorded.
INTERIOR	Inspected
POOLS	Does not Exist
STRUCTURAL	Inspected
COLUMNS/BEAMS/BEARING WALLS	Inspected
Condition	3 - Fair
Deficiency	STEEL COLUMNS/BEAMS: DETERIORATED MASONRY FIREPROOFING
Deficiency Location/Instance	Basement
Deficiency Quantity	50
Quantity Uom	S.F.
Potential Action	REPLACE
Urgency of Action	PRIORITY 4
Purpose of Action	LEVEL 5
Deficiency Photo1

Question	Response
EXTERIOR	
WINDOWS	
WINDOWS	
Potential Action	REPLACE BALANCES
Urgency of Action	PRIORITY 3
Purpose of Action	LEVEL 2
Deficiency Photo1

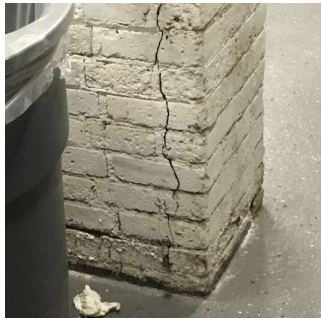
Custodian Shop (Boiler Room similar)
Violations	No violations recorded.
Deficiency	STEEL COLUMNS/BEAMS: DETERIORATED/MISSING PLASTER FIREPROOFING
Deficiency Location/Instance	Basement
Deficiency Quantity	35
Quantity Uom	S.F.
Potential Action	REPLACE
Urgency of Action	PRIORITY 4
Purpose of Action	LEVEL 5

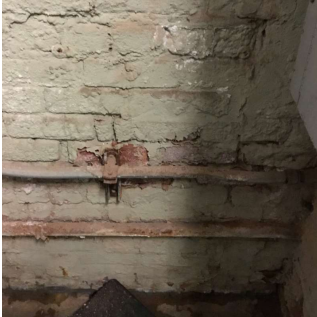
Violations	Electrical Panel Room No violations recorded.
Deficiency	CRACKS, SPALLING
Deficiency Location/Instance	Vault
Deficiency Quantity	100
Quantity Uom	S.F.
Potential Action	REPAIR
Urgency of Action	PRIORITY 4
Purpose of Action	LEVEL 5
Deficiency Photo1

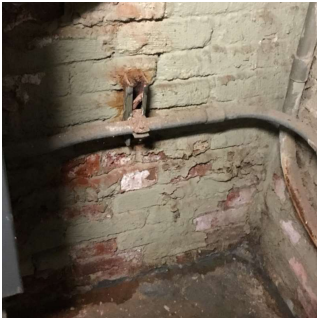
Violations	Electrical Panel Room (Vault at Boiler Room similar) No violations recorded.
Slab Structure	Inspected
Condition	2 - Between Good and Fair
Deficiency	No deficiencies recorded
Vault/Ash Hoist Doors and Framing	Does not Exist
AUDITORIUM	Does not Exist
CAFETERIA	Inspected
Instance on Basement	Inspected
Ceiling	
Instance on Basement	Inspected
Condition	2 - Between Good and Fair
Deficiency	No deficiencies recorded
Door(s)	
Instance on Basement	Inspected
Condition	5 - Poor
Deficiency	WOOD: DETERIORATED DOOR
Deficiency Location/Instance	Exits 7,6,5,4
Deficiency Quantity	4

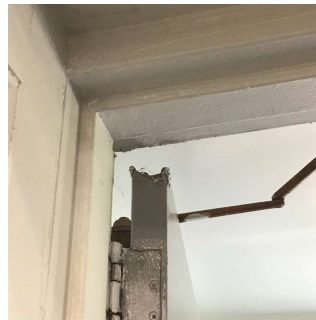
Exit 8

METAL: DETERIORATED DOOR

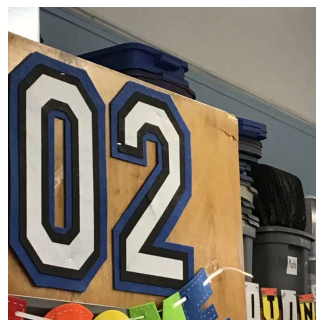
WOOD: DETERIORATED DOOR

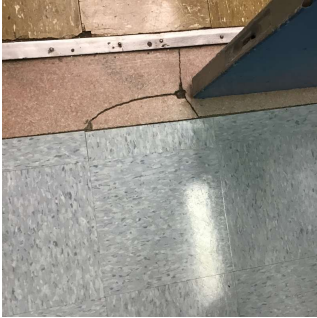
Corridor near Multi-Purpose Room
Violations	No violations recorded.
Deficiency	VINYL TILES: BROKEN/DETERIORATED/MISSING TILES
Deficiency Location/Instance	Room 305, Corridor near 1st Floor pre-k Toilet, Exit 9, 6
Deficiency Quantity	60
Quantity Uom	S.F.
Potential Action	REPLACE
Urgency of Action	PRIORITY 3
Purpose of Action	LEVEL 2
Deficiency Photo1

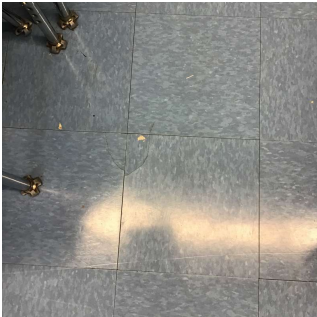
Room 305
Violations	No violations recorded.
Deficiency	CONCRETE: CRACKS
Deficiency Location/Instance	Near Stair C/Basement, Exit 6
Deficiency Quantity	20

Quantity Uom	S.F.
Potential Action	REPLACE
Urgency of Action	PRIORITY 3
Purpose of Action	LEVEL 2

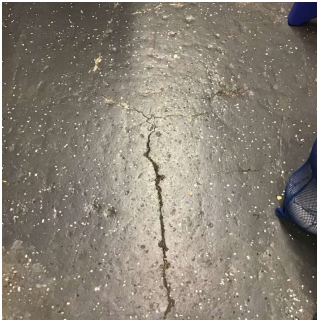
Near Stair C/Basement
Violations	No violations recorded.
Walls	Inspected
Condition	2 - Between Good and Fair
Deficiency	CERAMIC TILE: BROKEN/ MISSING
Deficiency Location/Instance	Exit 5 Vestibule, 4
Deficiency Quantity	20
Quantity Uom	S.F.
Potential Action	REPLACE
Urgency of Action	PRIORITY 3
Purpose of Action	LEVEL 2
Deficiency Photo1

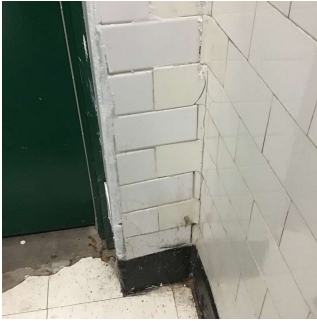
Exit 4 Vestibule
Violations	No violations recorded.
Deficiency	PLASTER: CRACKS/SPALLING
Deficiency Location/Instance	Room 305, 300, Exit 2 Vestibule, Corridor near 3rd Floor - Girls, Main Entrance, and others
Deficiency Quantity	60
Quantity Uom	S.F.
Potential Action	REPLACE
Urgency of Action	PRIORITY 3
Purpose of Action	LEVEL 2

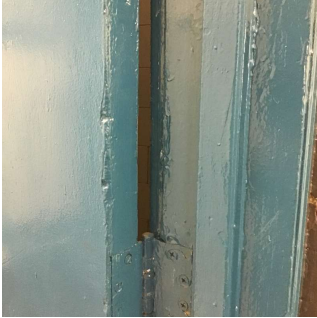
Violations	Exit 3 Vestibule No violations recorded.
Deficiency	METAL: DETERIORATED DOOR
Deficiency Location/Instance	Stair AB/3

Deficiency Quantity	2
Quantity Uom	EACH
Potential Action	MAINTENANCE
Urgency of Action	PRIORITY 3
Purpose of Action	LEVEL 2

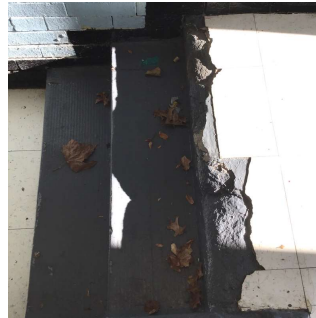
Exit 7

CONCRETE: CRACKS/SPALLING - MAJOR

REPLACE

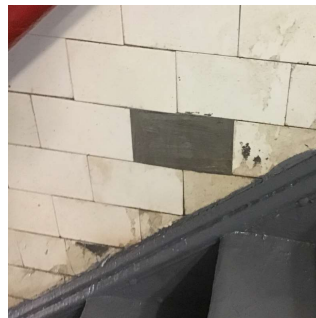
CERAMIC TILE: BROKEN/ MISSING

REPLACE

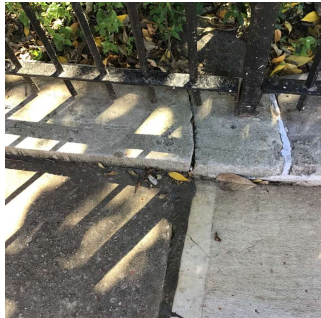
Question	Response
SITE	
Drainage System for Soil	Inspected
Culverts - Soil Covering	Does not Exist
DRINKING FOUNTAINS	
Condition	5 - Poor
Deficiency	INOPERABLE
Deficiency Location/Instance	Schoolyard
Deficiency Quantity	1
Quantity Uom	EACH
Potential Action	MAINTENANCE
Urgency of Action	PRIORITY 3
Purpose of Action	LEVEL 2
Deficiency Photo1	No photo recorded
Violations	No violations recorded.
FENCES	
Condition	4 - Between Fair and Poor
Deficiency	CONCRETE CURB: DAMAGED/DETERIORATED
Deficiency Location/Instance	Along 11th Avenue, Windsor Place
Deficiency Quantity	100
Quantity Uom	S.F.
Potential Action	REPLACE
Urgency of Action	PRIORITY 3
Purpose of Action	LEVEL 2
Deficiency Photo1

Violations	Along 11th Avenue No violations recorded.
Deficiency	WROUGHT IRON: RUST - MAJOR
Deficiency Location/Instance	Near Schoolyard, Along Sherman Street, 11th Avenue, Windsor Place
Deficiency Quantity	2,800
Quantity Uom	S.F.
Potential Action	REPLACE

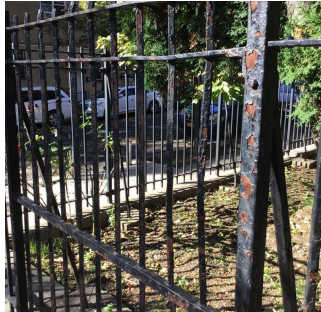
Question	Response
SITE	
FENCES	
Violations	Near Schoolyard No violations recorded.
Deficiency	CHAIN LINK: DAMAGED/DETERIORATED
Deficiency Location/Instance	Schoolyard
Deficiency Quantity	75
Quantity Uom	S.F.
Potential Action	REPLACE
Urgency of Action	PRIORITY 3
Purpose of Action	LEVEL 2
Deficiency Photo1	 
Violations	Schoolyard No violations recorded.
Deficiency	CHAIN LINK: DAMAGED POST/RAIL
Deficiency Location/Instance	Schoolyard
Deficiency Quantity	75
Quantity Uom	L.F.
Potential Action	REPLACE
Urgency of Action	PRIORITY 3
Purpose of Action	LEVEL 2
Deficiency Photo1

Urgency of Action	PRIORITY 3
Purpose of Action	LEVEL 2
Deficiency Photo1

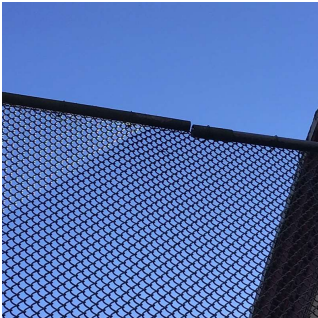
Violations	Schoolyard No violations recorded.
IRRIGATION SYSTEM	
	Does not Exist
PAVING	
	Inspected
Student Non-Use	
	Does not Exist
Student Use	
Gravel Exists?	No
Asphalt	
	Inspected
Condition	4 - Between Fair and Poor
Deficiency	HEAVING
Deficiency Location/Instance	Schoolyard

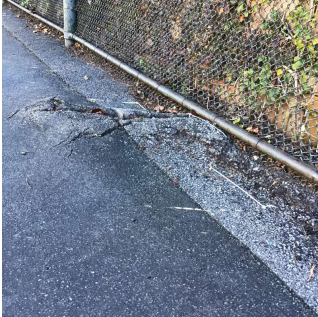
Question	Response
SITE	
PAVING	
Student Use	
Asphalt	
Deficiency Quantity	20
Quantity Uom	S.F.
Potential Action	REPLACE
Urgency of Action	PRIORITY 5
Purpose of Action	LEVEL 6
Deficiency Photo1

Schoolyard
Violations	No violations recorded.
Deficiency	CRACKS - MAJOR
Deficiency Location/Instance	Schoolyard
Deficiency Quantity	1,200
Quantity Uom	S.F.
Potential Action	REPLACE
Urgency of Action	PRIORITY 3
Purpose of Action	LEVEL 2
Deficiency Photo1

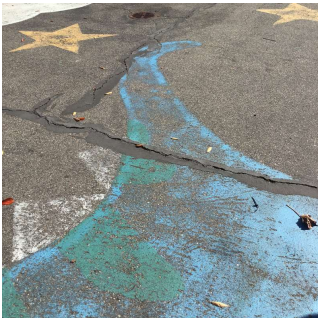
Schoolyard
Violations	No violations recorded.
Concrete	Inspected
Condition	3 - Fair
Deficiency	CRACKS - MAJOR
Deficiency Location/Instance	Schoolyard
Deficiency Quantity	50
Quantity Uom	S.F.
Potential Action	REPLACE
Urgency of Action	PRIORITY 3
Purpose of Action	LEVEL 2

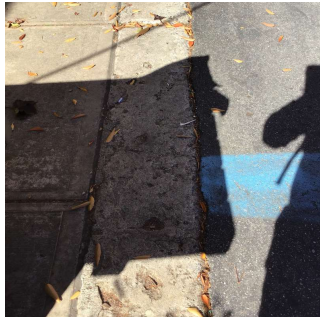
Violations	Schoolyard No violations recorded.
Pavers	Inspected
Condition	2 - Between Good and Fair
Deficiency	DAMAGED/MISSING
Deficiency Location/Instance	Near Entrance
Deficiency Quantity	10
Quantity Uom	S.F.
Potential Action	REPLACE
Urgency of Action	PRIORITY 5
Purpose of Action	LEVEL 6
Deficiency Photo1

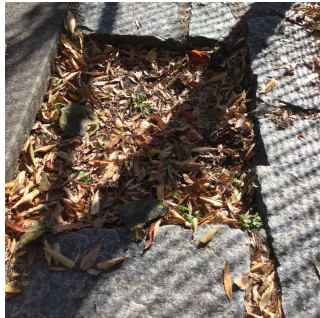
No	Tripping Hazard	Missing pavers is a potential tripping hazard.	SITE PAVING Student Use Pavers	Near Entrance	Donald LaMastra	Custodian

Violations	Near entrance No violations recorded.
Site Sidewalks & Walkways	Inspected
Asphalt	Does not Exist
Concrete	Inspected
Condition	3 - Fair
Deficiency	CRACKS - MAJOR
Deficiency Location/Instance	Along Sherman Street, Windsor Place
Deficiency Quantity	50
Quantity Uom	S.F.
Potential Action	REPLACE
Urgency of Action	PRIORITY 3
Purpose of Action	LEVEL 2

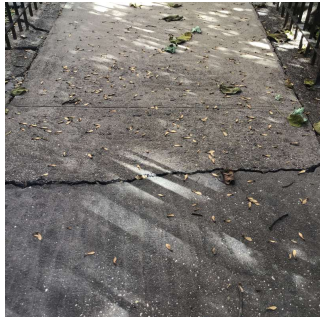
Violations	Along Sherman Street No violations recorded.
Pavers	Does not Exist
DOT Sidewalk	Inspected
Asphalt	Does not Exist
Concrete	Inspected
Condition	4 - Between Fair and Poor
Deficiency	DAMAGED CURBS
Deficiency Location/Instance	Along Sherman Street, 11th Avenue, Windsor Place
Deficiency Quantity	65
Quantity Uom	L.F.
Potential Action	REPLACE
Urgency of Action	PRIORITY 3
Purpose of Action	LEVEL 2
Deficiency Photo1

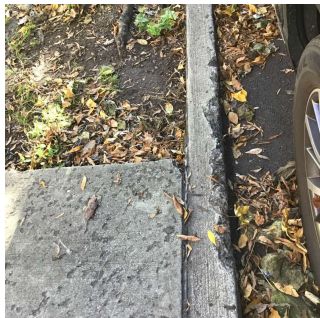
Violations	Along Sherman Street No violations recorded.
Deficiency	DAMAGED/DETERIORATED/MISSING SECTIONS
Deficiency Location/Instance	Along Sherman Street, 11th Avenue, Windsor Place
Deficiency Quantity	900
Quantity Uom	S.F.
Potential Action	REPLACE
Urgency of Action	PRIORITY 3
Purpose of Action	LEVEL 2

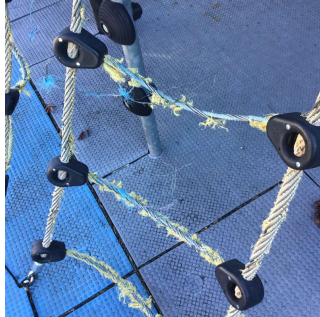
Priority Condition Exist Last Year?	Priority Category	Condition Description	Component Affected	Location Description	Person(s) Notified	Person(s) Title	PhotoImage
No	Protruding Elements	Severely damaged play equipment is a potential safety hazard.	SITE PLAYGROUNDS Play Equipment	Near center	Donald LaMastra	Custodian

Violations	Near center No violations recorded.
Safety Surfacing	
Instance on Schoolyard	Inspected
Condition	2 - Between Good and Fair
