NYC Department of Education
Building Condition Assessment Survey 2023 - 2024

Architectural Inspection

Asset: P.S. 155 - BROOKLYN, 1355 HERKIMER STREET, New York, 11233

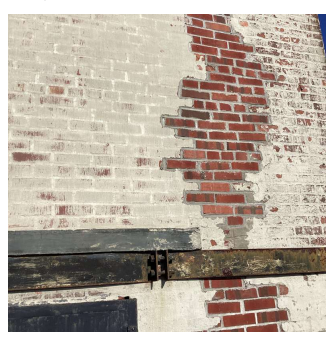
| Question | Response |
|---|--|
| Condition | 3 - Fair |
| Deficiency | BRICK: DETERIORATED JOINTS |

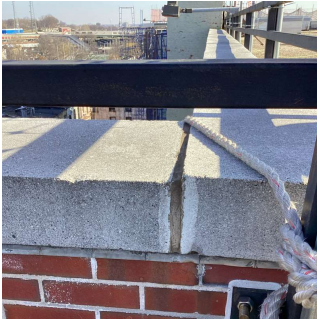
| Question | Response |
|---|--|
| Violations | Roof 1 No violations recorded. |

| Question | Response |
|---|--|
| Condition | Inspected 3 - Fair |
| Deficiency | CAST STONE: DETERIORATED TRANSVERSE JOINTS |

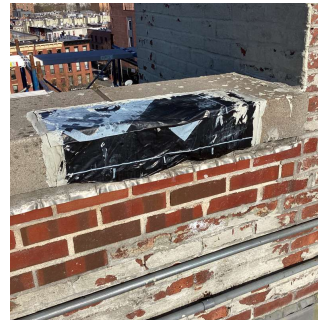
Roof 1
 No violations recorded.

| Question | Response |
|---|--|
| Deficiency | CAST STONE: CRACKED/BROKEN PIECES |

80
 L.F.
 REPLACE-IN-KIND
 PRIORITY 4
 LEVEL 2

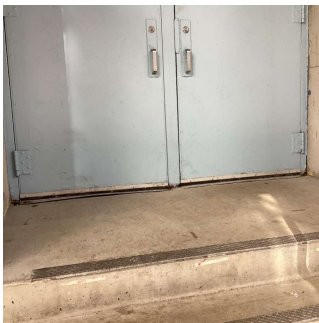
| Question | Response |
|---|--|
| | Main Entrance |

METAL CLAD: DETERIORATED DOOR AND FRAME - MAJOR DETERIORATION

6
 EACH
 REPLACE
 PRIORITY 4
 LEVEL 2

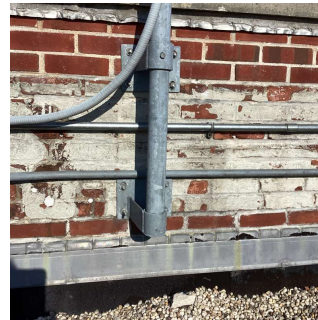
Roof 1

| Question | Response |
|---|--|
| Instance Condition | 4 - Between Fair and Poor |
| Deficiency | BRICK: MAJOR DETERIORATION/CRACKS |

100
 S.F.
 REMOVE AND REBUILD
 PRIORITY 4
 LEVEL 2

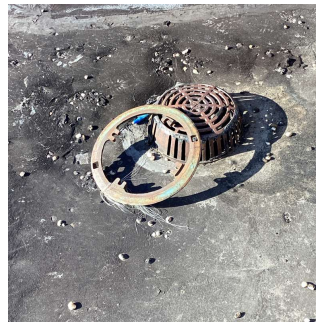
Roof 1

DETERIORATED

REPLACE

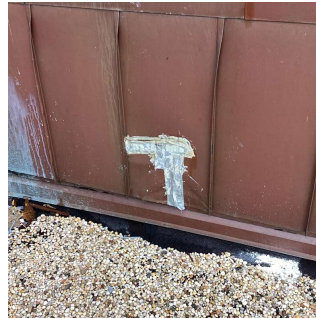
BH

BULKHEAD/PENTHOUSE WALLS/EXTERIOR: DAMAGED METAL SIDING

REPLACE

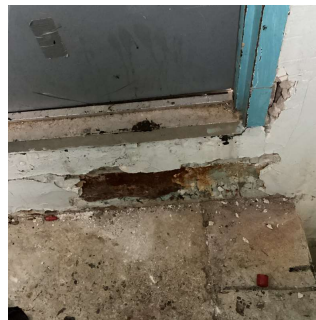
BH

BULKHEAD/PENTHOUSE WALLS/INTERIOR: PLASTER CRACKS/SPALLING

REPLACE

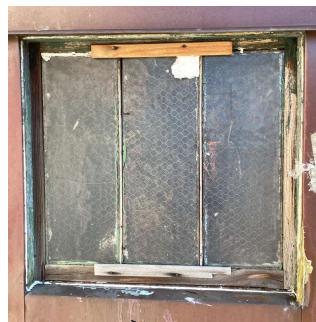
BH
No violations recorded.

BULKHEAD/PENTHOUSE WINDOWS: DAMAGED, DETERIORATED WINDOWS

30
S.F.
REPLACE
PRIORITY 4
LEVEL 2

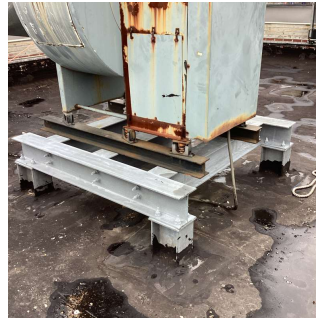
Roof 1

HEIGHT LESS THAN 18"

30
L.F.
REPLACE
PRIORITY 3
LEVEL 2

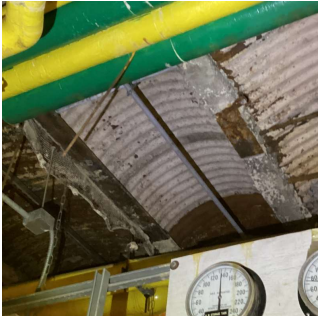
| Question | Response |
|---|--|
| Condition | 4 - Between Fair and Poor |
| Deficiency | STEEL COLUMNS/BEAMS: DETERIORATED/MISSING PLASTER FIREPROOFING |
| Deficiency Location/Instance | Cellar - Boiler Room, Storage Room, East side of Cellar |

| Question | Response |
|---|--|
| Potential Action | REPLACE |

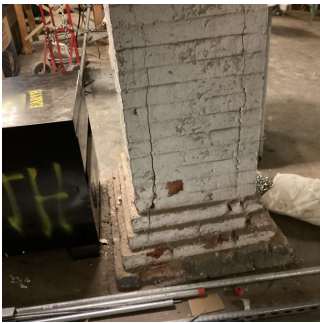
| Question | Response |
|---|--|
| Deficiency | STEEL COLUMNS/BEAMS: DETERIORATED MASONRY FIREPROOFING |
| Deficiency Location/Instance | Cellar - Boiler Room, West side of Cellar |

| Question | Response |
|---|--|
| Potential Action | REPLACE |

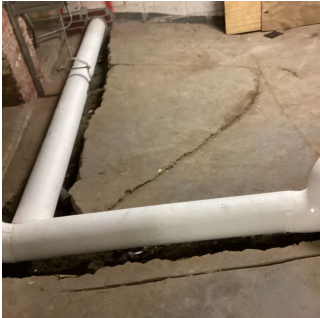
| Question | Response |
|---|--|
| Violations | Boiler Room near Ash Hoist Vault No violations recorded. |

| Question | Response |
|---|--|
| Deficiency | CONCRETE SLAB ON GRADE: THRU CRACKS |
| Deficiency Location/Instance | Cellar - Boiler Room |

| Question | Response |
|---|--|
| Potential Action | REPAIR |

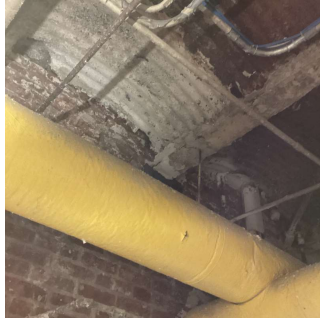
| Question | Response |
|---|--|
| Violations | Cellar - Boiler Room No violations recorded. |

| Question | Response |
|---|--|
| Deficiency | CINDER CONCRETE ARCH: METAL PAN DETERIORATED, SPALLED |
| Deficiency Location/Instance | Cellar - Sprinkler Valve Room, Boiler Room, Electrical Panel Room, Storage Room, East, West and South Sides of Cellar |

| Question | Response |
|---|--|
| Potential Action | REPAIR |

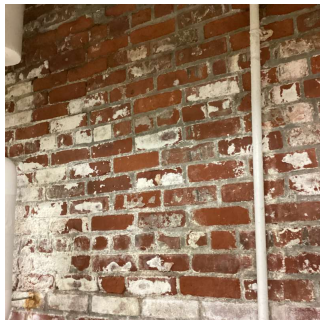
| Question | Response |
|---|--|
| Violations | Cellar Boiler Room No violations recorded. |

| Question | Response |
|---|--|
| Condition | 5 - Poor |
| Deficiency | BRICK: CRACKED/SPALLED |
| Deficiency Location/Instance | Cellar - Boiler Room, Mechanical Equipment Room near Oil Tank Room |

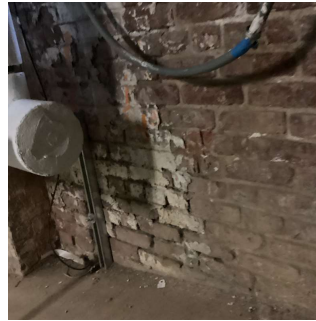
Cellar Boiler Room

| Question | Response |
|---|--|
| Deficiency | BRICK: DETERIORATED JOINTS |
| Deficiency Location/Instance | Cellar - Boiler Room, Mechanical Equipment Room near Oil Tank Room |

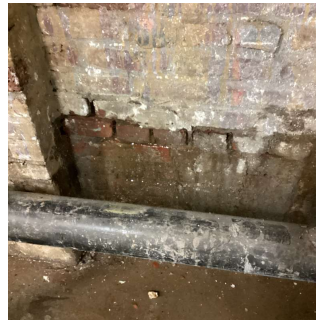
Boiler Room

BRICK: WATER INFILTRATION IN NON- INSTRUCTIONAL SPACE

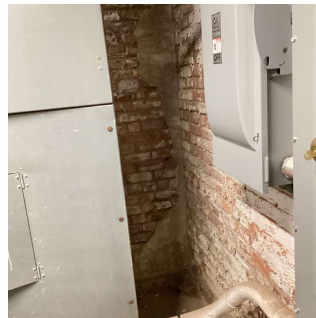
Cellar - Electrical Panel Room

BRICK: WATER INFILTRATION IN ELECTRICAL PANEL ROOM

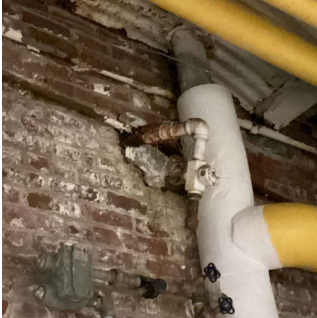
| Question | Response |
|---|--|
| Violations | Cellar Sprinkler Room No violations recorded. |

| Question | Response |
|---|--|
| Deficiency | BRICK: BULGING/DISPLACED |
| Deficiency Location/Instance | Cellar - Sprinkler Valve Room |

| Question | Response |
|---|--|
| Potential Action | REPAIR |

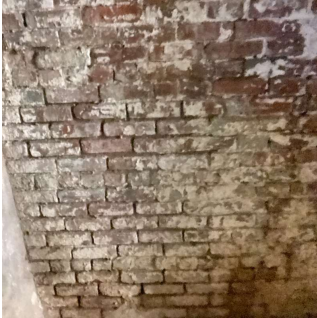
| Question | Response |
|---|--|
| Violations | Ash Hoist Vault No violations recorded. |

| Question | Response |
|---|--|
| Deficiency | DETERIORATED JOINTS |
| Deficiency Location/Instance | Cellar - Ash Hoist Vault |

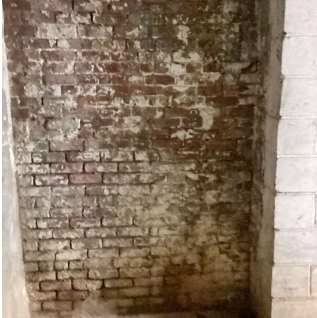
| Question | Response |
|--|--|
| Violations | Ash Hoist Vault No violations recorded. |

| Question | Response |
|---|--|
| Deficiency | CRACKS, SPALLING |
| Deficiency Location/Instance | Cellar - Ash Hoist Vault |

| Question | Response |
|--|--|
| Potential Action | REPAIR |

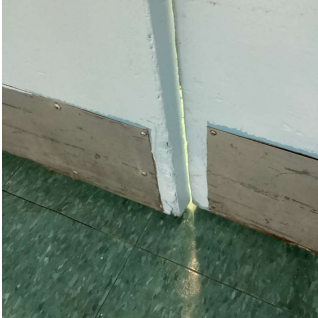
| Question | Response |
|---|--|
| Violations | Exit Vestibule No violations recorded. |

| Question | Response |
|---|--|
| Condition | 4 - Between Fair and Poor |
| Deficiency | WOOD: DETERIORATED DOOR |
| Deficiency Location/Instance | Exit Vestibule |

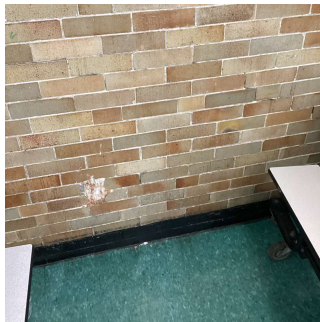
| Question | Response |
|--|--|
| Violations | Near Exit to Multi-Purpose Room No violations recorded. |

| Question | Response |
|--|--|
| Deficiency | BRICK: CRACKS/SPALLING |
| Deficiency Location/Instance | Near Exit to Multi-Purpose Room |

| Question | Response |
|--|--|
| Potential Action | REPLACE |

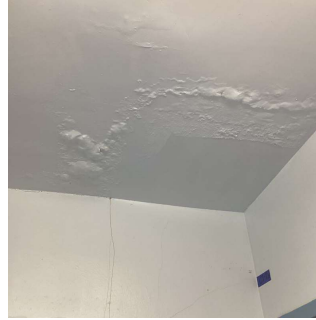
Corridor near Room 312

| Question | Response |
|--|--|
| Deficiency | PLASTER: CRACKS/SPALLING |
| Deficiency Location/Instance | Corridor near Rooms 309, 312, Rooms 111, 405 |

| Potential Action | REPLACE |

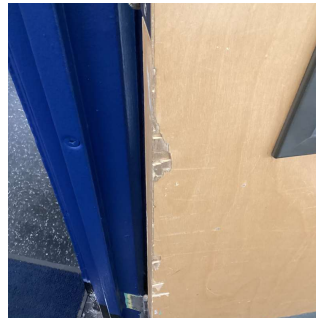
Main Entrance Vestibule

| Condition | 5 - Poor |

| Deficiency | WOOD: DETERIORATED DOOR |
| Deficiency Location/Instance | Main Entrance Vestibule, Rooms 101, 301, 405, and others |

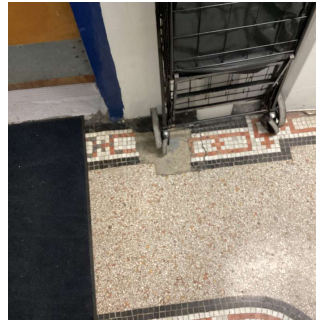
| Deficiency | CERAMIC TILE: BROKEN/MISSING TILES |
| Deficiency Location/Instance | Main Entrance |

| Potential Action | REPLACE |

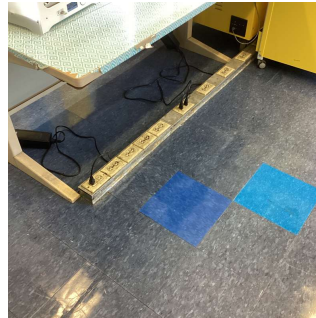
Room 410

VINYL TILES: TRIPPING HAZARD - ELECTRICAL OUTLET

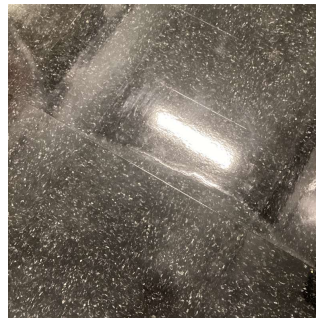
Corridor near Room 107

VINYL TILES: DETERIORATED SUBSTRATE

REPLACE
