NYC Department of Education
Building Condition Assessment Survey 2023 - 2024

Architectural Inspection

Asset: P.S. 160 - BROOKLYN, 5105 FORT HAMILTON PARKWAY, New York, 11219

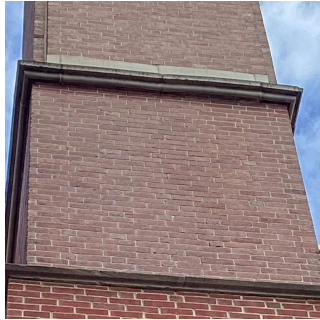
Question	Response
Architectural	
EXTERIOR	Inspected
AREAWAY	Does not Exist
AWNINGS AND CANOPIES	Does not Exist
CHIMNEY	Inspected
Material Type(s)	Masonry
Condition	3 - Fair
Deficiency	BRICK: DETERIORATED JOINTS
Roof Plan reference	K160

Deficiency Quantity	60
Quantity Uom	S.F.
Potential Action	REPOINT
Urgency of Action	PRIORITY 3
Purpose of Action	LEVEL 2

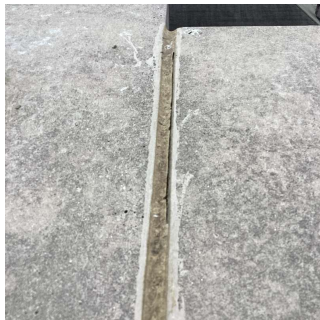
Violations	CH No violations recorded.
COPING	
Condition	Inspected 3 - Fair
Deficiency	CAST STONE: DETERIORATED TRANSVERSE JOINTS
Roof Plan reference	K160
Deficiency Quantity	80
Quantity Uom	L.F.
Potential Action	MAINTENANCE
Urgency of Action	PRIORITY 3
Purpose of Action	LEVEL 2
Deficiency Photo1

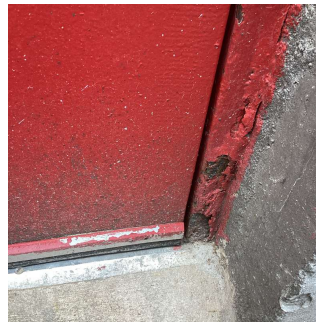
Facade A

Violations	Roof 1 No violations recorded.
CORNICE	
Condition	Inspected 2 - Between Good and Fair
Deficiency	No deficiencies recorded
DOORS	
Inspected	
DOORS AND FRAMES	
Condition	Inspected 5 - Poor
Deficiency	METAL CLAD: DETERIORATED DOOR AND FRAME - MAJOR DETERIORATION

4
EACH
REPLACE
PRIORITY 4
LEVEL 2

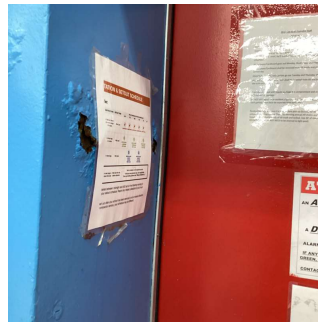
Facade A

Deficiency METAL: AIR/WATER INFILTRATION, DETERIORATED JOINTS WITH DAMAGED CAULKING

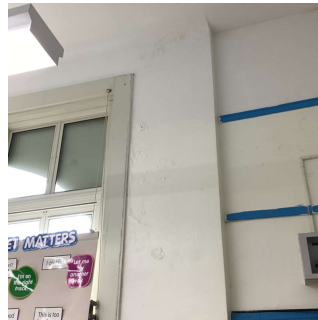
Facade C - Room 401 (Shown), Facade D - Rooms 205, 404B

BRICK: WATER INFILTRATION IN INSTRUCTIONAL SPACE

REPAIR

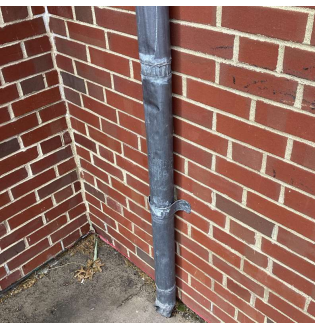
Question	Response
EXTERIOR	
EXTERIOR WALLS	
Urgency of Action	PRIORITY 4
Purpose of Action	LEVEL 2
Deficiency Photo1	 
Violations	Facade F No violations recorded.
EXTERIOR SOFFITS	Inspected
Condition	2 - Between Good and Fair
Deficiency	No deficiencies recorded
LOADING DOCK	Does not Exist
LOUVER	Inspected
Condition	2 - Between Good and Fair
Deficiency	No deficiencies recorded
PARAPETS	Inspected
Material Type(s)	Masonry
Replacement Quantity	3,000
Replacement Uom	C.F.
Instance on All Roofs	Inspected
Instance Condition	2 - Between Good and Fair
Instance Quantity	3,000
Instance Quantity Uom	C.F.
Deficiency	No deficiencies recorded
PLAZA DECK	Does not Exist
ROOF	Inspected
Roofing	Inspected
Replacement Quantity	13,700
Replacement Uom	S.F.
ROOF HATCH/SMOKE HATCH	Does not Exist
LEADERS, GUTTERS, DOWNSPOUTS, SCUPPERS	Inspected
Condition	3 - Fair
Deficiency	DAMAGED/MISSING

Deficiency Quantity	20
Quantity Uom	L.F.
Potential Action	REPLACE
Urgency of Action	PRIORITY 4
Purpose of Action	LEVEL 2
Deficiency Photo1

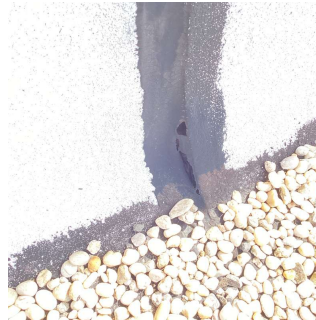
Roof 1
No violations recorded.

BUILT-UP: FLASHING: DETERIORATED JOINTS
K160

20
L.F.
MAINTENANCE
PRIORITY 3
LEVEL 2

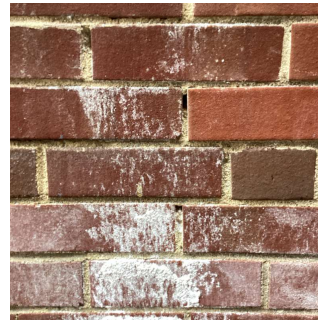
Facade E

BRICK: DETERIORATED JOINTS

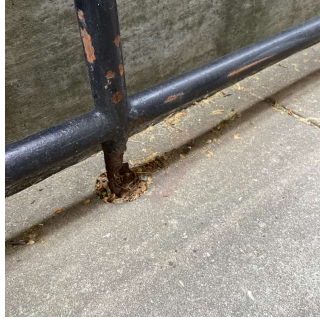
Violations	Facade A No violations recorded.
RAILINGS	
Condition	Inspected 5 - Poor
Deficiency	RUST - MAJOR
Roof Plan reference	K160

Deficiency Quantity	35
Quantity Uom	L.F.
Potential Action	REPLACE
Urgency of Action	PRIORITY 4
Purpose of Action	LEVEL 2
Deficiency Photo1

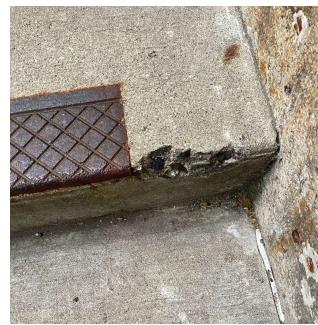
Facade C

Violations	Facade A No violations recorded.
STAIRS/RAMPS	
Condition	Inspected 4 - Between Fair and Poor
Deficiency	CONCRETE: WORN-OUT TREAD/RISER/NOSING

10
S.F.
REPLACE
PRIORITY 4
LEVEL 2

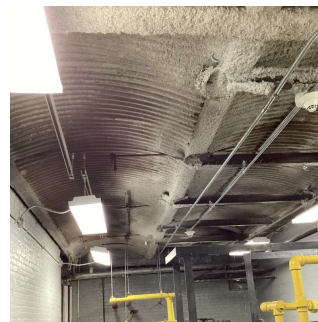
Basement - Oil Tank Room

STEEL COLUMNS/BEAMS: DETERIORATED/MISSING SPRAY-ON FIREPROOFING

REPLACE

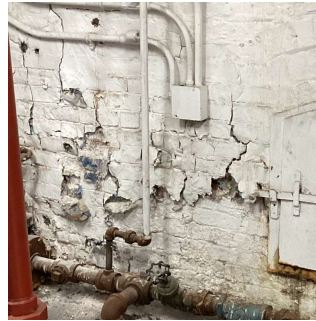
Violations	Basement - B3 No violations recorded.
FOUNDATION WALLS	
Material Type(s)	Inspected Concrete, Masonry
Condition	5 - Poor
Deficiency	BRICK: WATER INFILTRATION IN NON- INSTRUCTIONAL SPACE
Deficiency Location/Instance	Basement - Boiler Room (2 location), Fan Room
Deficiency Quantity	300
Quantity Uom	S.F.
Potential Action	INSTALL WATERPROOFING
Urgency of Action	PRIORITY 5
Purpose of Action	LEVEL 5

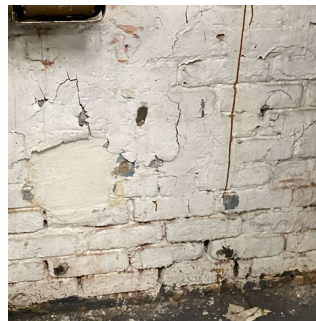
Basement - Boiler Room

BRICK: DETERIORATED JOINTS

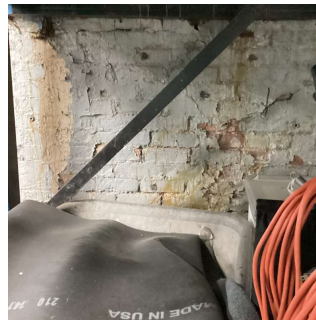
Basement - Boiler Room

BRICK: CRACKED/SPALLED

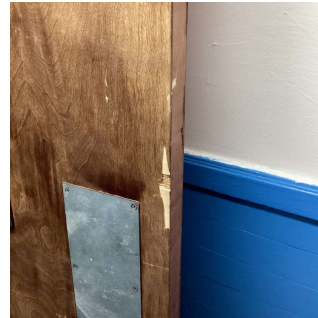
Exit 9 Vestibule

Deficiency	WOOD: DETERIORATED DOOR
Deficiency Location/Instance	Exit 9, 7 Vestibules
Deficiency Quantity	2
Quantity Uom	EACH
Potential Action	MAINTENANCE
Urgency of Action	PRIORITY 3

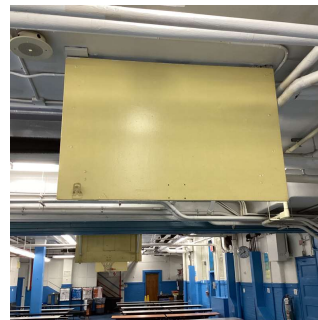
Instance on Basement	Inspected
Condition	3 - Fair
Deficiency	DAMAGED/MISSING
Deficiency Location/Instance	Near Serving area
Deficiency Quantity	1
Quantity Uom	EACH
Potential Action	MAINTENANCE
Urgency of Action	PRIORITY 3
Purpose of Action	LEVEL 2
Deficiency Photo1

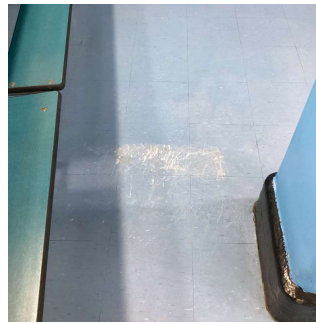
Instance on Basement	Inspected
Condition	2 - Between Good and Fair
Deficiency	VINYL TILES: BROKEN/DETERIORATED/MISSING TILES
Deficiency Location/Instance	Right Side
Deficiency Quantity	10
Quantity Uom	S.F.
Potential Action	REPLACE
Urgency of Action	PRIORITY 3
Purpose of Action	LEVEL 2

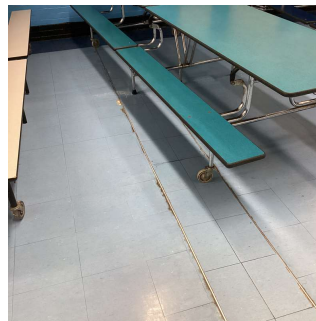
Center

VINYL TILES: DETERIORATED SUBSTRATE

REPLACE

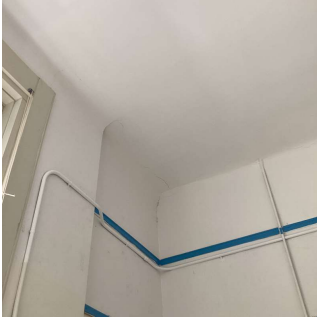
Room 309
Violations	No violations recorded.
Deficiency	PLASTER: CRACKS/SPALLING
Deficiency Location/Instance	Rooms 409, 306, 206
Deficiency Quantity	60
Quantity Uom	S.F.
Potential Action	REPLACE
Urgency of Action	PRIORITY 3
Purpose of Action	LEVEL 2
Deficiency Photo1

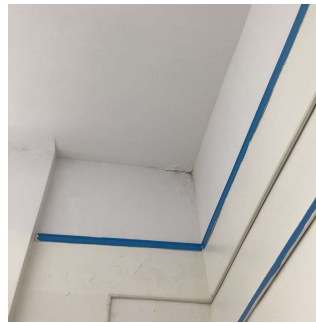
Room 409
Violations	No violations recorded.
Deficiency	PLASTER: CRACKS/SPALLING - ACTIVE LEAK
Deficiency Location/Instance	Room 401
Deficiency Quantity	10
Quantity Uom	S.F.
Potential Action	REPLACE
Urgency of Action	PRIORITY 5

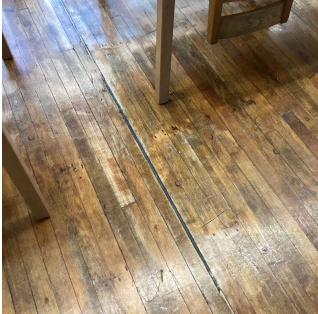
Violations	Corridor near Room 309 No violations recorded.
Deficiency	WOOD: DAMAGED/DETERIORATED
Deficiency Location/Instance	Rooms 410, 406, 404B
Deficiency Quantity	60

Quantity Uom	S.F.
Potential Action	REPLACE
Urgency of Action	PRIORITY 3
Purpose of Action	LEVEL 2
Deficiency Photo1

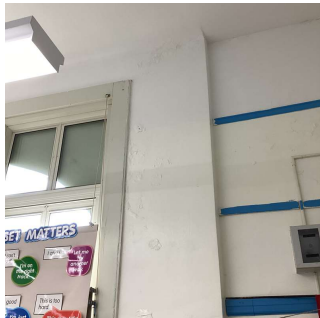
Violations	No violations recorded.
Deficiency	PLASTER: CRACKS/SPALLING - ACTIVE LEAK
Deficiency Location/Instance	Rooms 205, 401, 404B
Deficiency Quantity	60
Quantity Uom	S.F.
Potential Action	REPLACE
Urgency of Action	PRIORITY 5
Purpose of Action	LEVEL 2
Deficiency Photo1

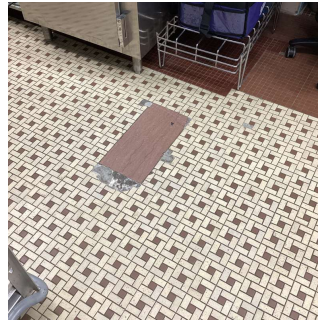
Near Entrance

Mop Room
Violations	No violations recorded.
Floor Finish	
Instance on Basement	Inspected
Condition	3 - Fair
Deficiency	CERAMIC TILE: BROKEN/MISSING TILES
Deficiency Location/Instance	Near Entrance, Center, Near Mop Room
Deficiency Quantity	40
Quantity Uom	S.F.
Potential Action	REPLACE
Urgency of Action	PRIORITY 3
Purpose of Action	LEVEL 2

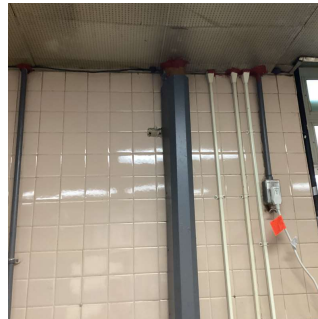
Instance on Basement	Inspected
Condition	2 - Between Good and Fair
Deficiency	CERAMIC TILE: BROKEN/ MISSING
Deficiency Location/Instance	Near Windows
Deficiency Quantity	10
Quantity Uom	S.F.
Potential Action	REPLACE
Urgency of Action	PRIORITY 3
Purpose of Action	LEVEL 2
Deficiency Photo1

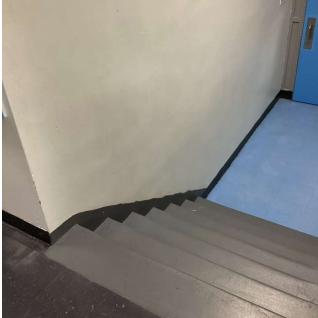
Question	Response
INTERIOR	
STAIRS/RAMPS: INTERIOR	
Railings	Inspected
Condition	5 - Poor
Deficiency	METAL: MISSING
Deficiency Location/Instance	Stairs BD/Basement, CE/Basement, Near Exits 7, 9, 15
Deficiency Quantity	40
Quantity Uom	L.F.
Potential Action	REPLACE
Urgency of Action	PRIORITY 5
Purpose of Action	LEVEL 6
Deficiency Photo1

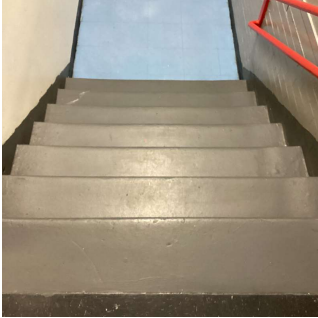
Violations	Stair CE/Basement No violations recorded.
Stairs and Landings	Inspected
Condition	4 - Between Fair and Poor
Deficiency	CONCRETE: WORN-OUT TREAD/NOSINGS
Deficiency Location/Instance	Stair CE/Basement
Deficiency Quantity	40
Quantity Uom	S.F.
Potential Action	REPLACE
Urgency of Action	PRIORITY 3
Purpose of Action	LEVEL 2
Deficiency Photo1

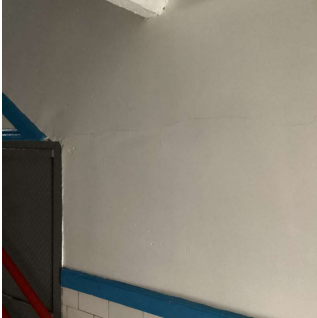
Question	Response
INTERIOR	
STAIRS/RAMPS: INTERIOR	
Walls	Inspected
Condition	2 - Between Good and Fair
Deficiency	PLASTER: CRACKS/SPALLING
Deficiency Location/Instance	Stair CE/Basement
Deficiency Quantity	20
Quantity Uom	S.F.
Potential Action	REPLACE
Urgency of Action	PRIORITY 3
Purpose of Action	LEVEL 2
Deficiency Photo1

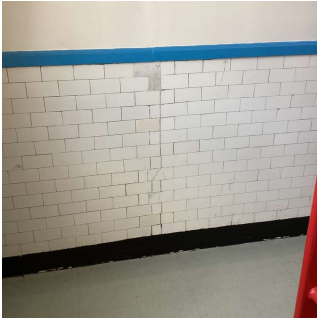
Violations	Stair CE/Basement No violations recorded.
Deficiency	CERAMIC TILE: BROKEN/ MISSING
Deficiency Location/Instance	Stairs BD/4, 3, 2, CE/4, 3 and others
Deficiency Quantity	70
Quantity Uom	S.F.
Potential Action	REPLACE
Urgency of Action	PRIORITY 3
Purpose of Action	LEVEL 2
Deficiency Photo1

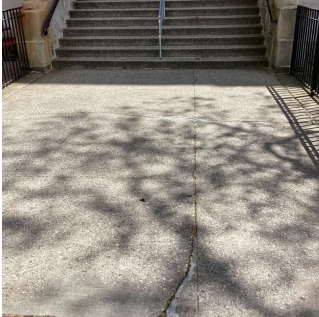
Violations	Exit 12 No violations recorded.
Concrete	Inspected
Condition	3 - Fair
Deficiency	CRACKS - MAJOR
Deficiency Location/Instance	Exit 10
Deficiency Quantity	150
Quantity Uom	S.F.
Potential Action	REPLACE
Urgency of Action	PRIORITY 3
Purpose of Action	LEVEL 2
Deficiency Photo1
