NYC Department of Education
Building Condition Assessment Survey 2023 - 2024

Architectural Inspection

Asset: P.S. 161 - BROOKLYN, 330 CROWN STREET, New York, 11225

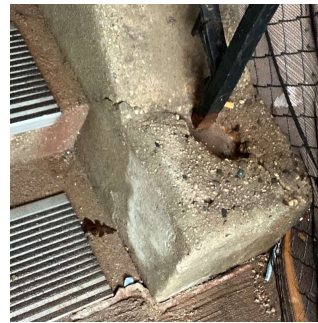
Facade G

15
S.F.
REPLACE
PRIORITY 4
LEVEL 2

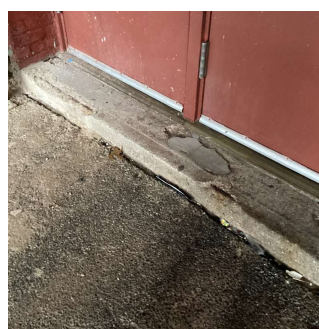
<p align="center">Facade E - Exit 6</p> <p align="center">No violations recorded.</p>
Deficiency Quantity Quantity Uom Potential Action Urgency of Action Purpose of Action Deficiency Photo1	<p>STONE: CRACKS/SPALLING - MINOR</p> <p>K161</p>

<p align="center">10 S.F. REPAIR PRIORITY 3 LEVEL 2</p>
Violations

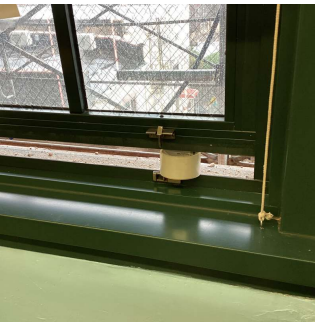
Question	Response
EXTERIOR	
WINDOWS	
WINDOWS	
Instance Quantity	10,000
Instance Quantity Uom	S.F.
Are these windows insulated	Yes
Installation Year	2008
Source of Installation	Custodial Staff
Deficiency	ALUMINUM - DOUBLE HUNG: BROKEN PANE
Roof Plan reference	<p>K161</p>
Elevation	
Deficiency Quantity	30
Quantity Uom	S.F.
Potential Action	MAINTENANCE
Urgency of Action	PRIORITY 3
Purpose of Action	LEVEL 2
Deficiency Photo1	
Violations	No violations recorded.
Deficiency	ALUMINUM - DOUBLE HUNG: INOPERABLE BALANCE

Deficiency Quantity	166
Quantity Uom	EACH
Potential Action	REPLACE BALANCES
Urgency of Action	PRIORITY 3
Purpose of Action	LEVEL 2
Deficiency Photo1

Violations	Room 205 (shown), Rooms 101, 302, 318 (similar) No violations recorded.
INTERIOR	
Inspected	
POOLS	
Does not Exist	
STRUCTURAL	
Inspected	
COLUMNS/BEAMS/BEARING WALLS	
Inspected	
Condition	3 - Fair
Deficiency	STEEL COLUMNS/BEAMS: DETERIORATED CONCRETE FIREPROOFING
Deficiency Location/Instance	Basement - Boiler Room, Basement - Mechanical Equipment East, West
Deficiency Quantity	60
Quantity Uom	S.F.
Potential Action	REPLACE

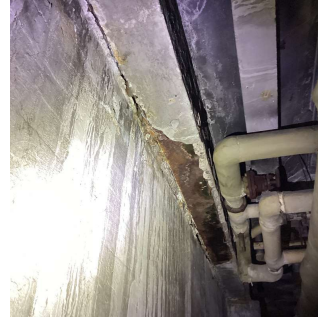
Basement - Mechanical Equipment East
No violations recorded.

PRIORITY 4
LEVEL 5

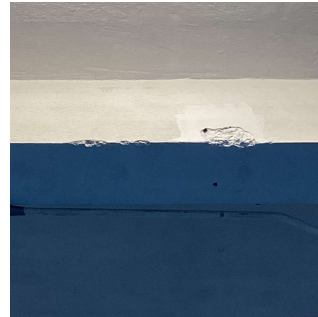
1st Floor - East Multi-Purpose Room
No violations recorded.

STEEL COLUMNS/BEAMS: DETERIORATED CONCRETE FIREPROOFING

REPLACE

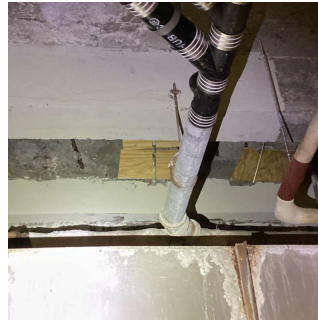
Basement - Mechanical Equipment West

CONCRETE: CRACKS/SPALLED/REINFORCEMENT EXPOSED

REPAIR

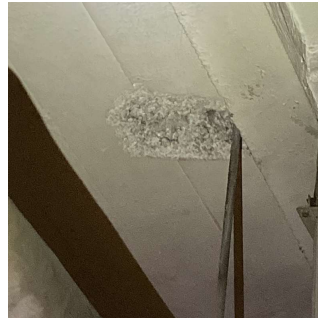
Basement - Mechanical Equipment East

CONCRETE: CRACKS/SPALLED/REINFORCEMENT EXPOSED

REPAIR

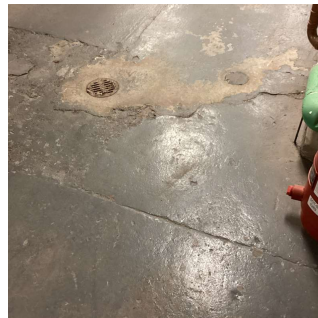
Basement - Boiler Room

CONCRETE SLAB ON GRADE: THRU CRACKS

REPAIR

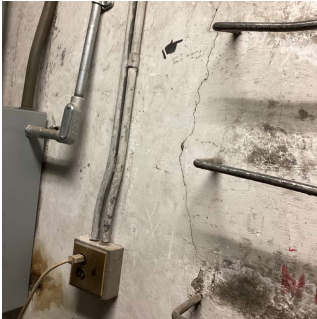
Question	Response
INTERIOR	
STRUCTURAL	
FOUNDATION WALLS	Inspected
Material Type(s)	Concrete
Condition	4 - Between Fair and Poor
Deficiency	CONCRETE: CRACKED/SPALLED/REINFORCEMENT EXPOSED
Deficiency Location/Instance	Basement - Mechanical Equipment East, West, Storage Room, Boiler Room
Deficiency Quantity	300
Quantity Uom	S.F.
Potential Action	REPAIR
Urgency of Action	PRIORITY 3
Purpose of Action	LEVEL 5
Deficiency Photo1

Violations	Basement - Mechanical Equipment East No violations recorded.
Deficiency	CONCRETE: WATER INFILTRATION IN NON- INSTRUCTIONAL SPACE
Deficiency Location/Instance	Basement - Room near House Blower #2, Crawlspace
Deficiency Quantity	200
Quantity Uom	S.F.
Potential Action	INSTALL WATERPROOFING
Urgency of Action	PRIORITY 5
Purpose of Action	LEVEL 5
Deficiency Photo1	 
Violations	Basement - House Blower #2 No violations recorded.
ROOF STRUCTURE	Inspected
Condition	2 - Between Good and Fair

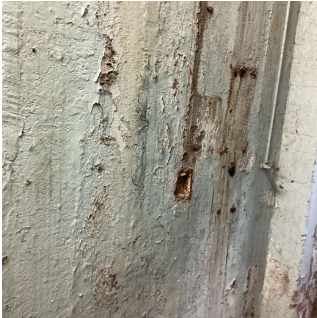
Question	Response
INTERIOR	
STRUCTURAL	
VAULTS-BUNKERS	
Foundation Walls	
Deficiency Location/Instance	Basement - Ash Hoist Vault
Deficiency Quantity	100
Quantity Uom	S.F.
Potential Action	INSTALL WATERPROOFING
Urgency of Action	PRIORITY 5
Purpose of Action	LEVEL 5
Deficiency Photo1

Violations	Basement - Ash Hoist Vault No violations recorded.
Slab Structure	Inspected
Condition	3 - Fair
Deficiency	CONCRETE: CRACKS/SPALLED/REINFORCEMENT EXPOSED
Deficiency Location/Instance	Basement Tunnel near the Boiler Room
Deficiency Quantity	30
Quantity Uom	S.F.
Potential Action	REPAIR
Urgency of Action	PRIORITY 4
Purpose of Action	LEVEL 5
Deficiency Photo1

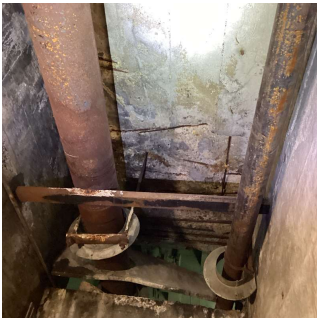
Violations	Basement Tunnel near the Boiler Room No violations recorded.
Deficiency	STEEL COLUMNS/BEAMS: DETERIORATED CONCRETE FIREPROOFING
Deficiency Location/Instance	Basement - Ash Hoist Vault
Deficiency Quantity	10
Quantity Uom	S.F.
Potential Action	REPAIR
Urgency of Action	PRIORITY 3

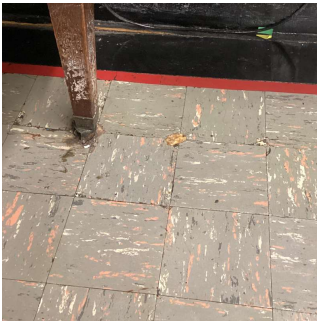
Question	Response
INTERIOR	
AUDITORIUM	
Floor Finish	
Deficiency Photo1

Violations	Platform No violations recorded.
Sliding-folding Partition	
Instance on 2nd Floor (650 Seats)	Does not Exist
Stage	
Instance on 2nd Floor (650 Seats)	Inspected
Stage	Inspected
Instance on 2nd Floor (650 Seats)	Inspected
Condition	3 - Fair
Deficiency	DAMAGED STEPS
Deficiency Location/Instance	Left side
Deficiency Quantity	10
Quantity Uom	S.F.
Potential Action	REPLACE
Urgency of Action	PRIORITY 3
Purpose of Action	LEVEL 2
Deficiency Photo1

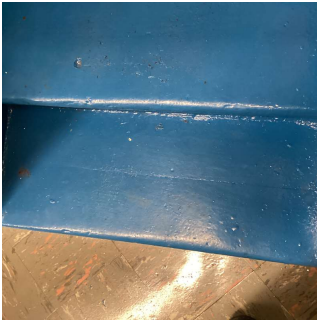
Violations	Left side No violations recorded.
Deficiency	DAMAGED FLOOR
Deficiency Location/Instance	Right side, center, left side
Deficiency Quantity	15
Quantity Uom	S.F.
Potential Action	REPLACE
Urgency of Action	PRIORITY 3
Purpose of Action	LEVEL 2

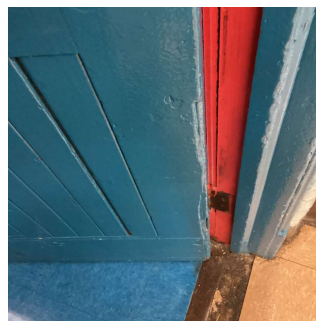
Entrance

WOOD: DETERIORATED DOOR

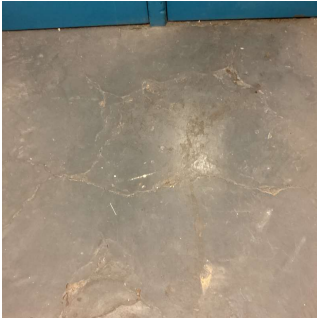
Question	Response
INTERIOR	
CLASSROOMS/CORRIDORS/ADMIN SPACES	
Floor Finish	
Violations	No violations recorded.
Deficiency	CONCRETE: CRACKS
Deficiency Location/Instance	Exit 3
Deficiency Quantity	10
Quantity Uom	S.F.
Potential Action	REPLACE
Urgency of Action	PRIORITY 3
Purpose of Action	LEVEL 2
Deficiency Photo1

Violations	Exit 3 No violations recorded.
Deficiency	TERRAZZO: CRACKS
Deficiency Location/Instance	Corridor near Auditorium
Deficiency Quantity	110
Quantity Uom	S.F.
Potential Action	REPLACE
Urgency of Action	PRIORITY 3
Purpose of Action	LEVEL 2
Deficiency Photo1

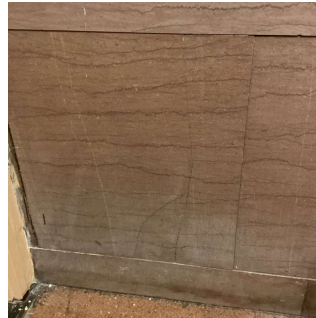
Main Entrance Vestibule

STONE: CRACKS/SPALLING

REPLACE

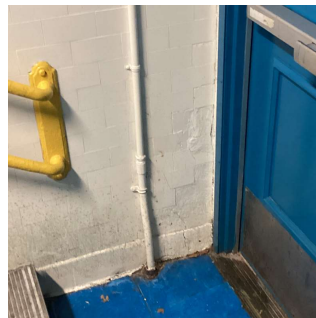
CERAMIC TILE: BROKEN/ MISSING

REPLACE

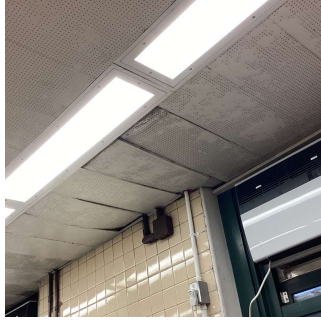
Instance on 1st Floor	Inspected
Ceiling	
Instance on 1st Floor	Inspected
Condition	2 - Between Good and Fair
Deficiency	METAL PAN: DAMAGED/MISSING
Deficiency Location/Instance	Near Windows, center
Deficiency Quantity	20
Quantity Uom	S.F.
Potential Action	REPLACE
Urgency of Action	PRIORITY 3
Purpose of Action	LEVEL 2
Deficiency Photo1

Near Windows
Violations	No violations recorded.

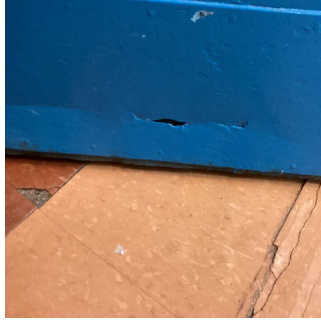
Instance on 1st Floor	Inspected
Condition	3 - Fair
Deficiency	METAL: DETERIORATED DOOR
Deficiency Location/Instance	Storage
Deficiency Quantity	1
Quantity Uom	EACH
Potential Action	MAINTENANCE
Urgency of Action	PRIORITY 3
Purpose of Action	LEVEL 2
Deficiency Photo1

Storage
Violations	No violations recorded.

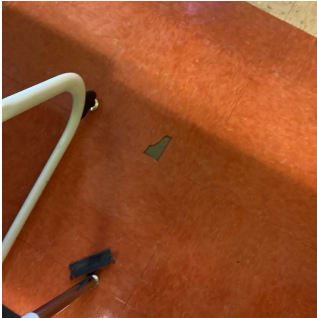
Question	Response
INTERIOR	
LIBRARY	
Floor Finish	
Deficiency	VINYL TILES: BROKEN/DETERIORATED/MISSING TILES
Deficiency Location/Instance	Near Windows
Deficiency Quantity	10
Quantity Uom	S.F.
Potential Action	REPLACE
Urgency of Action	PRIORITY 3
Purpose of Action	LEVEL 2
Deficiency Photo1

Violations	Near Windows No violations recorded.
Deficiency	VINYL TILES: DETERIORATED SUBSTRATE
Deficiency Location/Instance	Near center
Deficiency Quantity	10
Quantity Uom	S.F.
Potential Action	REPLACE
Urgency of Action	PRIORITY 3
Purpose of Action	LEVEL 2
Deficiency Photo1

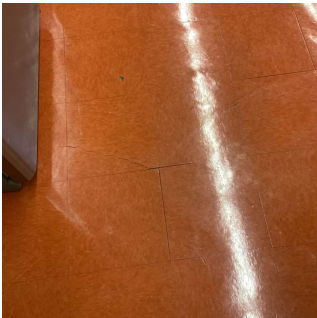
Violations	Near center No violations recorded.
Deficiency	VINYL TILES: TRIPPING HAZARD - ELECTRICAL OUTLET
Deficiency Location/Instance	Room 407
Deficiency Quantity	10
Quantity Uom	S.F.
Potential Action	REMOVE
Urgency of Action	PRIORITY 5
Purpose of Action	LEVEL 6

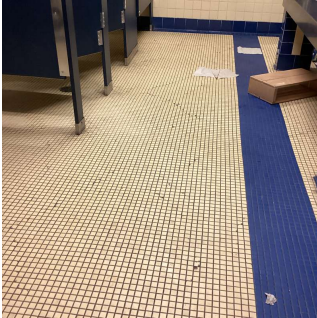
Violations	Room 151 No violations recorded.
Deficiency	CERAMIC TILE: DETERIORATED SUBSTRATE
Deficiency Location/Instance	Room 161
Deficiency Quantity	100
Quantity Uom	S.F.
Potential Action	REPLACE
Urgency of Action	PRIORITY 4
Purpose of Action	LEVEL 4
Deficiency Photo1

Violations	Room 161 35674634K
Deficiency	CERAMIC TILE: BROKEN/MISSING TILES
Deficiency Location/Instance	Room 161
Deficiency Quantity	10
Quantity Uom	S.F.
Potential Action	REPLACE
Urgency of Action	PRIORITY 5
Purpose of Action	LEVEL 6

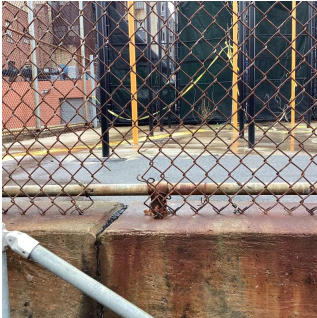
Violations	Schoolyard No violations recorded.
Deficiency	WROUGHT IRON: RUST - MAJOR
Deficiency Location/Instance	Along Montgomery Street
Deficiency Quantity	480
Quantity Uom	S.F.
Potential Action	REPLACE
Urgency of Action	PRIORITY 3
Purpose of Action	LEVEL 2
Deficiency Photo1

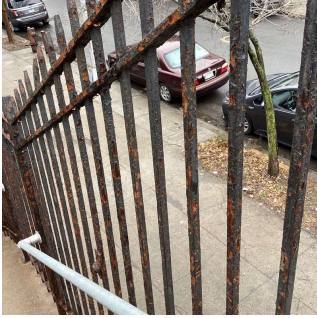
Violations	Along Montgomery Street No violations recorded.
Deficiency	CHAIN LINK: RUST - MAJOR
Deficiency Location/Instance	Schoolyard

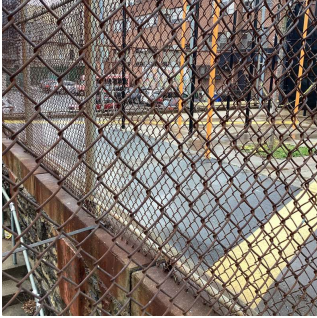
Violations	Schoolyard No violations recorded.
Deficiency	CHAIN LINK: DAMAGED POST/RAIL
Deficiency Location/Instance	Schoolyard
Deficiency Quantity	40
Quantity Uom	L.F.
Potential Action	REPLACE
Urgency of Action	PRIORITY 3
Purpose of Action	LEVEL 2
Deficiency Photo1

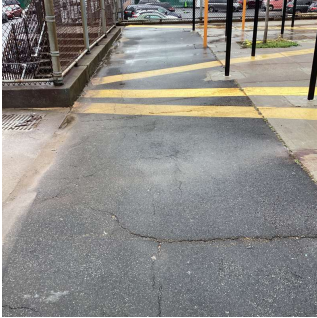
Violations	Schoolyard No violations recorded.
Concrete	Inspected
Condition	3 - Fair
Deficiency	DAMAGED/DETERIORATED/MISSING SECTIONS
Deficiency Location/Instance	Schoolyard
Deficiency Quantity	200
Quantity Uom	S.F.
Potential Action	REPLACE
Urgency of Action	PRIORITY 3
Purpose of Action	LEVEL 2
Deficiency Photo1

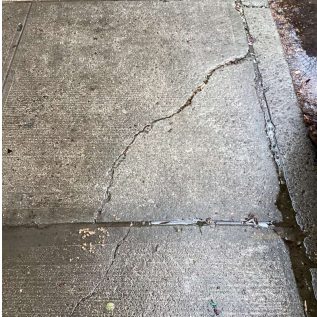
Violations	Along Crown Street No violations recorded.
Deficiency	DAMAGED CURBS
Deficiency Location/Instance	Along Crown Street, Montgomery Street
Deficiency Quantity	175
Quantity Uom	L.F.
Potential Action	REPLACE
Urgency of Action	PRIORITY 3
Purpose of Action	LEVEL 2
Deficiency Photo1
