NYC Department of Education
Building Condition Assessment Survey 2023 - 2024

Architectural Inspection

Asset: I.S. 162 - BROOKLYN, 1390 WILLOUGHBY AVENUE, New York, 11237

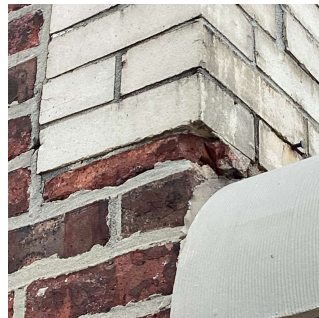
| Question | Response |
|---|--|
| Deficiency | BRICK: MAJOR / THRU CRACKS |

| Question | Response |
|---|--|
| Urgency of Action | PRIORITY 4 |

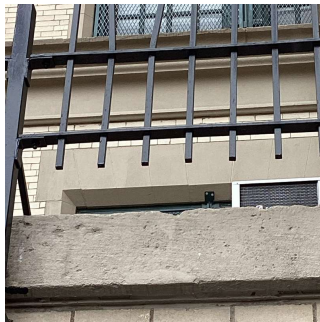
| Question | Response |
|---|---|
| Violations | Facade E No violations recorded. |

| Question | Response |
|---|---|
| Deficiency | CAST STONE: CRACKED/BROKEN PIECES |

| Question | Response |
|---|---|
| Potential Action | REPLACE-IN-KIND |

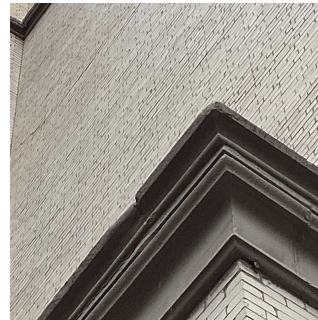
Facade E
No violations recorded.

| Question | Response |
|---|---|
| Deficiency | STONE: MAJOR CRACKS, SPALLING |

20
S.F.
REPLACE
PRIORITY 4
LEVEL 2

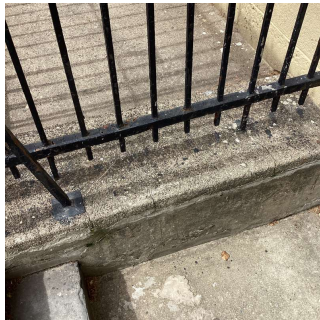
| Question | Response |
|---|--|
| Violations | Facade L - Exit 4 No violations recorded. |

| Question | Response |
|---|--|
| Deficiency | CAST IN PLACE CONCRETE: CRACKS/SPALLING - MINOR |

| Question | Response |
|---|--|
| Potential Action | REPAIR |

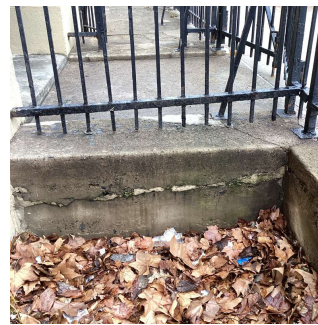
Facade L - Exit 2

| Question | Response |
|---|--|
| Deficiency | CAST IN PLACE CONCRETE: CRACKS/SPALLING - MAJOR |

20
 S.F.
 REPLACE
 PRIORITY 4
 LEVEL 2

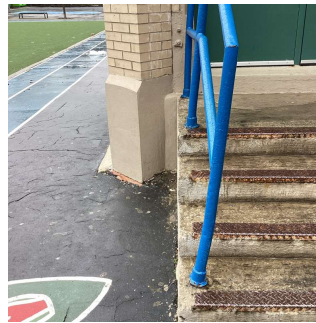
Facade F

DAMAGED

10
 L.F.
 REPLACE
 PRIORITY 4
 LEVEL 2

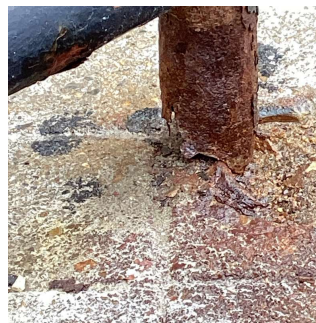
Facade B

RUST - MAJOR

REPLACE

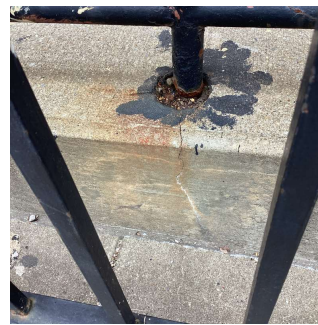
Facade B - Exit 3

CONCRETE: CRACKS/SPALLING - MINOR

10
S.F.
REPAIR
PRIORITY 3
LEVEL 2

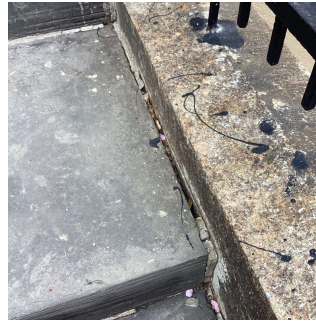
Facade B - Exit 5

STONE: DETERIORATED JOINTS

10
L.F.
REPOINT
PRIORITY 4
LEVEL 2

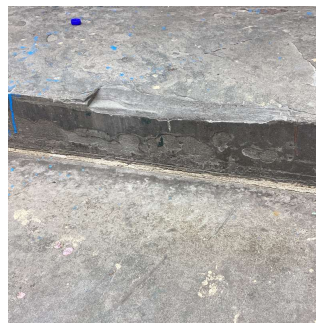
Facade B - Exit 5

STONE: CRACKS/SPALLING - MAJOR

REPLACE

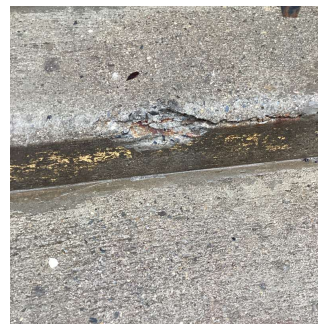
Facade B

CONCRETE: WORN-OUT TREAD/RISER/NOSING

20
 S.F.
 REPLACE
 PRIORITY 4
 LEVEL 2

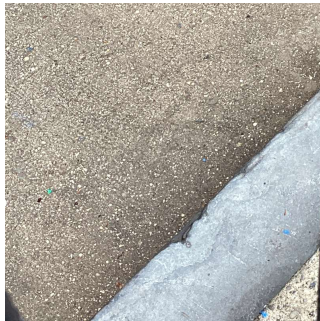
| Question | Response |
|---|--|
| Violations | Facade L No violations recorded. |

STONE: WORN-OUT TREAD/RISER/NOSING

20
 S.F.
 REPLACE
 PRIORITY 4
 LEVEL 2

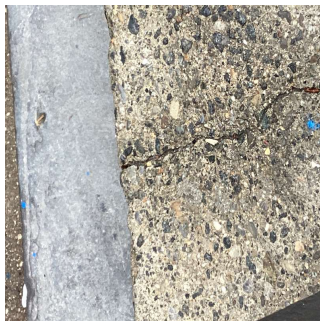
| Question | Response |
|---|--|
| Violations | Facade L No violations recorded. |

| Question | Response |
|---|--|
| Deficiency | CONCRETE: CRACKS/SPALLING - MAJOR |

| Question | Response |
|---|--|
| Potential Action | REPLACE |

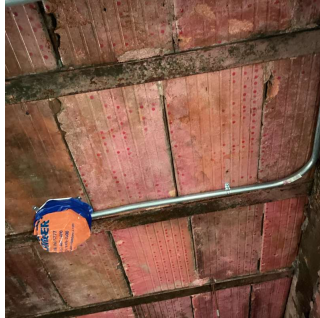
| Question | Response |
|---|--|
| Violations | PH No violations recorded. |

| Question | Response |
|---|--|
| Deficiency | CINDER CONCRETE FLAT SLAB: CRACKED/SPALLED/REINFORCEMENT EXPOSED |

| Question | Response |
|---|--|
| Potential Action | REPAIR |

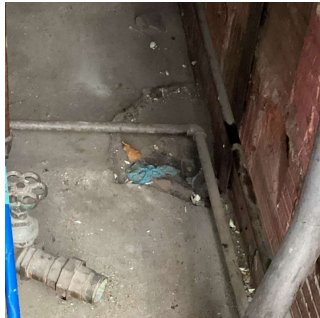
| Question | Response |
|---|--|
| Violations | PH No violations recorded. |

| Question | Response |
|---|--|
| Deficiency | CONCRETE: CRACKS/SPALLED/REINFORCEMENT EXPOSED |
