NYC Department of Education
Building Condition Assessment Survey 2023 - 2024

Architectural Inspection

Asset: P.S. 164 - BROOKLYN, 4211 14TH AVENUE, New York, 11219

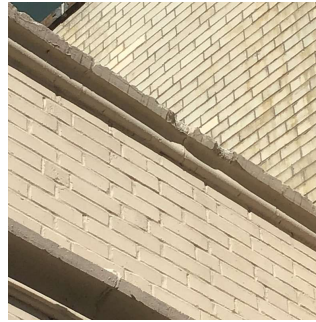
Facade E

TERRA COTTA: CRACKED/BROKEN PIECES

20
L.F.
REPLACE-IN-KIND
PRIORITY 4
LEVEL 2

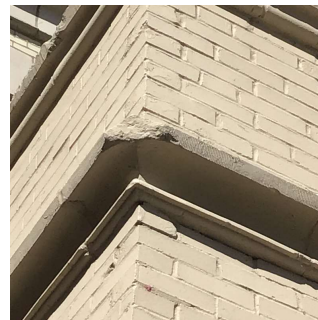
Facade E

TERRA COTTA: MAJOR CRACKS, SPALLING

REPLACE

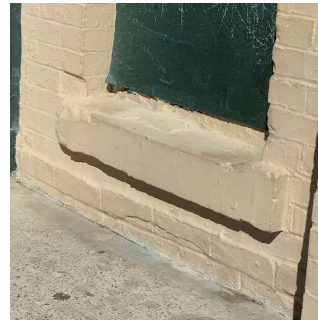
Facade E

Violations	Facade M No violations recorded.
DOOR HARDWARE	Inspected
Condition	3 - Fair
Deficiency	No deficiencies recorded
LINTELS	Inspected
Condition	2 - Between Good and Fair
Deficiency	No deficiencies recorded
TRANSOM/SIDE LIGHT	Inspected
Condition	2 - Between Good and Fair
Deficiency	No deficiencies recorded
EXTERIOR WALLS	Inspected
Material Type(s)	Masonry
Replacement Quantity	30,000
Replacement Uom	S.F.
Instance on All Facades	Inspected
Instance Condition	4 - Between Fair and Poor
Instance Quantity	30,000
Instance Quantity Uom	S.F.
Deficiency	BRICK: DETERIORATED MASONRY SILLS - MAJOR

REMOVE AND REPLACE

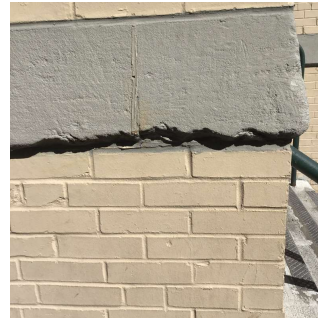
Facade E

STONE: CHIPPED/SPALLED/BROKEN PIECES - MAJOR

REPLACE

PRIORITY 4
LEVEL 2

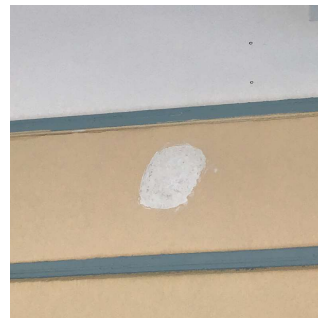
BRICK: WATER INFILTRATION IN INSTRUCTIONAL SPACE

REPAIR

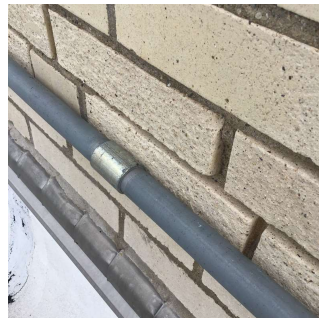
Question	Response
EXTERIOR	
EXTERIOR WALLS	Inspected
	Facade D - Room 402, also Facade B - Staircase A/B, Room 301, Facades B, D - Room 302, Facade K - Rooms 212, 312, Facade J - Room 310
Violations	No violations recorded.
EXTERIOR SOFFITS	Inspected
Condition	2 - Between Good and Fair
Deficiency	No deficiencies recorded
LOADING DOCK	Does not Exist
LOUVER	Inspected
Condition	2 - Between Good and Fair
Deficiency	No deficiencies recorded
PARAPETS	Inspected
Material Type(s)	Masonry
Replacement Quantity	5,000
Replacement Uom	C.F.
Instance on All Facades	Inspected
Instance Condition	3 - Fair
Instance Quantity	5,000
Instance Quantity Uom	C.F.
Deficiency	BRICK: DETERIORATED JOINTS
Roof Plan reference

Deficiency Quantity	50
Quantity Uom	S.F.
Potential Action	REPOINT
Urgency of Action	PRIORITY 4
Purpose of Action	LEVEL 2
Deficiency Photo1

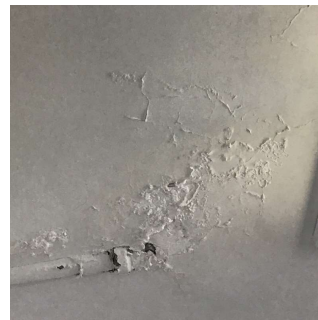
Exit 8 - Vestibule Roof

MODIFIED BITUMEN: ROOFING: MAJOR ACTIVE ROOF LEAKS IN INSTRUCTIONAL SPACE

REPLACE ROOFING WITHOUT MAJOR EQUIPMENT REMOVAL

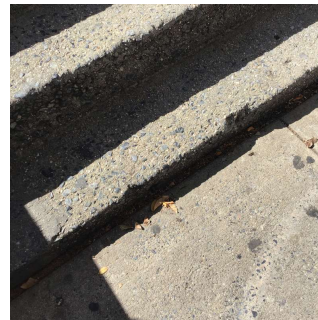
Facade C

CONCRETE: WORN-OUT TREAD/RISER/NOSING

REPLACE

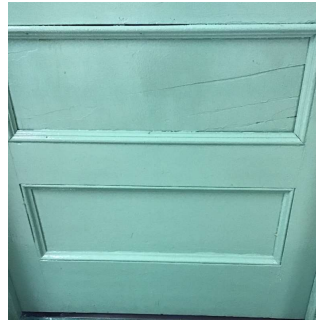
Room 101

Violations	Room 407 No violations recorded.
Door(s)	
Condition	Inspected
Condition	5 - Poor
Deficiency	WOOD: DETERIORATED DOOR
Deficiency Location/Instance	Rooms 101,201,208,211,407A and others
Deficiency Quantity	13
Quantity Uom	EACH
Potential Action	MAINTENANCE
Urgency of Action	PRIORITY 3
Purpose of Action	LEVEL 2

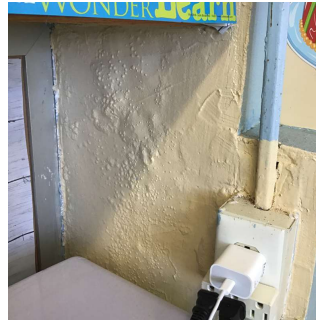
Room 312

Violations	Room 202 No violations recorded.
Walls	Inspected
Condition	2 - Between Good and Fair
Deficiency	PLASTER: CRACKS/SPALLING - ACTIVE LEAK
Deficiency Location/Instance	Rooms 402,312,310,302,301,212

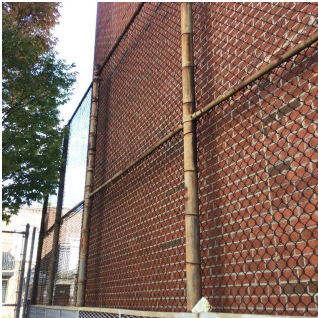
Violations	Playground No violations recorded.
Deficiency	CHAIN LINK: RUST - MAJOR
Deficiency Location/Instance	Along Playground
Deficiency Quantity	3,300
Quantity Uom	S.F.
Potential Action	REPLACE
Urgency of Action	PRIORITY 3

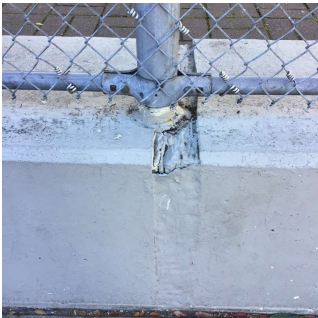
Along 42nd Street
Violations	No violations recorded.
Deficiency	CAST IN PLACE CONCRETE: DETERIORATED CONTROL/EXPANSION JOINT
Deficiency Location/Instance	42nd Street
Deficiency Quantity	10
Quantity Uom	L.F.
Potential Action	REPLACE
Urgency of Action	PRIORITY 3
Purpose of Action	LEVEL 2
