NYC Department of Education
Building Condition Assessment Survey 2023 - 2024

Architectural Inspection

Asset: P.S. 165 - BROOKLYN, 76 LOTT AVENUE, New York, 11212

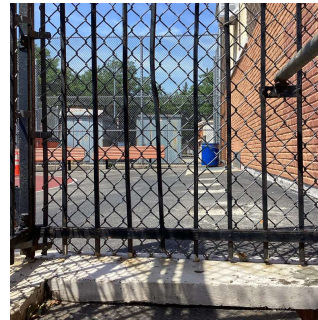
AW8
No violations recorded.

Question	Response
Architectural	
EXTERIOR	Inspected
AREAWAY	Inspected
Instance on AW1 - AW15	Inspected
Instance Condition	3 - Fair
Instance Quantity	15
Instance Quantity Uom	EACH
Deficiency	AREAWAY STAIRS: DETERIORATED RAILINGS

10
L.F.
REPLACE
PRIORITY 4
LEVEL 2

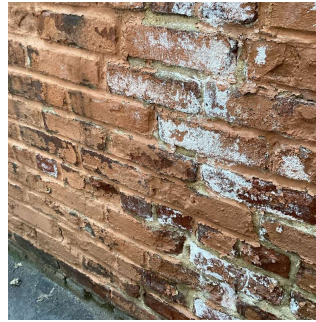
AW8

AREAWAY WALLS: CRACKS AND SPALLING

60
S.F.
REPLACE
PRIORITY 4
LEVEL 2

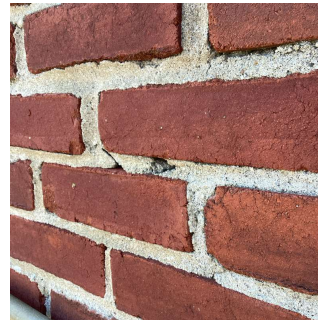
CH

BRICK: DETERIORATED JOINTS

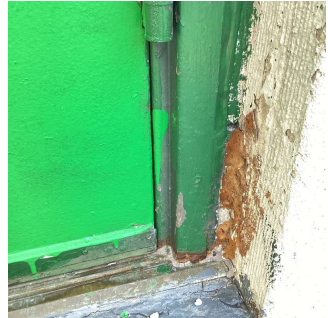
Violations	Roof 1 No violations recorded.
CORNICE	Inspected
Condition	2 - Between Good and Fair
Deficiency	No deficiencies recorded
DOORS	Inspected
DOORS AND FRAMES	Inspected
Condition	5 - Poor
Deficiency	METAL: DETERIORATED DOOR AND FRAME - MAJOR DETERIORATION
Roof Plan reference	K165  
Deficiency Quantity	9
Quantity Uom	EACH
Potential Action	REPLACE
Urgency of Action	PRIORITY 4
Purpose of Action	LEVEL 2
Deficiency Photo1	 
Violations	Facade A No violations recorded.
Deficiency	METAL: DETERIORATED DOOR AND FRAME - MINOR DETERIORATION

Deficiency Quantity	2
Quantity Uom	EACH
Potential Action	MAINTENANCE
Urgency of Action	PRIORITY 3
Purpose of Action	LEVEL 2
Deficiency Photo1

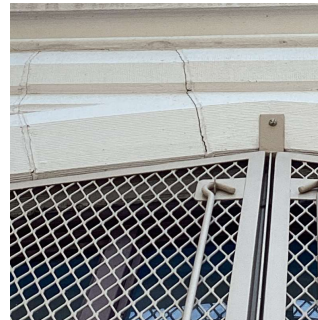
Violations	Facade D No violations recorded.
DOOR HARDWARE	Inspected
Condition	3 - Fair
Deficiency	No deficiencies recorded
LINTELS	Inspected
Condition	2 - Between Good and Fair
Deficiency	No deficiencies recorded
TRANSOM/SIDE LIGHT	Inspected
Condition	2 - Between Good and Fair
Deficiency	No deficiencies recorded
EXTERIOR WALLS	Inspected
Material Type(s)	Concrete, Masonry
Replacement Quantity	37,000
Replacement Uom	S.F.
Instance on All Facades	Inspected
Instance Condition	3 - Fair
Instance Quantity	37,000
Instance Quantity Uom	S.F.
Deficiency	STONE: DETERIORATED JOINTS

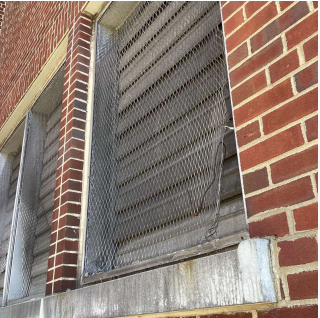
Question	Response
EXTERIOR	
EXTERIOR WALLS	
Urgency of Action	PRIORITY 1
Purpose of Action	LEVEL 1
Deficiency Photo1	No photo recorded
Violations	No violations recorded.
EXTERIOR SOFFITS	
	Does not Exist
LOADING DOCK	
	Does not Exist
LOUVER	
Condition	3 - Fair
Deficiency	MISSING/DAMAGED SCREEN
Roof Plan reference	<p>K165</p>

Deficiency Quantity	120
Quantity Uom	S.F.
Potential Action	REPLACE
Urgency of Action	PRIORITY 4
Purpose of Action	LEVEL 2
Deficiency Photo1

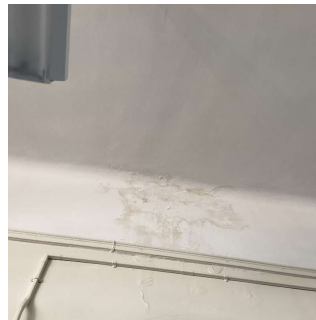
Roof 1 - Room 409 shown, Roof 1 - Rooms 402, 403, 405 , 407 similar

BUILT-UP: ROOFING: MAJOR ACTIVE ROOF LEAKS IN INSTRUCTIONAL SPACE

REPLACE ROOFING WITHOUT MAJOR EQUIPMENT REMOVAL

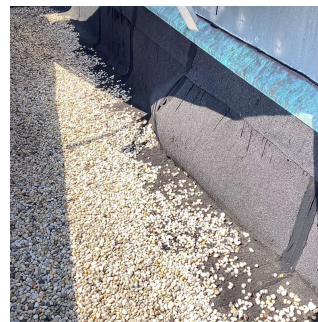
Roof 1
No violations recorded.

BUILT-UP: FLASHING: BASE FLASHING DETERIORATED

10
S.F.
REMOVE AND REPLACE
PRIORITY 4
LEVEL 2

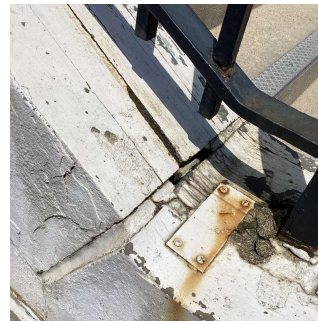
Facade B
 No violations recorded.

STONE: DETERIORATED JOINTS

20
 S.F.
 REPOINT
 PRIORITY 4
 LEVEL 2

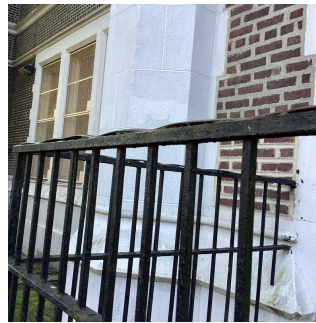
Facade A

RUST - MAJOR

REPLACE

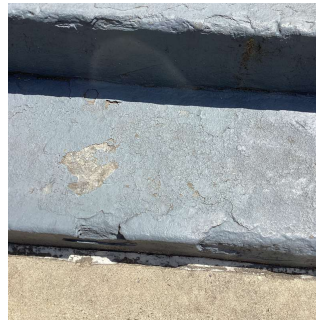
Facade C

STONE: WORN-OUT TREAD/RISER/NOSING

REPLACE

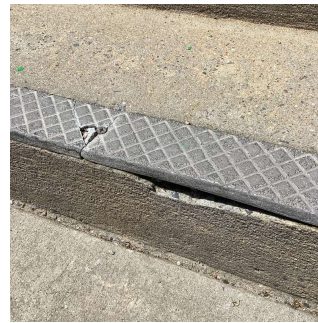
Facade B

CONCRETE: WORN-OUT TREAD/RISER/NOSING

10
S.F.
REPLACE
PRIORITY 4
LEVEL 2

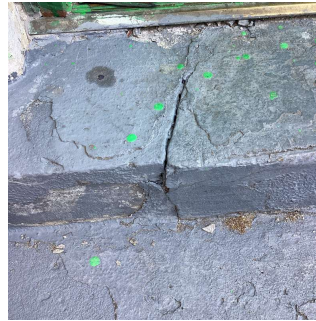
Facade C

STONE: CRACKS/SPALLING - MAJOR

10
S.F.
REPLACE
PRIORITY 4
LEVEL 2

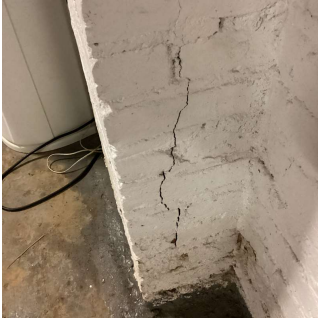
Question	Response
INTERIOR	
STRUCTURAL	
COLUMNS/BEAMS/BEARING WALLS	Inspected
Condition	3 - Fair
Deficiency	STEEL COLUMNS/BEAMS: DETERIORATED MASONRY FIREPROOFING
Deficiency Location/Instance	Basement - Staff Room
Deficiency Quantity	40
Quantity Uom	S.F.
Potential Action	REPLACE
Urgency of Action	PRIORITY 4
Purpose of Action	LEVEL 5
Deficiency Photo1

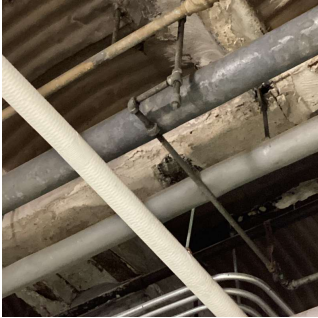
Violations	Basement - Staff Room No violations recorded.
Deficiency	STEEL COLUMNS/BEAMS: DETERIORATED/MISSING PLASTER FIREPROOFING
Deficiency Location/Instance	Basement - Corridor, Storage, Boiler Room, Staff Room
Deficiency Quantity	50
Quantity Uom	S.F.
Potential Action	REPLACE
Urgency of Action	PRIORITY 4
Purpose of Action	LEVEL 5
Deficiency Photo1

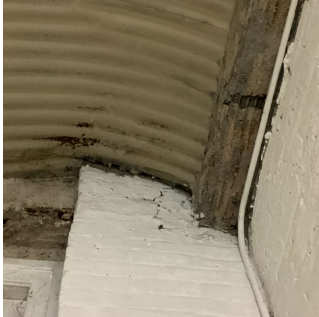
Violations	Basement - Storage No violations recorded.
FLOOR STRUCTURE	
	Inspected
Condition	3 - Fair
Deficiency	CINDER CONCRETE ARCH: METAL PAN DETERIORATED, SPALLED
Deficiency Location/Instance	Basement - Corridor, Boiler Room, Staff Room

Deficiency Quantity	110
Quantity Uom	S.F.
Potential Action	REPAIR
Urgency of Action	PRIORITY 3

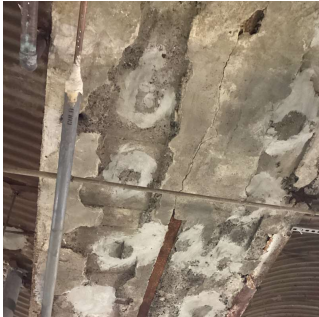
Violations	Basement - Corridor No violations recorded.
Deficiency	CONCRETE: CRACKS/SPALLED/REINFORCEMENT EXPOSED
Deficiency Location/Instance	Basement - Storage
Deficiency Quantity	30
Quantity Uom	S.F.
Potential Action	REPAIR
Urgency of Action	PRIORITY 4
Purpose of Action	LEVEL 5
Deficiency Photo1

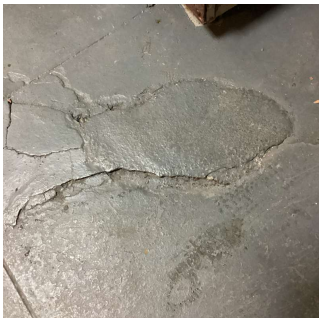
Violations	Basement - Storage No violations recorded.
Deficiency	CONCRETE SLAB ON GRADE: THRU CRACKS
Deficiency Location/Instance	Basement - Storage Room, Boiler Room
Deficiency Quantity	50
Quantity Uom	S.F.
Potential Action	REPLACE
Urgency of Action	PRIORITY 4
Purpose of Action	LEVEL 5
Deficiency Photo1

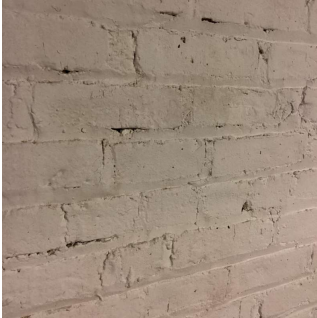
Question	Response
INTERIOR	
STRUCTURAL	
FLOOR STRUCTURE	Inspected
Violations	No violations recorded.
FOUNDATION WALLS	Inspected
Material Type(s)	Concrete, Masonry
Condition	3 - Fair
Deficiency	BRICK: DETERIORATED JOINTS
Deficiency Location/Instance	Basement - Storage, Staff Room, Boiler Room, Corridor
Deficiency Quantity	320
Quantity Uom	S.F.
Potential Action	REPOINT
Urgency of Action	PRIORITY 3
Purpose of Action	LEVEL 5
Deficiency Photo1

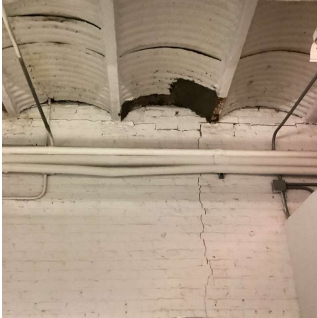
Violations	Basement - Staff Room No violations recorded.
Deficiency	BRICK: CRACKED/SPALLED
Deficiency Location/Instance	Basement - Staff Room
Deficiency Quantity	20
Quantity Uom	S.F.
Potential Action	RESTITCH
Urgency of Action	PRIORITY 4
Purpose of Action	LEVEL 5
Deficiency Photo1

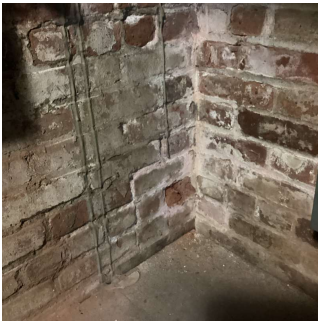
Violations	Basement - Staff Room No violations recorded.
Deficiency	BRICK: CRACKED/SPALLED
Deficiency Location/Instance	Basement - Electrical Room, Storage Room
Deficiency Quantity	30
Quantity Uom	S.F.

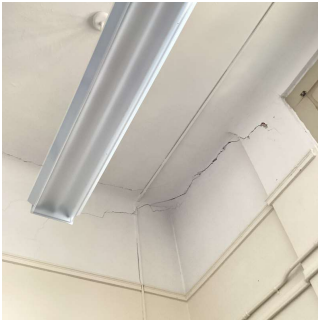
Basement - Electrical Room
Violations	No violations recorded.
ROOF STRUCTURE	
Condition	Inspected
Deficiency	3 - Fair
Deficiency Location/Instance	CONCRETE: CRACKED/SPALLED/REINFORCEMENT EXPOSED
Deficiency Quantity	Rooms 403, 409 (Shown)
Quantity Uom	40
Potential Action	S.F.
Urgency of Action	REPAIR
Purpose of Action	PRIORITY 4
Deficiency Photo1	LEVEL 5

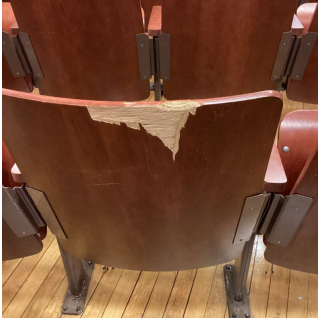
Question	Response
INTERIOR	
AUDITORIUM	
Fixed Seating	
Condition	2 - Between Good and Fair
Deficiency	DAMAGED/BROKEN/INOPERABLE
Deficiency Location/Instance	Seats A/109, 110, B/102, L/16
Deficiency Quantity	4
Quantity Uom	EACH
Potential Action	REPLACE
Urgency of Action	PRIORITY 3
Purpose of Action	LEVEL 2
Deficiency Photo1

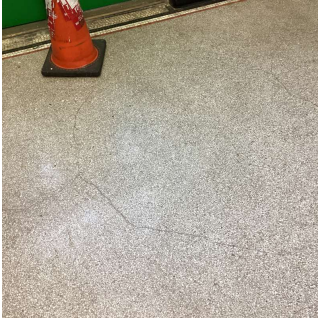
Seat L/16
Violations	No violations recorded.
Floor Finish	
Instance on Ground Floor (540 Seats)	Inspected
Condition	2 - Between Good and Fair
Deficiency	TERRAZZO: CRACKS
Deficiency Location/Instance	Exit 4 Vestibule
Deficiency Quantity	20
Quantity Uom	S.F.
Potential Action	REPLACE
Urgency of Action	PRIORITY 3
Purpose of Action	LEVEL 2
Deficiency Photo1

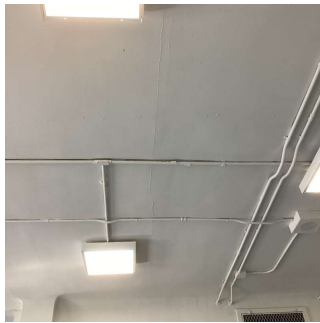
Potential Action	MAINTENANCE
Urgency of Action	PRIORITY 3
Purpose of Action	LEVEL 2
Deficiency Photo1	No photo recorded
Violations	No violations recorded.
CAFETERIA	
Instance on Ground Floor	Inspected
Ceiling	
Instance on Ground Floor	Inspected
Condition	2 - Between Good and Fair
Deficiency	PLASTER: CRACKS/SPALLING
Deficiency Location/Instance	Center
Deficiency Quantity	20
Quantity Uom	S.F.
Potential Action	REPLACE
Urgency of Action	PRIORITY 3
Purpose of Action	LEVEL 2

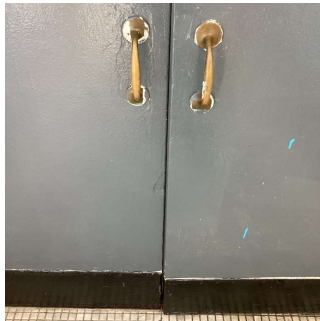
Violations	Center No violations recorded.
Door(s)	
Instance on Ground Floor	Inspected
Condition	5 - Poor
Deficiency	WOOD: DETERIORATED DOOR
Deficiency Location/Instance	Rear Exit, Main Entrance
Deficiency Quantity	4
Quantity Uom	EACH
Potential Action	MAINTENANCE
Urgency of Action	PRIORITY 3
Purpose of Action	LEVEL 2
Deficiency Photo1

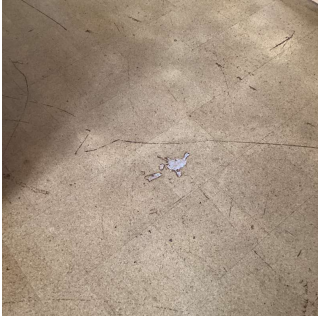
Question	Response
INTERIOR	
LIBRARY	
Door(s)	
Instance on 3rd Floor	Inspected
Condition	2 - Between Good and Fair
Deficiency	No deficiencies recorded
Floor Finish	
Instance on 3rd Floor	Inspected
Condition	5 - Poor
Deficiency	CORK: WORN/DETERIORATED
Deficiency Location/Instance	Near Entrance, Center, Left and Right Side
Deficiency Quantity	300
Quantity Uom	S.F.
Potential Action	REPLACE
Urgency of Action	PRIORITY 3
Purpose of Action	LEVEL 2
Deficiency Photo1

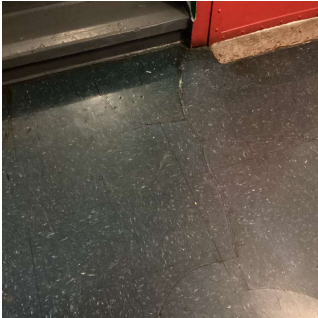
Question	Response
INTERIOR	
STAIRS/RAMPS: INTERIOR	
Stairs and Landings	
Deficiency	VINYL TILES: DETERIORATED SUBSTRATE
Deficiency Location/Instance	Stair HI/Ground Floor, 1, 2, 3, 4 and others
Deficiency Quantity	200
Quantity Uom	S.F.
Potential Action	REPLACE
Urgency of Action	PRIORITY 3
Purpose of Action	LEVEL 2
Deficiency Photo1

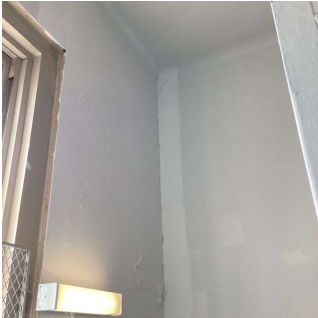
Violations	Stair HI/Ground Floor No violations recorded.
Walls	Inspected
Condition	2 - Between Good and Fair
Deficiency	PLASTER: CRACKS/SPALLING
Deficiency Location/Instance	Stair FG/4, 3, 2
Deficiency Quantity	80
Quantity Uom	S.F.
Potential Action	REPLACE
Urgency of Action	PRIORITY 3
Purpose of Action	LEVEL 2
Deficiency Photo1

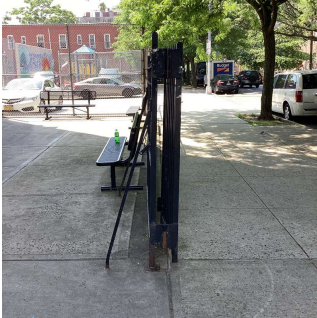
Priority Condition Exist Last Year?	Priority Category	Condition Description	Component Affected	Location Description	Person(s) Notified	Person(s) Title	PhotoImage
Yes	Potential Falling Debris	Severely damaged and Leaning wrought Iron fence is a potential safety hazard.	SITE FENCES	Near Exit 2	Namom Krider	Fireman
