NYC Department of Education
Building Condition Assessment Survey 2023 - 2024

Architectural Inspection

Asset: P.S. 167 - BROOKLYN, 1025 EASTERN PKWY, New York, 11213

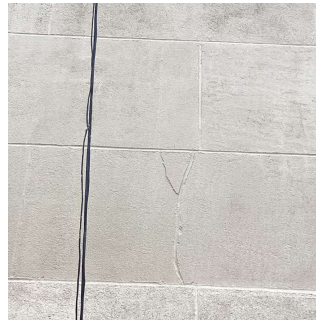
Facade A - Near AW9

CAST IN PLACE / PRE-CAST CONCRETE: MINOR
CRACKS/SPALLING

REPAIR

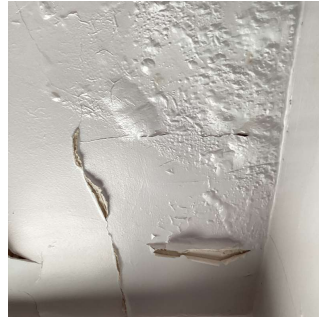
Question	Response
EXTERIOR	
ROOF	
Specialties	Inspected
BULKHEAD/PENTHOUSE	Inspected
Condition	3 - Fair
Deficiency	BULKHEAD/PENTHOUSE CEILING: PLASTER DAMAGED/DETERIORATED
Roof Plan reference

Deficiency Quantity	20
Quantity Uom	S.F.
Potential Action	REPLACE
Urgency of Action	PRIORITY 4
Purpose of Action	LEVEL 2
Deficiency Photo1

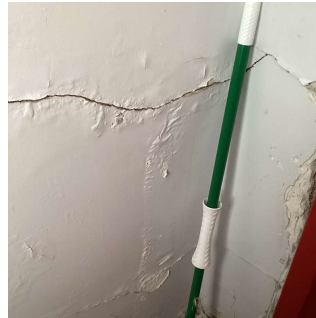
Roof 1 - BH

Violations	No violations recorded.
Deficiency	BULKHEAD/PENTHOUSE WALLS/INTERIOR: PLASTER CRACKS/SPALLING
Roof Plan reference

Deficiency Quantity	40
Quantity Uom	S.F.
Potential Action	REPLACE
Urgency of Action	PRIORITY 3
Purpose of Action	LEVEL 2

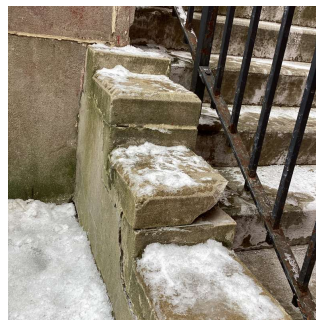
Facade K - HC Ramp

STONE: DETERIORATED COPING STONE

REPLACE

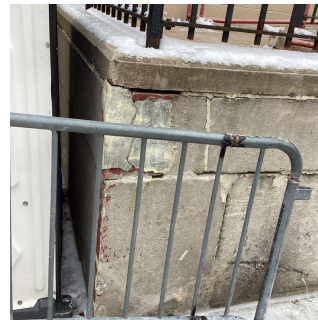
Facade L - HC Ramp

STONE: CRACKS/SPALLING - MAJOR

REPLACE

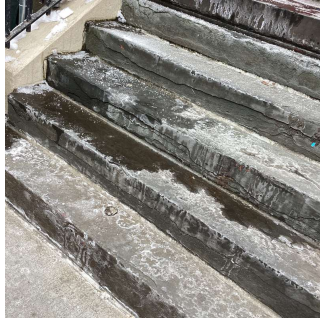
Deficiency Quantity	70
Quantity Uom	S.F.
Potential Action	REPLACE
Urgency of Action	PRIORITY 4
Purpose of Action	LEVEL 2
Deficiency Photo1

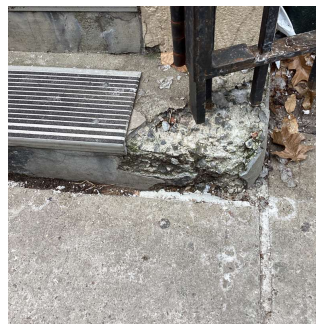
Facade M - Exit 10
No violations recorded.

Violations	Facade M - Exit 9 No violations recorded.
Deficiency	CONCRETE: CRACKS/SPALLING - MINOR

50
S.F.
REPAIR
PRIORITY 3
LEVEL 2

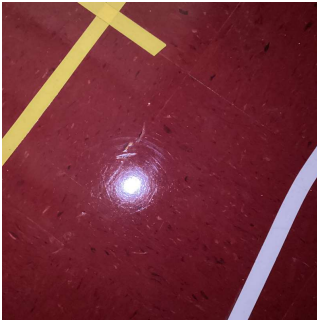
Left side
Violations	No violations recorded.
Deficiency	DAMAGED STEPS
Deficiency Location/Instance	Right side
Deficiency Quantity	10
Quantity Uom	S.F.
Potential Action	REPLACE
Urgency of Action	PRIORITY 3
Purpose of Action	LEVEL 2

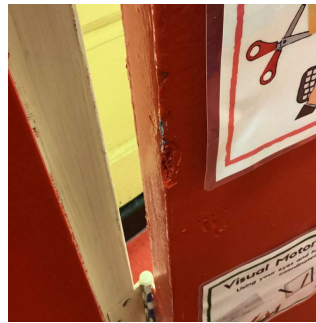
Room 307A

Violations	Nurses Office No violations recorded.
Door(s)	
Condition	5 - Poor
Deficiency	WOOD: DETERIORATED DOOR
Deficiency Location/Instance	Room 307A,307,306A,206B,113, and others
Deficiency Quantity	9
Quantity Uom	EACH
Potential Action	MAINTENANCE
Urgency of Action	PRIORITY 3
Purpose of Action	LEVEL 2

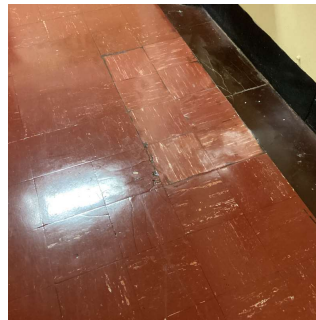
Corridor near Room 303

VINYL TILES: DETERIORATED SUBSTRATE

REPLACE

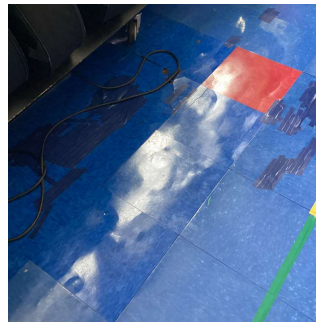
No	Tripping Hazard	Severely rotted floor is a potential tripping hazard.	INTERIOR CLASSROOMS /CORRIDORS/ ADMIN SPACES Floor Finish	Room 202	Jeffrey Taylor	Fireman

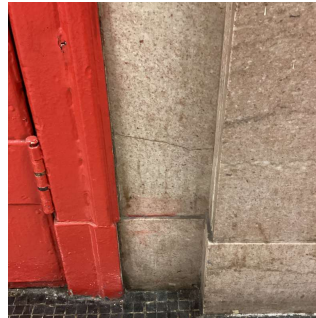
Main Entrance Lobby

STONE: CRACKS/SPALLING

REPLACE

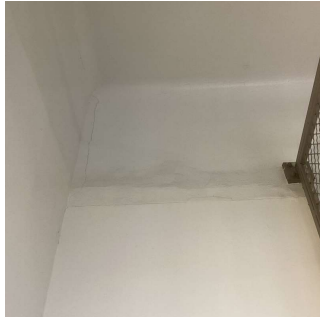
Exit 6
Violations	No violations recorded.
Walls	Inspected
Condition	2 - Between Good and Fair
Deficiency	PLASTER: CRACKS/SPALLING
Deficiency Location/Instance	Stair EF/4, C/4,2,
Deficiency Quantity	30
Quantity Uom	S.F.
Potential Action	REPLACE
Urgency of Action	PRIORITY 3
Purpose of Action	LEVEL 2
Deficiency Photo1

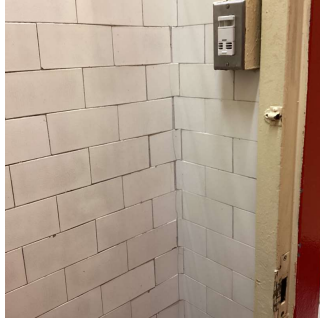
Room 250
Violations	No violations recorded.
Deficiency	PLASTER: CRACKS/SPALLING
Deficiency Location/Instance	Room 450,250, Ground Floor - Boys,Girls
Deficiency Quantity	30
Quantity Uom	S.F.
Potential Action	REPLACE
Urgency of Action	PRIORITY 3
Purpose of Action	LEVEL 2
Deficiency Photo1

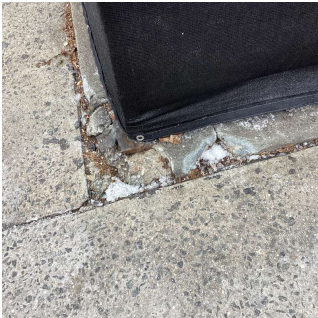
Question	Response
SITE	
Drainage System for Soil	Does not Exist
DRINKING FOUNTAINS	Under Construction
FENCES	Inspected
Condition	3 - Fair
Deficiency	CONCRETE CURB: DAMAGED/DETERIORATED
Deficiency Location/Instance	Along Eastern Parkway, Schenectady Avenue
Deficiency Quantity	115
Quantity Uom	S.F.
Potential Action	REPLACE
Urgency of Action	PRIORITY 3
Purpose of Action	LEVEL 2
Deficiency Photo1

Along Schenectady Avenue
Violations	No violations recorded.
IRRIGATION SYSTEM	Does not Exist
PAVING	Inspected
Student Non-Use	Inspected
Gravel Exists?	No
Asphalt	Does not Exist
Concrete	Inspected
Condition	2 - Between Good and Fair
Deficiency	No deficiencies recorded
Pavers	Does not Exist
Student Use	Inspected
Gravel Exists?	No
Asphalt	Under Construction
Concrete	Does not Exist
Pavers	Does not Exist
Site Sidewalks & Walkways	Inspected
Asphalt	Does not Exist
Concrete	Inspected
Condition	3 - Fair
Deficiency	DAMAGED/DETERIORATED/MISSING SECTIONS

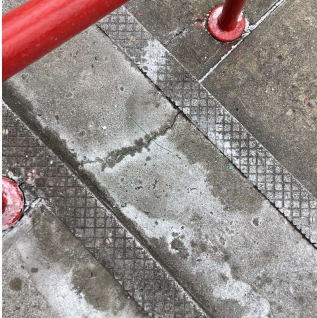
Question	Response
SITE	
STAIRS/RAMPS: EXTERIOR	
Stairs/ramps	
Deficiency	CAST IN PLACE CONCRETE: CRACKS/SPALLING - MAJOR
Deficiency Location/Instance	Main Entrance
Deficiency Quantity	10
Quantity Uom	S.F.
Potential Action	REPLACE
Urgency of Action	PRIORITY 3
Purpose of Action	LEVEL 2
Deficiency Photo1

Violations	Main Entrance No violations recorded.
ARTWORK	
Instance	Inspected
Instance Photo	Interior - Lobby - 21071
