NYC Department of Education
Building Condition Assessment Survey 2023 - 2024

Architectural Inspection

Asset: P.S. 169 - BROOKLYN, 4305 7TH AVENUE, New York, 11232

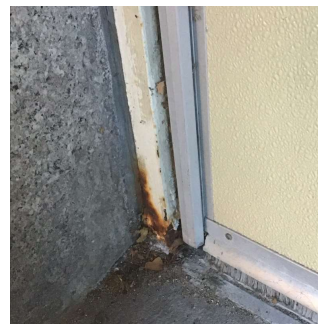
Facade B

Condition	Inspected
Deficiency	4 - Between Fair and Poor
	METAL: DETERIORATED DOOR AND FRAME - MAJOR DETERIORATION

5
EACH
REPLACE
PRIORITY 4
LEVEL 2

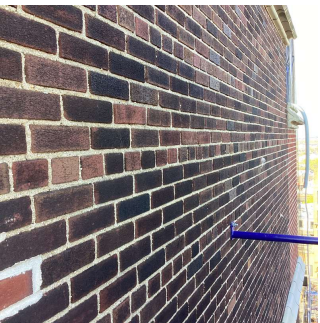
Question	Response
EXTERIOR	
ROOF	
Roofing	
LEADERS, GUTTERS, DOWNSPOUTS, SCUPPERS	Inspected
Violations	No violations recorded.
ROOF BARRIER/FENCE	Under Construction
ROOF CAGE	Does not Exist
ROOFING	Inspected
Instance on Built-Up: Roof 1 - 4	Under Construction
Instance Quantity	21,000
Instance Quantity Uom	S.F.
Instance on IRMA: Roof 6	Under Construction
Instance Quantity	6,000
Instance Quantity Uom	S.F.
Instance on Modified Bitumen: Roofs 7, 8	Under Construction
Instance Quantity	200
Instance Quantity Uom	S.F.
ROOFING DRAINS	Under Construction
Specialties	Inspected
BULKHEAD/PENTHOUSE	Inspected
Condition	3 - Fair
Deficiency	BULKHEAD/PENTHOUSE WALLS/EXTERIOR: DETERIORATED JOINTS
Roof Plan reference

Deficiency Quantity	80
Quantity Uom	S.F.
Potential Action	REPOINT
Urgency of Action	PRIORITY 3
Purpose of Action	LEVEL 2
Deficiency Photo1

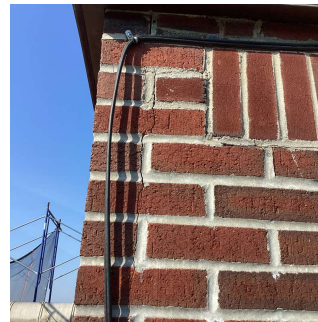
BH3

**BULKHEAD/PENTHOUSE WALLS/EXTERIOR:
CRACKS/SPALLING - MINOR**

REPAIR

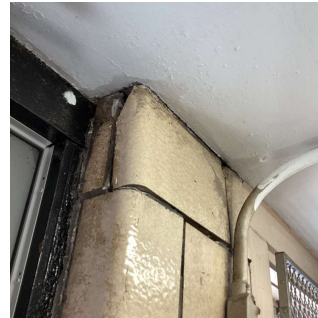
BH3

**BULKHEAD/PENTHOUSE WALLS/INTERIOR: GLAZED BLOCK
CRACKS/SPALLING**

REPLACE

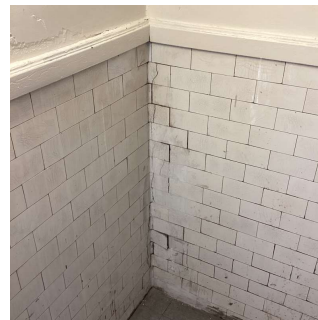
BH2

**BULKHEAD/PENTHOUSE WALLS/INTERIOR: BRICK
CRACKS/SPALLING**

REPLACE

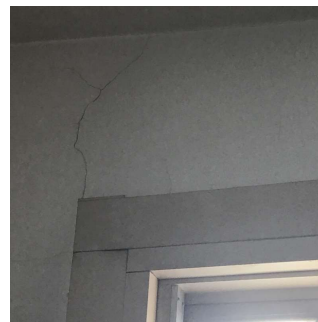
**BULKHEAD/PENTHOUSE WALLS/INTERIOR: PLASTER
CRACKS/SPALLING**

50
S.F.
REPLACE
PRIORITY 4
LEVEL 2

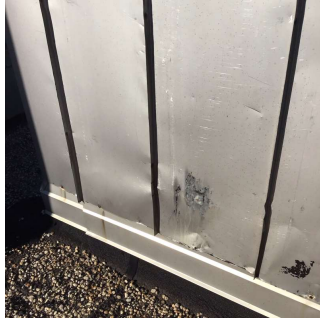
BULKHEAD/PENTHOUSE WALLS/EXTERIOR: DAMAGED METAL SIDING

50
S.F.
REPLACE
PRIORITY 4
LEVEL 2

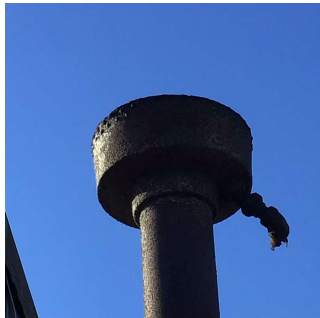
Violations	BH2 No violations recorded.
CUPOLA/ SPIRES/ TOWERS	Does not Exist
DORMER	Does not Exist
DUNNAGE STEEL	Does not Exist
SKYLIGHT/ROOF VENT	Inspected
Material Type(s)	Glass
Condition	3 - Fair
Deficiency	SHAFT VENTS DAMAGED
Roof Plan reference

Deficiency Quantity	2
Quantity Uom	EACH
Potential Action	MAINTENANCE
Urgency of Action	PRIORITY 3
Purpose of Action	LEVEL 2
Deficiency Photo1

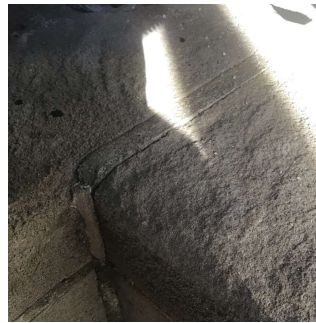
Facade K

STONE: DETERIORATED JOINTS AT COPING STONES

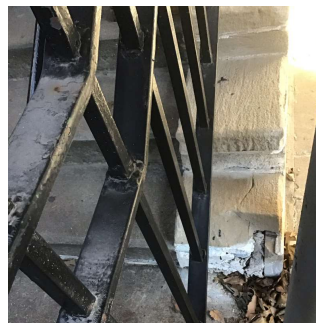
Facade K

STONE: CRACKS/SPALLING - MAJOR

REPLACE

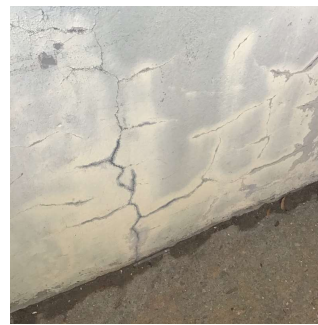
Facade B

CAST IN PLACE CONCRETE: CRACKS/SPALLING - MINOR

40
S.F.
REPAIR
PRIORITY 3
LEVEL 2

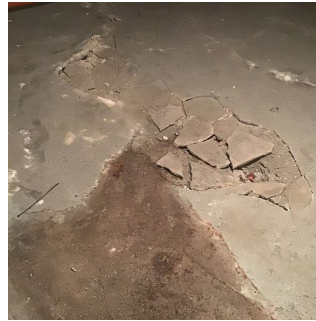
Basement (1937 Addition) - Mechanical Room

CONCRETE SLAB ON GRADE: THRU CRACKS

REPLACE

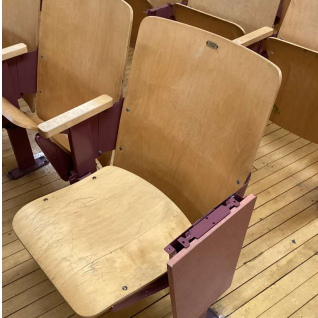
Question	Response
INTERIOR	
AUDITORIUM	
Fixed Seating	
Deficiency Location/Instance	Seats E/102, F/106, H/102, Q/207
Deficiency Quantity	4
Quantity Uom	EACH
Potential Action	REPLACE
Urgency of Action	PRIORITY 5
Purpose of Action	LEVEL 6
Deficiency Photo1

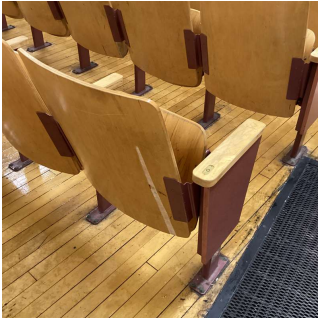
Violations	No violations recorded.
Deficiency	DAMAGED/BROKEN/INOPERABLE
Deficiency Location/Instance	Seats B/201, C/201, 207, D/201 G/201 and others
Deficiency Quantity	7
Quantity Uom	EACH
Potential Action	REPLACE
Urgency of Action	PRIORITY 3
Purpose of Action	LEVEL 2
Deficiency Photo1

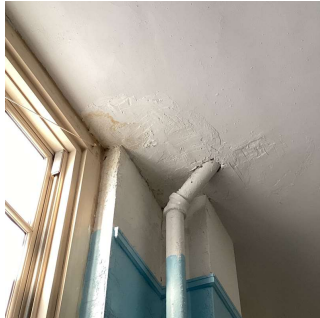
Question	Response
INTERIOR	
CLASSROOMS/CORRIDORS/ADMIN SPACES	
Ceiling	
Violations	No violations recorded.
Deficiency	PLASTER: CRACKS/SPALLING
Deficiency Location/Instance	Rooms 400, 541, 541A, Main Entrance - Vestibule, Corridor near Room 421 and others
Deficiency Quantity	150
Quantity Uom	S.F.
Potential Action	REPLACE
Urgency of Action	PRIORITY 3
Purpose of Action	LEVEL 2
Deficiency Photo1

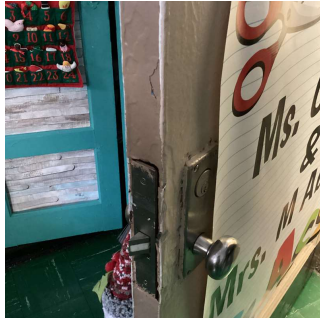
Violations	Room 541 No violations recorded.
Door(s)	
Condition	Inspected 5 - Poor
Deficiency	METAL CLAD WOOD: DETERIORATED DOOR
Deficiency Location/Instance	Room 514
Deficiency Quantity	1
Quantity Uom	EACH
Potential Action	MAINTENANCE
Urgency of Action	PRIORITY 3
Purpose of Action	LEVEL 2
Deficiency Photo1

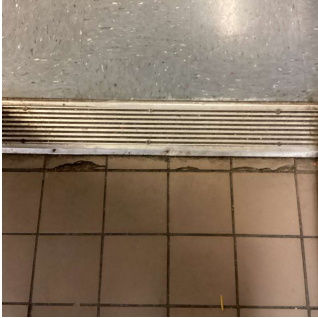
Question	Response
INTERIOR	
CLASSROOMS/CORRIDORS/ADMIN SPACES	
Floor Finish	Inspected
Condition	3 - Fair
Deficiency	QUARRY TILE: BROKEN/MISSING TILES
Deficiency Location/Instance	Corridor near Stair D/1
Deficiency Quantity	10
Quantity Uom	S.F.
Potential Action	REPLACE
Urgency of Action	PRIORITY 3
Purpose of Action	LEVEL 2
Deficiency Photo1

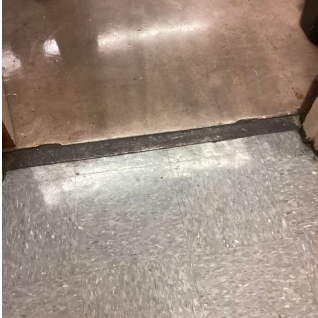
Violations	Corridor near Stair D/1 No violations recorded.
Deficiency	SHEET VINYL: BROKEN/DETERIORATED
Deficiency Location/Instance	Rooms 243B, 241B
Deficiency Quantity	20
Quantity Uom	S.F.
Potential Action	REPLACE
Urgency of Action	PRIORITY 3
Purpose of Action	LEVEL 2
Deficiency Photo1

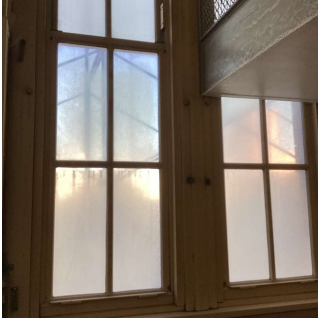
Question	Response
INTERIOR	
INTERIOR GUARDS	
Deficiency	DETERIORATED/TORN-OUT/MISSING
Deficiency Location/Instance	Stairs A/1, 3, 4, C/1, D/1 and others
Deficiency Quantity	160
Quantity Uom	S.F.
Potential Action	REPLACE
Urgency of Action	PRIORITY 3
Purpose of Action	LEVEL 2
Deficiency Photo1
