NYC Department of Education
Building Condition Assessment Survey 2023 - 2024

Architectural Inspection

Asset: P.S. 170 - BROOKLYN, 7109 6TH AVENUE, New York, 11209

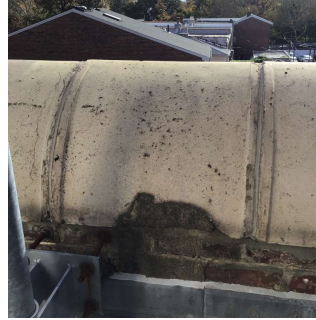
Roof 2 - Facade G

TERRA COTTA: CRACKED/BROKEN PIECES

REPLACE-IN-KIND

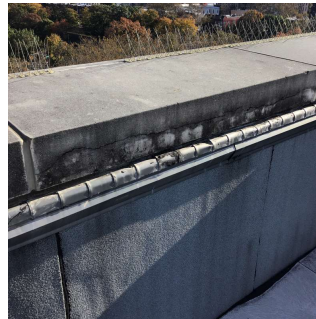
Roof 4 - Facade F

CAST STONE: CRACKED/BROKEN PIECES

REPLACE-IN-KIND

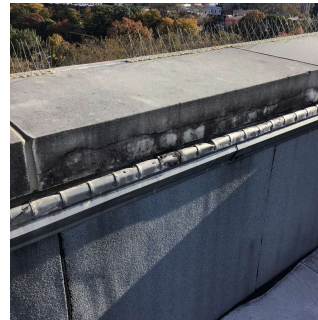
Roof 4 - Facade F

10
L.F.
REPLACE-IN-KIND
PRIORITY 4
LEVEL 2

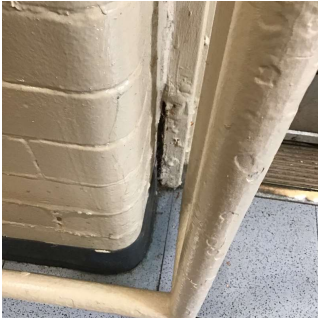
Deficiency Quantity	1
Quantity Uom	EACH
Potential Action	REPLACE
Urgency of Action	PRIORITY 4
Purpose of Action	LEVEL 2
Deficiency Photo1

Violations	Facade C - Exit 6 No violations recorded.
Deficiency	METAL: DETERIORATED DOOR AND FRAME - MAJOR DETERIORATION

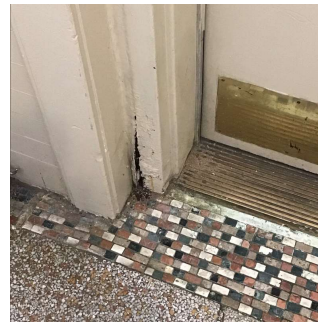
Facade C - Exit 5

2
EACH
REPLACE
PRIORITY 4
LEVEL 2

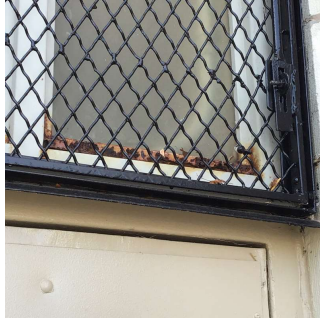
METAL: DENTED, MAJOR RUSTING

10
S.F.
REPLACE

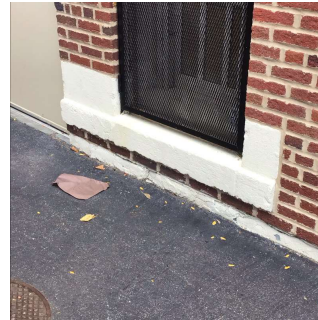
Facade D

Deficiency Quantity	20
Quantity Uom	L.F.
Potential Action	REPAIR
Urgency of Action	PRIORITY 3
Purpose of Action	LEVEL 2

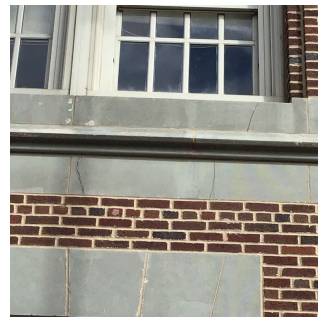
Facade A

STONE: CHIPPED/SPALLED/BROKEN PIECES - MINOR

REPAIR

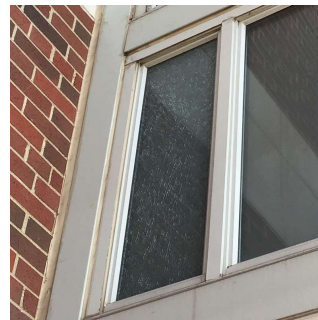
Facade A

METAL/GLASS CURT WALL: BROKEN GLASS

REPLACE

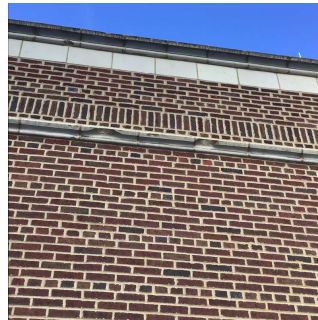
Facade D

STONE: CHIPPED/SPALLED/BROKEN PIECES - MAJOR

REPLACE

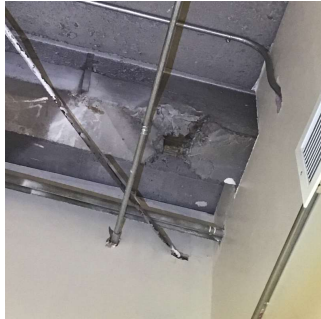
Question	Response
INTERIOR	Inspected
POOLS	Does not Exist
STRUCTURAL	Inspected
COLUMNS/BEAMS/BEARING WALLS	Inspected
Condition	3 - Fair
Deficiency	STEEL COLUMNS/BEAMS: DETERIORATED CONCRETE FIREPROOFING
Deficiency Location/Instance	1st Floor - Room 107B, Corridor near 107B
Deficiency Quantity	20
Quantity Uom	S.F.
Potential Action	REPLACE
Urgency of Action	PRIORITY 4
Purpose of Action	LEVEL 5
Deficiency Photo1

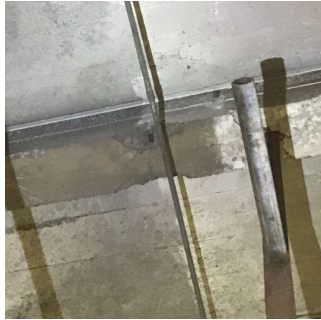
Room 107B
Violations	No violations recorded.
Deficiency	STEEL COLUMNS/BEAMS: DETERIORATED CONCRETE FIREPROOFING
Deficiency Location/Instance	1st Floor - Boiler Room
Deficiency Quantity	10
Quantity Uom	S.F.
Potential Action	REPLACE
Urgency of Action	PRIORITY 3
Purpose of Action	LEVEL 5
Deficiency Photo1

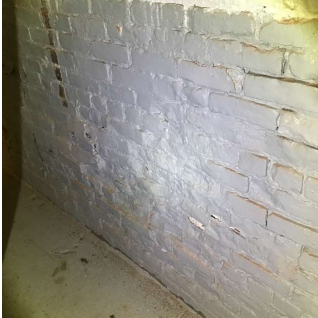
Question	Response
INTERIOR	
STRUCTURAL	
FOUNDATION WALLS	
Deficiency Location/Instance	1st Floor - Oil Tank Room
Deficiency Quantity	20
Quantity Uom	S.F.
Potential Action	RESTITCH
Urgency of Action	PRIORITY 4
Purpose of Action	LEVEL 5
Deficiency Photo1

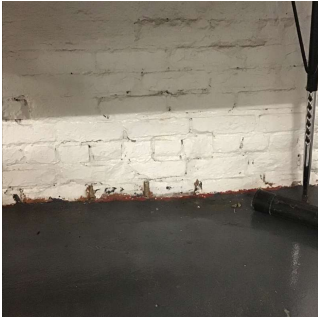
Violations	Oil Tank Room No violations recorded.
Deficiency	BRICK: DETERIORATED JOINTS
Deficiency Location/Instance	1st Floor - Boiler Room, Oil Tank Room
Deficiency Quantity	60
Quantity Uom	S.F.
Potential Action	REPOINT
Urgency of Action	PRIORITY 3
Purpose of Action	LEVEL 5
Deficiency Photo1

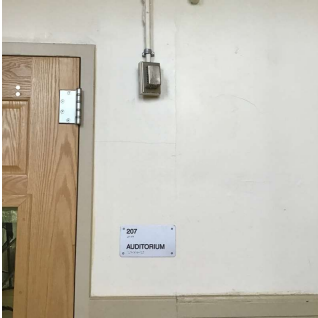
Question	Response
INTERIOR	
AUDITORIUM	
Walls	
Instance on 2nd Floor (601 Seats)	Inspected
Condition	2 - Between Good and Fair
Deficiency	PLASTER: CRACKS/SPALLING
Deficiency Location/Instance	Exit H - Vestibule
Deficiency Quantity	10
Quantity Uom	S.F.
Potential Action	REPLACE
Urgency of Action	PRIORITY 3
Purpose of Action	LEVEL 2
Deficiency Photo1

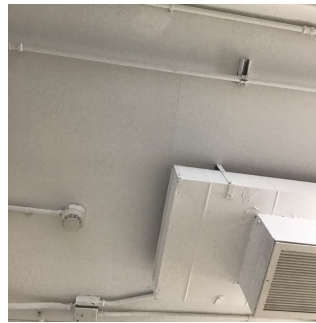
Deficiency	PLASTER: CRACKS/SPALLING
Deficiency Location/Instance	Corridor near Room 206
Deficiency Quantity	10
Quantity Uom	S.F.
Potential Action	REPLACE
Urgency of Action	PRIORITY 3
Purpose of Action	LEVEL 2

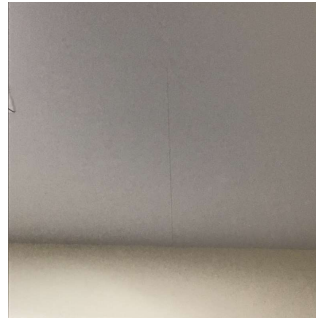
Corridor near Women Toilet - 1st Floor

GYPSUM BOARD: DAMAGED/DETERIORATED

REPLACE

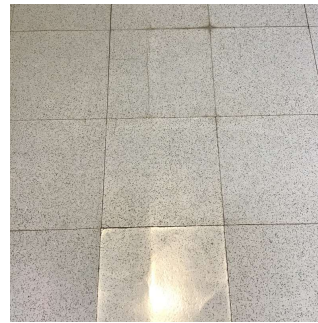
Corridor near Room 510

Violations	Room 503 No violations recorded.
Deficiency	VINYL TILES: DETERIORATED SUBSTRATE
Deficiency Location/Instance	Rooms 105,406,504, Corridor near Rooms 510,559A and others
Deficiency Quantity	160

Quantity Uom	S.F.
Potential Action	REPLACE
Urgency of Action	PRIORITY 3
Purpose of Action	LEVEL 2

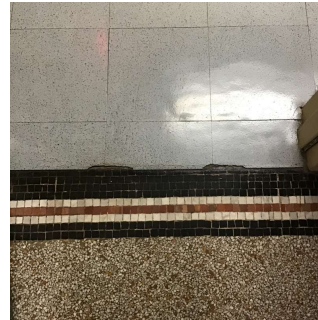
Corridor near Room 114

VINYL TILES: BROKEN/DETERIORATED/MISSING TILES

REPLACE

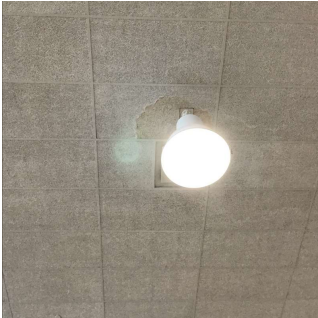
Instance on 5th Floor	Inspected
Condition	2 - Between Good and Fair
Deficiency	TECTUM: DAMAGED/MISSING
Deficiency Location/Instance	Near Windows
Deficiency Quantity	20
Quantity Uom	S.F.
Potential Action	REPLACE
Urgency of Action	PRIORITY 3
Purpose of Action	LEVEL 2
Deficiency Photo1

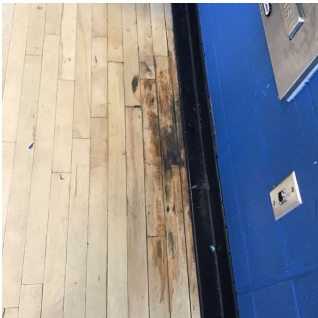
Instance on 5th Floor	Inspected
Condition	2 - Between Good and Fair
Deficiency	WOOD: DAMAGED/DETERIORATED
Deficiency Location/Instance	Near Drinking Fountain
Deficiency Quantity	10
Quantity Uom	S.F.
Potential Action	REPLACE
Urgency of Action	PRIORITY 3
Purpose of Action	LEVEL 2
Deficiency Photo1
