**NYC Department of Education**  
**Building Condition Assessment Survey 2023 - 2024**

Architectural Inspection

**Asset:**        **I.S. 171 - BROOKLYN, 528 RIDGEWOOD AVENUE, New York, 11208**

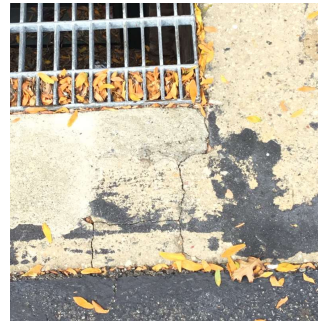
AW7

Question	Response
<b>Architectural</b>	
<b>EXTERIOR</b>	Inspected
<b>AREAWAY</b>	Inspected
Instance on AW1-AW13	Inspected
Instance Condition	3 - Fair
Instance Quantity	13
Instance Quantity Uom	EACH
Deficiency	AREAWAY WALLS: CRACKS AND SPALLING

REPAIR

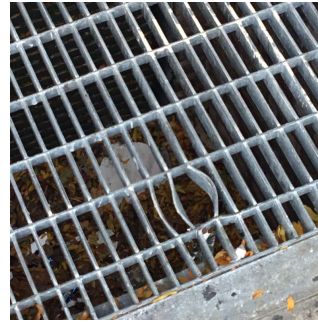
AW6

AREAWAY GRATINGS: MAJOR RUSTING / OR BROKEN

REPLACE

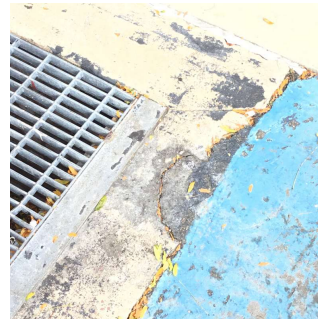
AW6

**AREAWAY WALLS: CRACKS AND SPALLING**

REPLACE

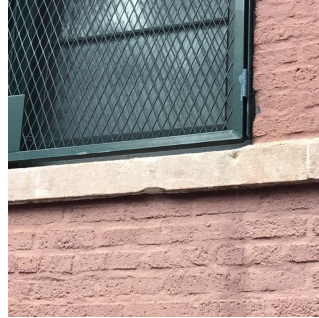
Question	Response
<b>EXTERIOR</b>	
<b>EXTERIOR WALLS</b>	
Instance on All Facades	Inspected
Instance Condition	5 - Poor
Instance Quantity	36,000
Instance Quantity Uom	S.F.
Deficiency	<b>BRICK: DETERIORATED MASONRY SILLS - MINOR</b>
Roof Plan reference	K171

Deficiency Quantity	10
Quantity Uom	L.F.
Potential Action	REPAIR
Urgency of Action	PRIORITY 3
Purpose of Action	LEVEL 2
Deficiency Photo1

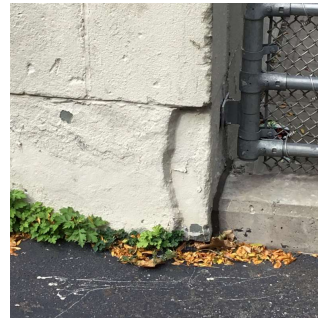
Violations	Facade C No violations recorded.
Deficiency	<b>STONE: CHIPPED/SPALLED/BROKEN PIECES - MAJOR</b>

REPLACE

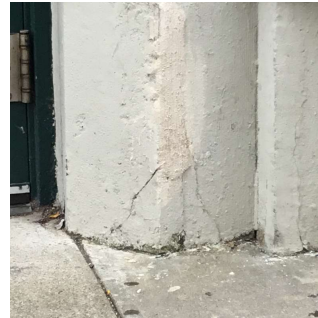
Facade A

STONE: CHIPPED/SPALLED/BROKEN PIECES - MINOR

REPAIR

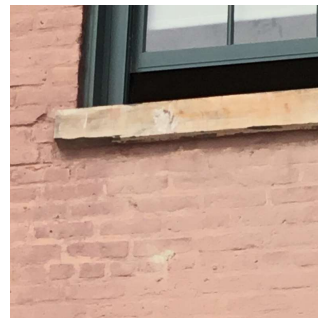
Facade E

**BRICK: DETERIORATED MASONRY SILLS - MAJOR  
K171**

REMOVE AND REPLACE

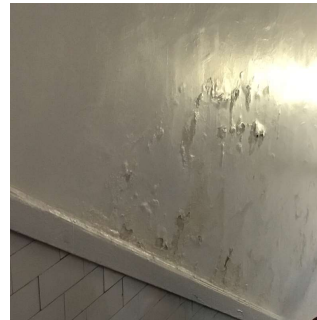
Facade F - Stairwell G/3 (Facade A - Rooms 104, 204, 304, 304B, 404, 405, 411, Facade B - Rooms 301,

**BRICK: WATER INFILTRATION IN INSTRUCTIONAL SPACE  
K171**

REPAIR

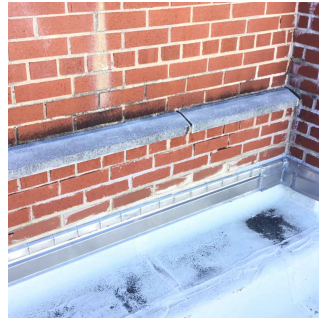
Question	Response
<b>EXTERIOR</b>	
<b>PARAPETS</b>	
Instance Condition	3 - Fair
Instance Quantity	4,800
Instance Quantity Uom	C.F.
Deficiency	<b>BRICK: DETERIORATED JOINTS</b>
Roof Plan reference	K171

Deficiency Quantity	60
Quantity Uom	S.F.
Potential Action	<b>REPOINT</b>
Urgency of Action	<b>PRIORITY 3</b>
Purpose of Action	<b>LEVEL 2</b>
Deficiency Photo1

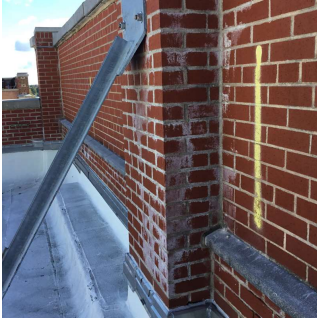
Violations	Roof 1 No violations recorded.
Deficiency	<b>BRICK: EFFLORESCENCE</b>
Roof Plan reference	K171

Deficiency Quantity	240
Quantity Uom	S.F.
Potential Action	<b>MAINTENANCE</b>
Urgency of Action	<b>PRIORITY 1</b>
Purpose of Action	<b>LEVEL 1</b>

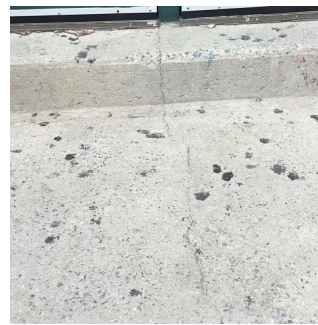
Facade G

CONCRETE: CRACKS/SPALLING - MINOR

25  
S.F.  
REPAIR  
PRIORITY 3  
LEVEL 2

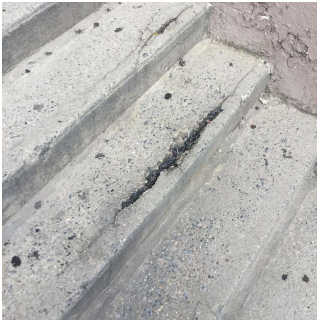
**CONCRETE: CRACKS/SPALLING - MAJOR**

35  
S.F.  
REPLACE  
PRIORITY 4  
LEVEL 2

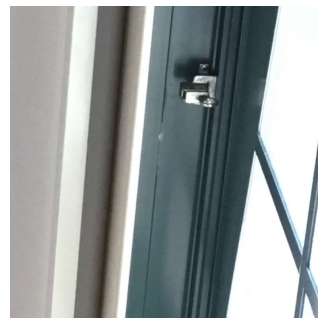
Facade B - Room 403

**ALUMINUM - DOUBLE HUNG: AIR/WATER INFILTRATION  
K171**

30  
L.F.  
REPLACE TRIM, SILLS OR WEATHERSTRIPPING  
PRIORITY 5  
LEVEL 2

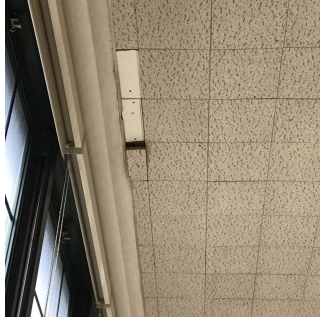
No	Potential Falling Debris	Loose ceiling tile is a potential safety hazard.	INTERIOR   CLASSROOMS /CORRIDORS/ ADMIN SPACES   Ceiling	Room 113	Patrick Rice	Fireman

Question	Response
<b>INTERIOR</b>	
<b>CAFETERIA</b>	
<b>Walls</b>	
Condition	2 - Between Good and Fair
Deficiency	PLASTER: CRACKS/SPALLING
Deficiency Location/Instance	Columns
Deficiency Quantity	30
Quantity Uom	S.F.
Potential Action	REPLACE
Urgency of Action	PRIORITY 3
Purpose of Action	LEVEL 2
Deficiency Photo1	 
Violations	Columns No violations recorded.
Deficiency	SALT GLAZED BRICK: CRACKS/SPALLING
Deficiency Location/Instance	Near windows
Deficiency Quantity	50
Quantity Uom	S.F.
Potential Action	REPLACE
Urgency of Action	PRIORITY 3
Purpose of Action	LEVEL 2
Deficiency Photo1	 
Violations	Near windows No violations recorded.
<b>Window Curtains/Shades/Blinds</b>	
Instance on Ground Floor - East	Does not Exist
Instance on Ground Floor - West	Does not Exist
<b>CLASSROOMS/CORRIDORS/ADMIN SPACES</b>	
<b>Ceiling</b>	Inspected
Condition	2 - Between Good and Fair
Deficiency	ACOUSTIC TILES ON PLASTER: DAMAGED/MISSING
Deficiency Location/Instance	Room 113

Question	Response
<b>INTERIOR</b>	
<b>CLASSROOMS/CORRIDORS/ADMIN SPACES</b>	
<b>Ceiling</b>	
Potential Action	REPLACE
Urgency of Action	PRIORITY 5
Purpose of Action	LEVEL 6
Deficiency Photo1
