NYC Department of Education
Building Condition Assessment Survey 2023 - 2024

Architectural Inspection

K172

Asset: P.S. 172 - BROOKLYN, 825 4TH AVENUE, New York, 11232

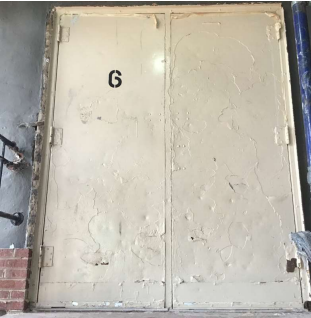
Question	Response
EXTERIOR	
COPING	
CORNICE	Under Construction
DOORS	Inspected
DOORS AND FRAMES	Inspected
Condition	3 - Fair
Deficiency	METAL: DETERIORATED DOOR AND FRAME - MAJOR DETERIORATION
Roof Plan reference	K172

Deficiency Quantity	2
Quantity Uom	EACH
Potential Action	REPLACE
Urgency of Action	PRIORITY 4
Purpose of Action	LEVEL 2
Deficiency Photo1

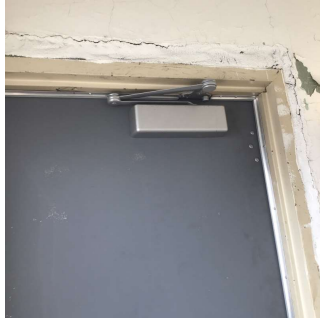
Deficiency	BULKHEAD/PENTHOUSE WALLS/INTERIOR: PLASTER CRACKS/SPALLING
Roof Plan reference	K172
Deficiency Quantity	20
Quantity Uom	S.F.
Potential Action	REPLACE
Urgency of Action	PRIORITY 3

Question	Response
EXTERIOR	
ROOF	
Specialties	
BULKHEAD/PENTHOUSE	
Purpose of Action	LEVEL 2
Deficiency Photo1

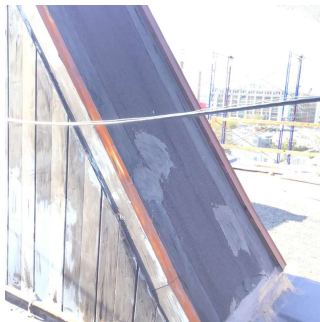
Violations	Bulk Head - South View No violations recorded.
CUPOLA/ SPIRES/ TOWERS	Does not Exist
DORMER	Does not Exist
DUNNAGE STEEL	Inspected
Condition	2 - Between Good and Fair
Deficiency	No deficiencies recorded
SKYLIGHT/ROOF VENT	Inspected
Material Type(s)	Glass

Violations	BH No violations recorded.
Deficiency	BULKHEAD/PENTHOUSE ROOF: DETERIORATED
Roof Plan reference	K172

Deficiency Quantity	60
Quantity Uom	S.F.
Potential Action	REPLACE
Urgency of Action	PRIORITY 4
Purpose of Action	LEVEL 2
Deficiency Photo1

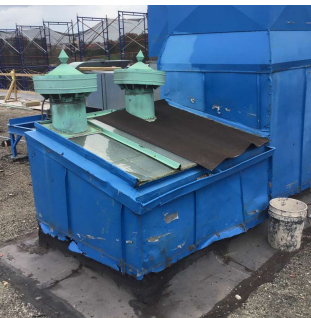
Violations	Roof 1 No violations recorded.
ROOF/GRAVITY TANK	
Condition	Inspected
Deficiency	3 - Fair
Roof Plan reference	TANK: NOT IN USE - MINOR DETERIORATION
	K172

Question	Response
EXTERIOR	
ROOF	
Specialties	
SKYLIGHT/ROOF VENT	
Condition	2 - Between Good and Fair
Deficiency	BROKEN FRAMING
Roof Plan reference	K172

Deficiency Quantity	10
Quantity Uom	L.F.
Potential Action	MAINTENANCE
Urgency of Action	PRIORITY 3
Purpose of Action	LEVEL 2
Deficiency Photo1

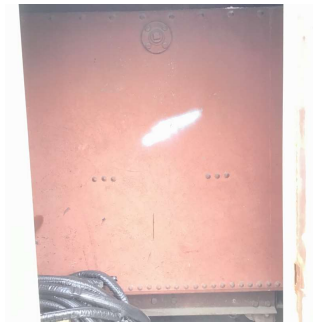
Roof Gravity TANK

Deficiency Quantity	1
Quantity Uom	EACH
Potential Action	NO ACTION
Urgency of Action	PRIORITY 1
Purpose of Action	LEVEL 1

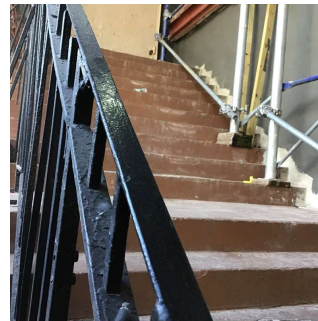
Exit 6 Stair

MISSING RAILING

Deficiency Quantity

25

REPLACE

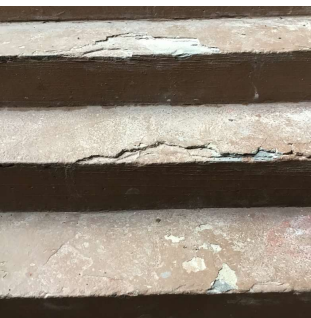
Question	Response
EXTERIOR	
STAIRS/RAMPS: EXTERIOR	
STAIRS/RAMPS	
Deficiency	STONE: CRACKS/SPALLING - MAJOR
Roof Plan reference	K172

Deficiency Quantity	250
Quantity Uom	S.F.
Potential Action	REPLACE
Urgency of Action	PRIORITY 5
Purpose of Action	LEVEL 6
Deficiency Photo1

Stair at Exit 6
Violations	No violations recorded.
WINDOWS	
	Inspected
Replacement Quantity	9,000
Replacement Uom	S.F.
EXTERIOR GUARDS	
	Under Construction
LINTELS	
	Under Construction
WINDOWS	
	Inspected
Material Type(s)	Aluminum
Instance on Aluminum - Other: AllFacades	Under Construction
Instance Quantity	9,000
Instance Quantity Uom	S.F.
INTERIOR	
	Inspected
POOLS	
	Does not Exist
STRUCTURAL	
	Inspected
COLUMNS/BEAMS/BEARING WALLS	
	Inspected
Condition	3 - Fair
Deficiency	STEEL COLUMNS/BEAMS: DETERIORATED MASONRY FIREPROOFING
Deficiency Location/Instance	Room near Oil Tank Room
Deficiency Quantity	10
Quantity Uom	S.F.

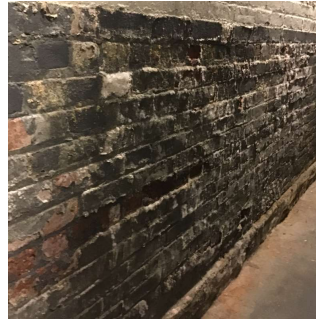
Oil Tank Room

BRICK: WATER INFILTRATION IN NON- INSTRUCTIONAL SPACE

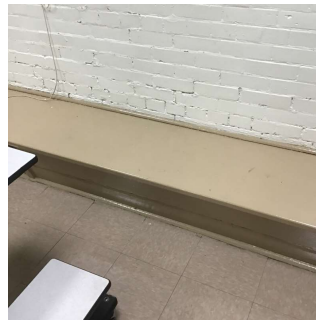
Cafeteria

BRICK: WATER INFILTRATION IN INSTRUCTIONAL SPACE

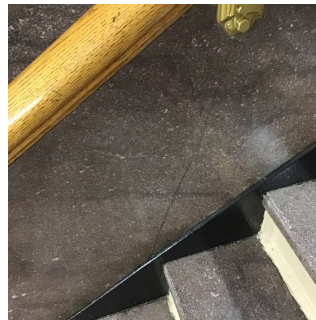
Main Entrance Lobby Stair

STONE: CRACKS/SPALLING

REPLACE

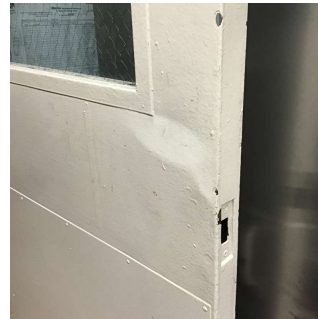
Entrance

METAL: DETERIORATED DOOR

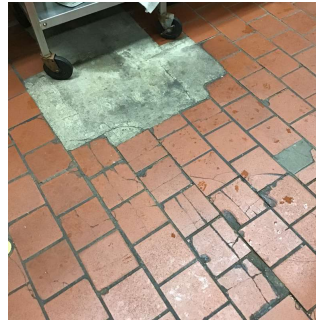
Center

QUARRY TILE: BROKEN/MISSING TILES

REPLACE

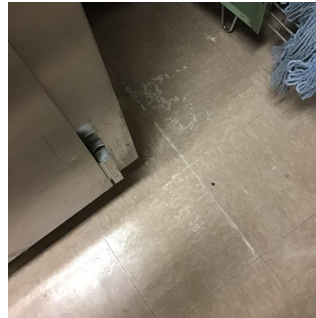
Store Room

VINYL TILES: BROKEN/DETERIORATED/MISSING TILES

REPLACE

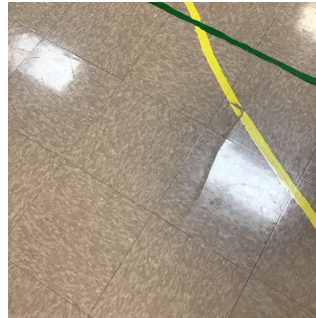
Center

VINYL TILES: DETERIORATED SUBSTRATE

REPLACE

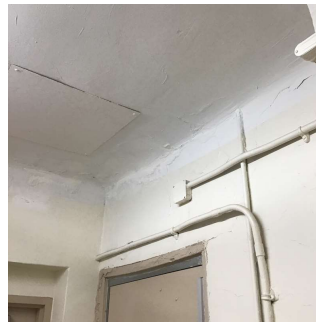
Deficiency	PLASTER: CRACKS/SPALLING
Deficiency Location/Instance	Exit 7 Vestibule
Deficiency Quantity	20
Quantity Uom	S.F.
Potential Action	REPLACE
Urgency of Action	PRIORITY 3
Purpose of Action	LEVEL 2

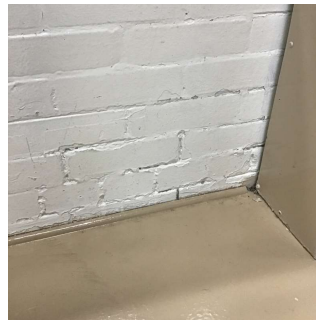
Under Windows

BRICK: CRACKS/SPALLING - ACTIVE LEAK

REPLACE

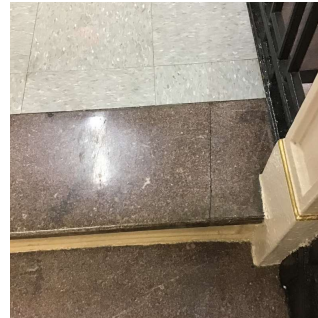
1st Floor Main Lobby Stair

STONE: BROKEN/MISSING

REPLACE

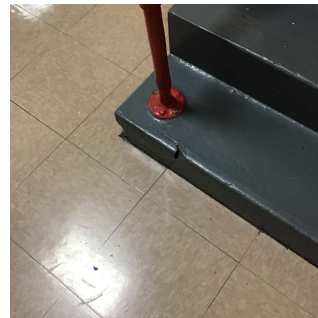
Cafeteria

CONCRETE: CRACKS/SPALLING - MAJOR

REPLACE
