**NYC Department of Education**  
**Building Condition Assessment Survey 2023 - 2024**

Architectural Inspection

**Asset:** P.S. 174 - BROOKLYN, 574 DUMONT AVENUE, New York, 11207

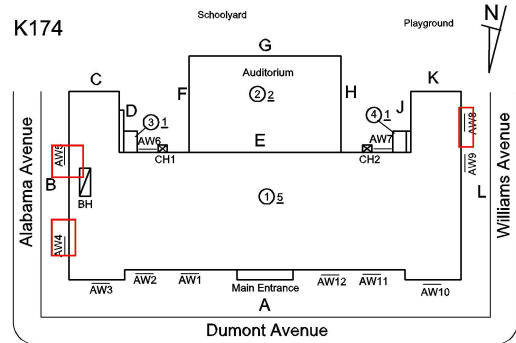
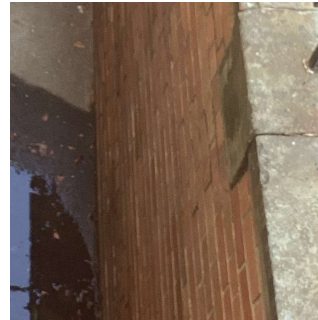
AW4

AREAWAY WALLS: DETERIORATED JOINTS

100  
 S.F.  
 REPAIR  
 PRIORITY 3  
 LEVEL 2

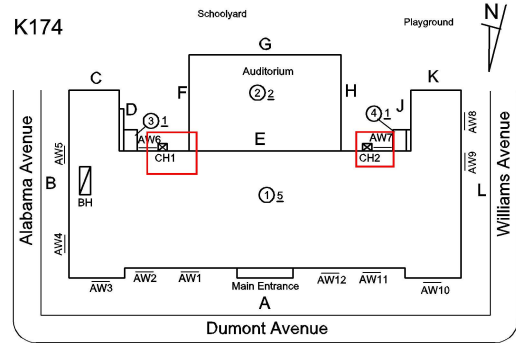
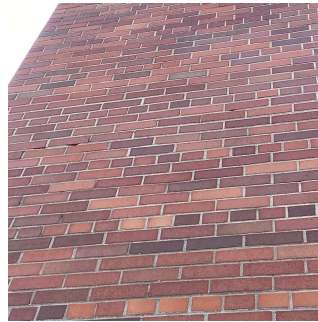
Roof 1  
 No violations recorded.

BRICK: DETERIORATED JOINTS

25  
 S.F.  
 REPOINT  
 PRIORITY 3  
 LEVEL 2

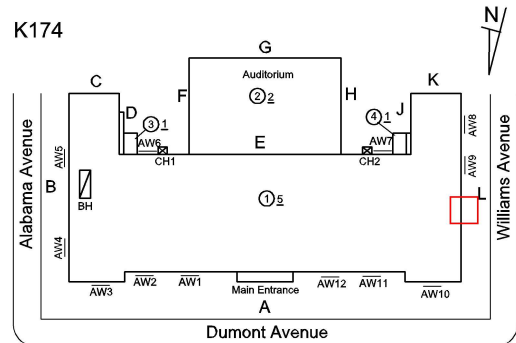
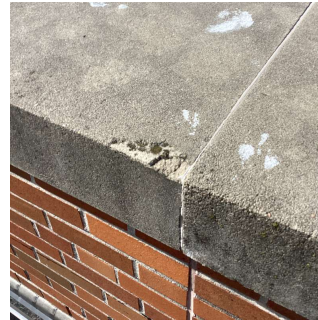
Roof 1

CAST STONE: CRACKED/BROKEN PIECES

10  
 L.F.  
 REPLACE-IN-KIND  
 PRIORITY 4  
 LEVEL 2

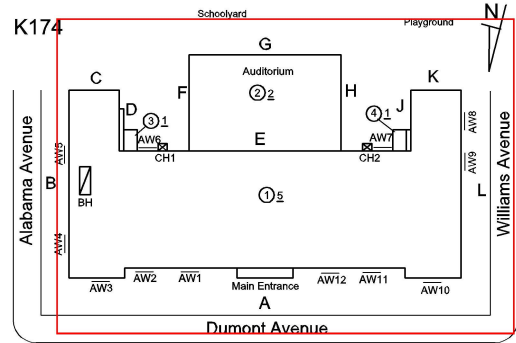
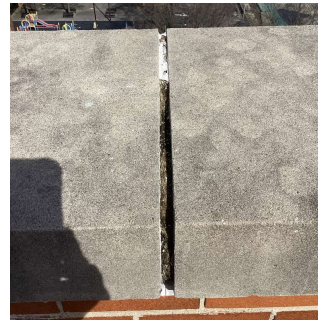
Roof 1  
 No violations recorded.

**CAST STONE: DETERIORATED TRANSVERSE JOINTS**

150  
 L.F.  
 MAINTENANCE  
 PRIORITY 3  
 LEVEL 2

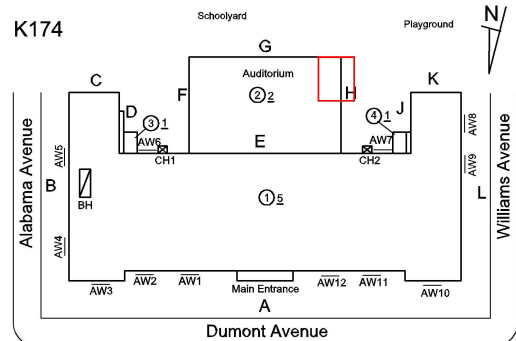
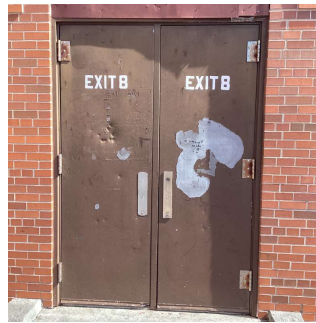
Exit 8  
No violations recorded.

**METAL: DETERIORATED DOOR - MAJOR DETERIORATION**

1  
 EACH  
 REPLACE  
 PRIORITY 4  
 LEVEL 2

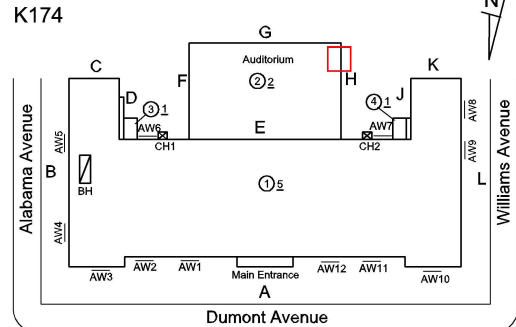
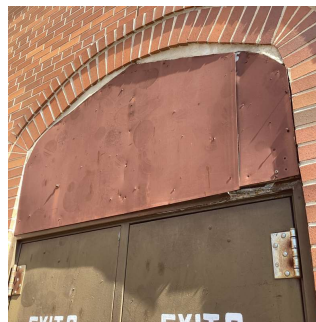
Facade H  
No violations recorded.

METAL: DENTED, MAJOR RUSTING

15  
S.F.  
REPLACE  
PRIORITY 4  
LEVEL 2

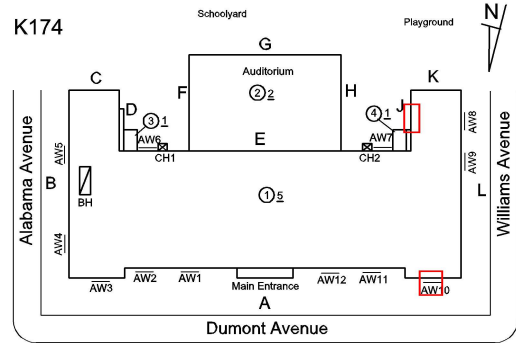
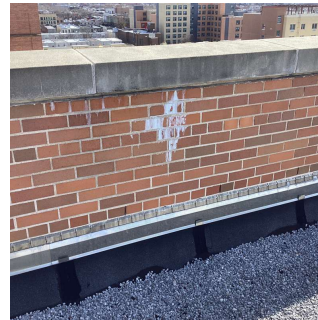
Roof 1

| Question | Response |
|---|--|
| Deficiency | BRICK: EFFLORESCENCE |

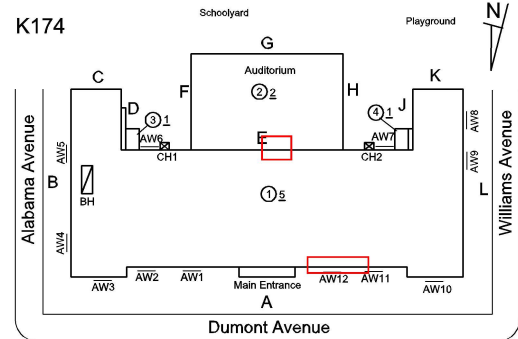
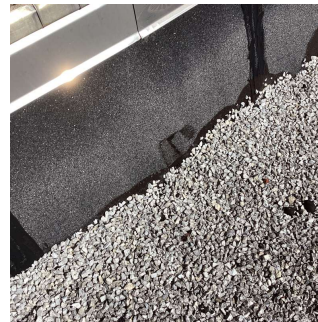
Roof 1

**BUILT-UP: FLASHING: BASE FLASHING DETERIORATED**

REPAIR

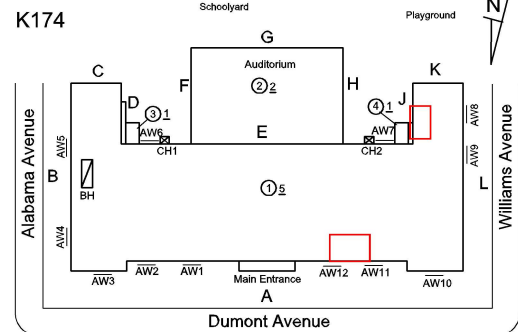
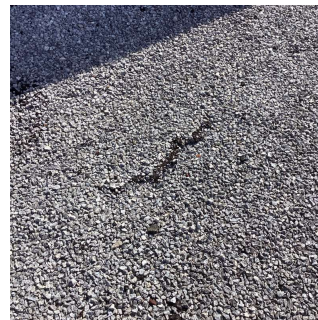
Roof 1

**BUILT-UP: ROOFING: DELAMINATION**

**REPLACE ROOFING WITHOUT MAJOR EQUIPMENT REMOVAL**

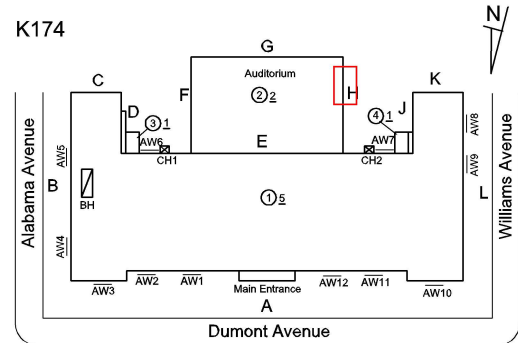
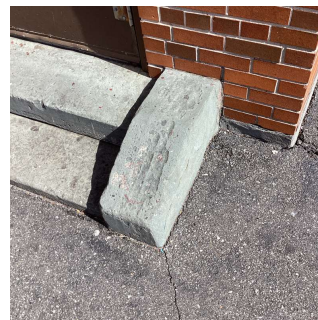
Facade H

STONE: CRACKS/SPALLING - MINOR

REPAIR

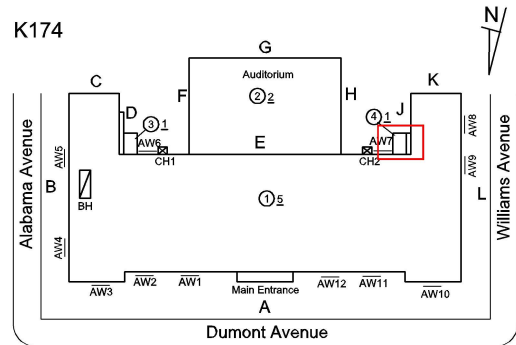
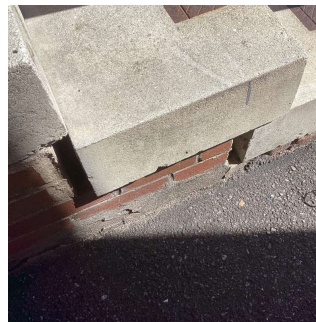
Exit 7

STONE: DETERIORATED SUBSTRATE

REPLACE SUBSTRATE AND RESET

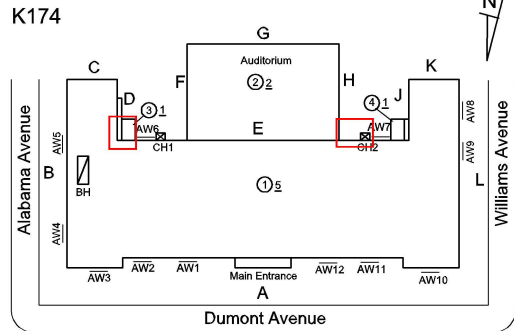
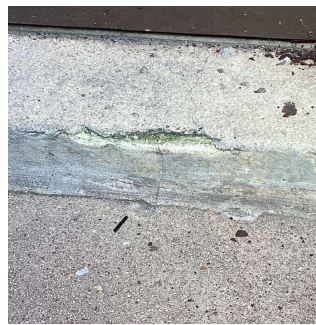
Exit 6A  
No violations recorded.

CONCRETE: CRACKS/SPALLING - MAJOR

35  
S.F.  
REPLACE  
PRIORITY 4  
LEVEL 2

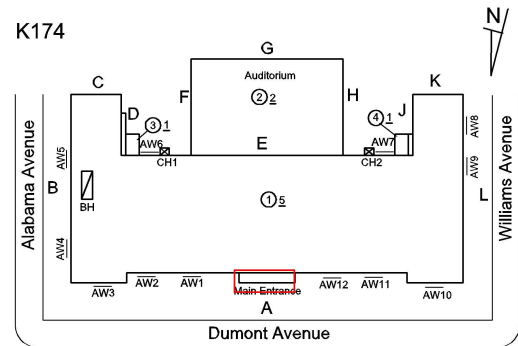
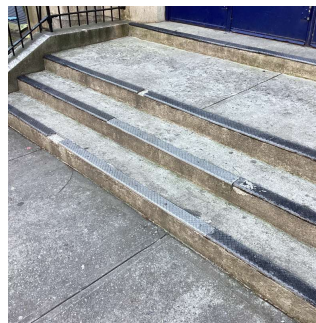
Main Entrance

**CONCRETE: CRACKS/SPALLING - MAJOR**

REPLACE

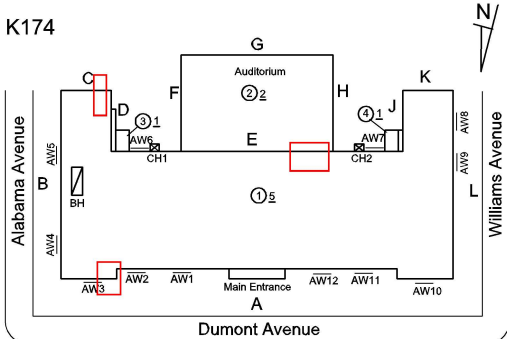
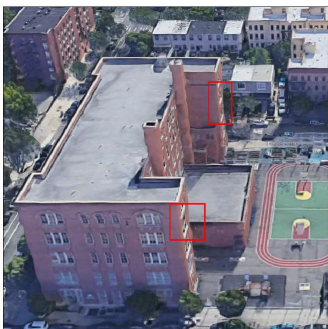
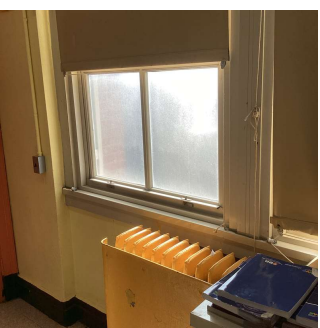
| Question | Response |
|---|--|
| Violations | Room 408<br>No violations recorded. |

| Question | Response |
|---|--|
| Deficiency | ALUMINUM - DOUBLE HUNG: INOPERABLE BALANCE |

| Question | Response |
|---|--|
| Potential Action | REPLACE BALANCES |
