NYC Department of Education
Building Condition Assessment Survey 2023 - 2024

Architectural Inspection

Asset: P.S. 176 - BROOKLYN, 1225 69 STREET, New York, 11219

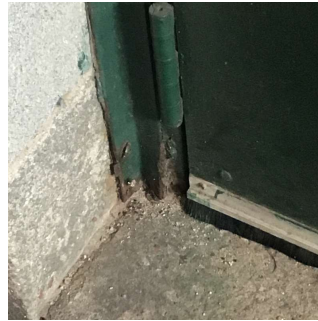
Facade H - Exit 6

Deficiency METAL CLAD: DETERIORATED DOOR AND FRAME - MAJOR DETERIORATION

REPLACE

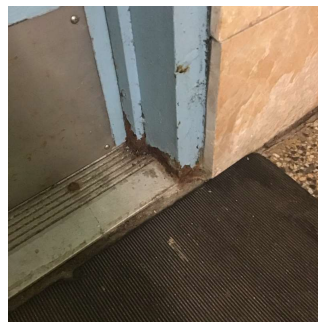
Facade F - Exit 5

METAL CLAD: DETERIORATED DOOR AND FRAME - MINOR DETERIORATION

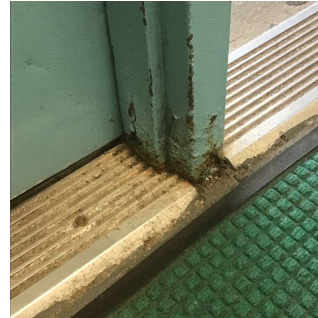
Facade B - Exit 1/2
35665273J

METAL: DETERIORATED DOOR AND FRAME - MAJOR DETERIORATION

5
EACH
REPLACE
PRIORITY 4
LEVEL 4

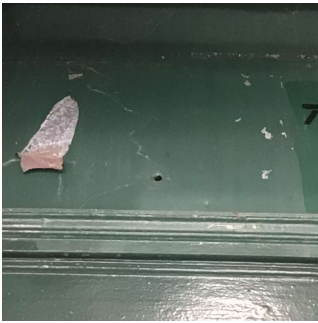
METAL: DENTED, MAJOR RUSTING

10
S.F.
REPLACE
PRIORITY 4
LEVEL 2

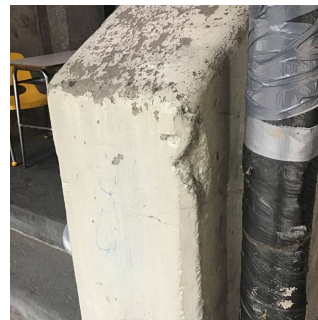
Facade J - Exit 3/4

CAST IN PLACE CONCRETE: CRACKS/SPALLING - MINOR

REPAIR

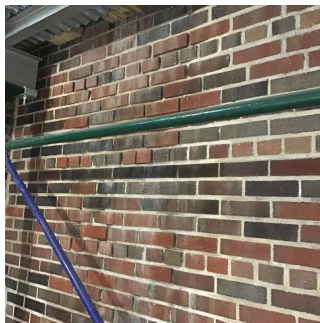
Question	Response
EXTERIOR	
STAIRS/RAMPS: EXTERIOR	
BUILDING CHEEK/FLANK WALLS	Inspected
Deficiency Photo1

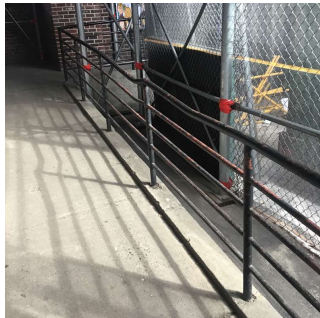
Facade C
Violations	No violations recorded.
RAILINGS	
Condition	Inspected
	5 - Poor
Deficiency	DAMAGED
Roof Plan reference	K176

Deficiency Quantity	30
Quantity Uom	L.F.
Potential Action	REPLACE
Urgency of Action	PRIORITY 4
Purpose of Action	LEVEL 2
Deficiency Photo1

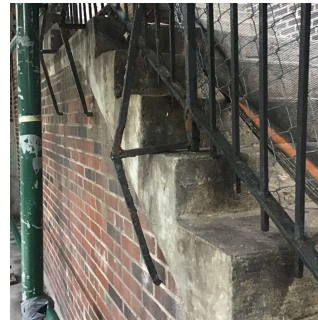
Facade C

Facade J - HC Ramp
Violations	No violations recorded.
Deficiency	RUST - MAJOR

20
 L.F.
 REPLACE
 PRIORITY 4
 LEVEL 2

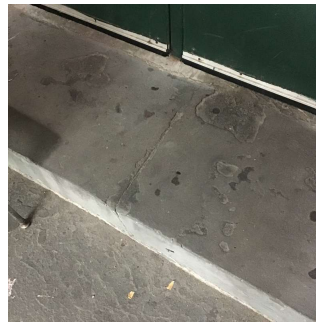
Facade J - Exit 3/4

STONE: CRACKS/SPALLING - MINOR
 K176

10
 S.F.
 REPAIR
 PRIORITY 3
 LEVEL 2

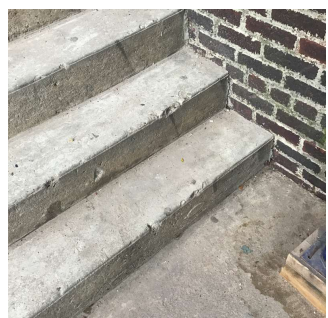
CONCRETE: CRACKS/SPALLING - MINOR

Question	Response
EXTERIOR	
STAIRS/RAMPS: EXTERIOR	
STAIRS/RAMPS	
Deficiency Quantity	60
Quantity Uom	S.F.
Potential Action	REPAIR
Urgency of Action	PRIORITY 3
Purpose of Action	LEVEL 2
Deficiency Photo1

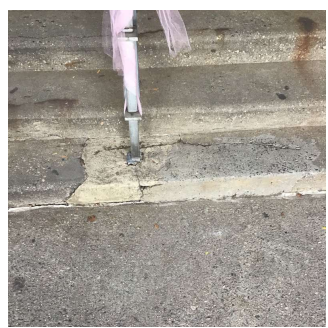
Facade A - Main Entrance

**CONCRETE: CRACKS/SPALLING - MAJOR
K176**

REPLACE

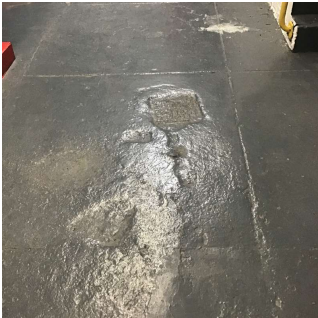
Question	Response
INTERIOR	
STRUCTURAL	
FLOOR STRUCTURE	
Violations	No violations recorded.
Deficiency	CONCRETE SLAB ON GRADE: THRU CRACKS
Deficiency Location/Instance	Basement - Boiler Room
Deficiency Quantity	30
Quantity Uom	S.F.
Potential Action	REPAIR
Urgency of Action	PRIORITY 3
Purpose of Action	LEVEL 5
Deficiency Photo1

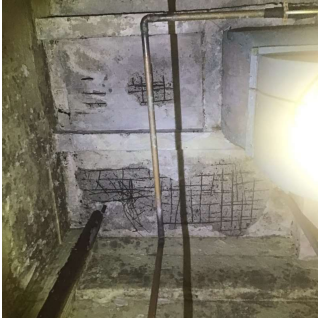
Boiler Room
Violations	No violations recorded.
Deficiency	CONCRETE: CRACKS/SPALLED/REINFORCEMENT EXPOSED
Deficiency Location/Instance	1st Floor - Room 102, 2nd Floor - Room 261
Deficiency Quantity	100
Quantity Uom	S.F.
Potential Action	REPAIR
Urgency of Action	PRIORITY 4
Purpose of Action	LEVEL 5
Deficiency Photo1

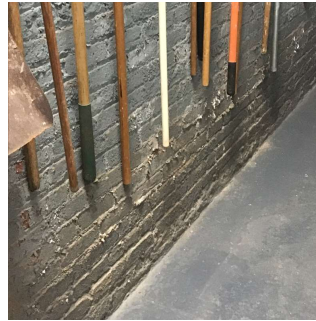
Room 102
Violations	No violations recorded.
FOUNDATION WALLS	
Material Type(s)	Inspected Masonry
Condition	4 - Between Fair and Poor
Deficiency	BRICK: DETERIORATED JOINTS
Deficiency Location/Instance	Basement - Corridor to Gas Meter Room
Deficiency Quantity	50
Quantity Uom	S.F.

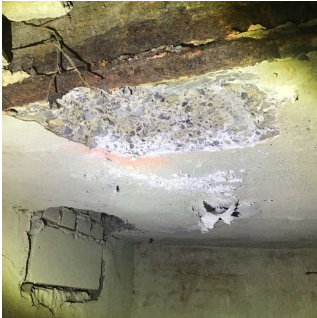
Condition	Inspected
Condition	3 - Fair
Deficiency	CONCRETE: CRACKS/SPALLED/REINFORCEMENT EXPOSED

Question	Response
INTERIOR	
STRUCTURAL	
VAULTS-BUNKERS	
Slab Structure	
Deficiency Location/Instance	Basement - Boiler Room Storage Vault
Deficiency Quantity	20
Quantity Uom	S.F.
Potential Action	REPAIR
Urgency of Action	PRIORITY 4
Purpose of Action	LEVEL 5
Deficiency Photo1

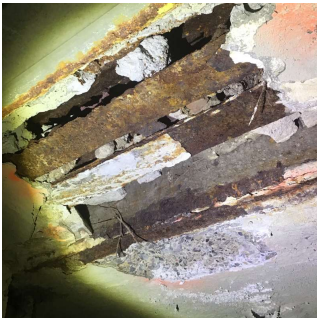
Violations	Boiler Room Storage Vault No violations recorded.
Deficiency	STEEL COLUMNS/BEAMS: MAJOR RUSTING
Deficiency Location/Instance	Basement - Boiler Room Storage Vault
Deficiency Quantity	20
Quantity Uom	S.F.
Potential Action	REPLACE
Urgency of Action	PRIORITY 4
Purpose of Action	LEVEL 5
Deficiency Photo1

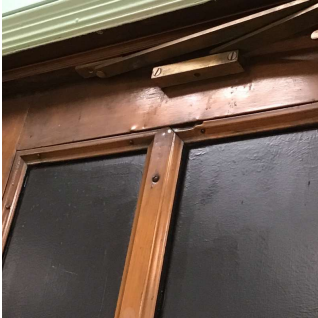
Condition	3 - Fair
Deficiency	METAL: DETERIORATED DOOR

Question	Response
INTERIOR	
AUDITORIUM	
Door(s)	
Deficiency Location/Instance	Main Entrance
Deficiency Quantity	1
Quantity Uom	EACH
Potential Action	MAINTENANCE
Urgency of Action	PRIORITY 3
Purpose of Action	LEVEL 2
Deficiency Photo1

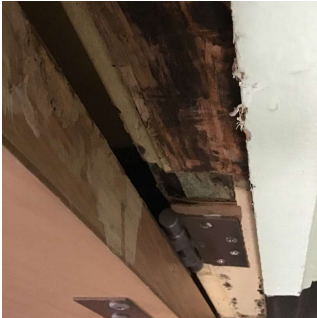
Corridor door near Room 356
Violations	No violations recorded.
Deficiency	WOOD: DETERIORATED DOOR
Deficiency Location/Instance	Room 307, Corridor door near Room 202 (by Auditorium)
Deficiency Quantity	2
Quantity Uom	EACH
Potential Action	MAINTENANCE
Urgency of Action	PRIORITY 3
Purpose of Action	LEVEL 2
Deficiency Photo1

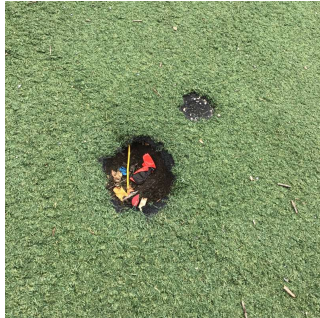
East Schoolyard
Violations	No violations recorded.
Unpaved Area	
Instance on East Schoolyard	Does not Exist
Instance on West Schoolyard - East Playground	Does not Exist
Instance on West Schoolyard - West Playground	Does not Exist
PLAYING SURFACE	
Playing Field	Inspected
Instance on West Schoolyard	Inspected
Instance Condition	5 - Poor
Deficiency	ARTIFICIAL TURF: MISSING AREAS
Deficiency Location/Instance	West Schoolyard
Deficiency Quantity	10
Quantity Uom	S.F.
Potential Action	REPLACE
Urgency of Action	PRIORITY 5
Purpose of Action	LEVEL 6
Deficiency Photo1

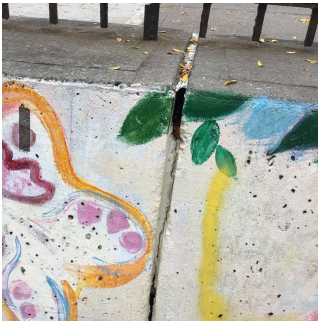
Violations	Schoolyard No violations recorded.
Running Track	Does not Exist
RETAINING WALLS	
Are there any Retaining Walls 6' OR higher facing public street/sidewalk?	Inspected No
Condition	3 - Fair
Deficiency	CAST IN PLACE CONCRETE: DETERIORATED CONTROL/EXPANSION JOINT
Deficiency Location/Instance	West Schoolyard
Deficiency Quantity	30
Quantity Uom	L.F.
Potential Action	REPLACE
Urgency of Action	PRIORITY 3
Purpose of Action	LEVEL 2
Deficiency Photo1
