NYC Department of Education
Building Condition Assessment Survey 2023 - 2024

Architectural Inspection

Asset: P.S. 177 - BROOKLYN, 346 AVENUE P, New York, 11204

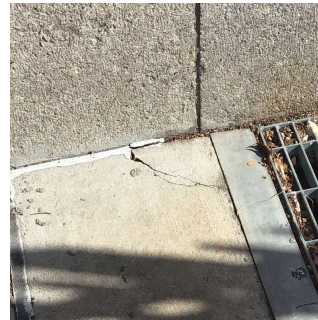
Facade K - AW6

Deficiency	AREAWAY WALLS: CRACKS AND SPALLING
------------	------------------------------------

REPAIR

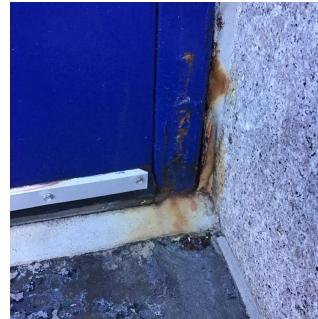
Facade K

METAL: DETERIORATED DOOR AND FRAME - MAJOR DETERIORATION

REPLACE

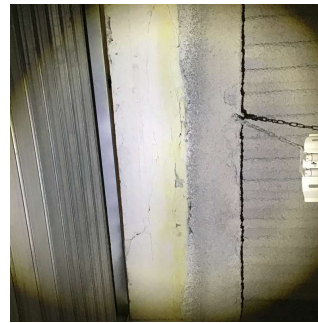
Roof 9

CONCRETE: MAJOR CRACKS

20
S.F.
REPLACE
PRIORITY 4

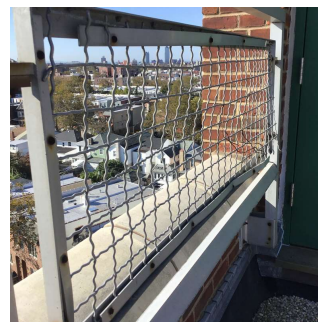
Roof 1

RAILINGS/PANELS: DETERIORATED, MAJOR RUSTING

REPLACE

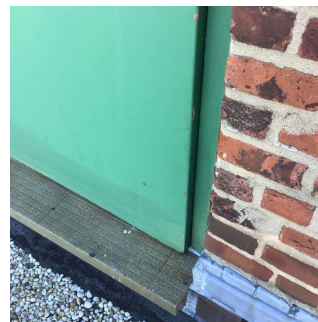
Violations	Roof 1 - Bulkhead 2 No violations recorded.
Deficiency	BULKHEAD/PENTHOUSE DOORS: DETERIORATED DOOR AND FRAME

Roof 2 - Bulkhead 3 - door does close properly

1
EACH
REPLACE DOOR AND FRAME
PRIORITY 4
LEVEL 2

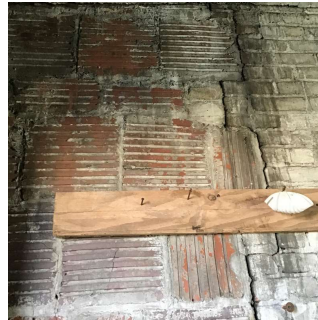
Roof 1 - Penthouse

**BULKHEAD/PENTHOUSE WALLS/INTERIOR: BRICK
CRACKS/SPALLING**

100
S.F.
REPLACE
PRIORITY 4
LEVEL 2

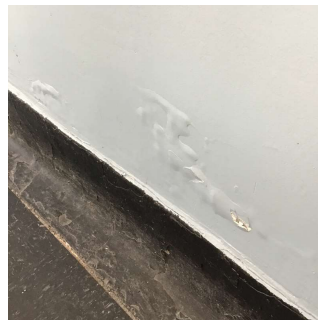
Roof 1 - Bulkhead 1

BULKHEAD/PENTHOUSE WALLS/INTERIOR: PLASTER CRACKS/SPALLING

REPLACE

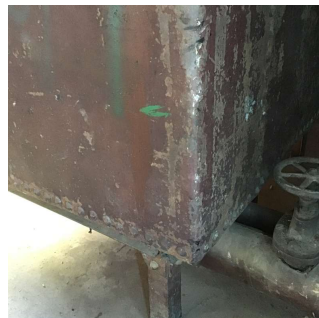
Question	Response
EXTERIOR	
ROOF	
Specialties	
ROOF/GRAVITY TANK	Inspected
Condition	3 - Fair
Deficiency	TANK: NOT IN USE - MINOR DETERIORATION
Roof Plan reference

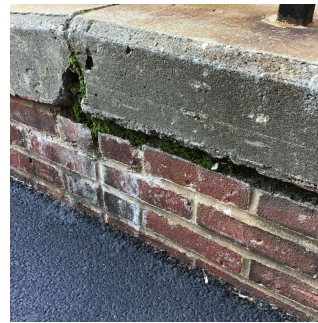
Facade G

Violations	Roof 1 - Penthouse No violations recorded.
STAIRS/RAMPS: EXTERIOR	Inspected
BUILDING CHEEK/FLANK WALLS	Inspected
Condition	4 - Between Fair and Poor
Deficiency	BRICK: DETERIORATED JOINTS
Roof Plan reference

Deficiency Quantity	10
Quantity Uom	S.F.
Potential Action	REPOINT
Urgency of Action	PRIORITY 4
Purpose of Action	LEVEL 2

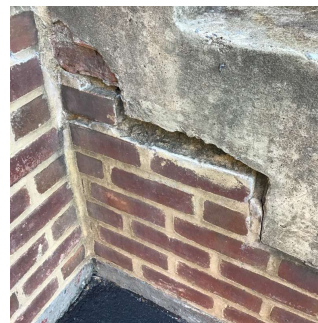
Facade G

BRICK: CRACKS/SPALLING - MAJOR

REPLACE

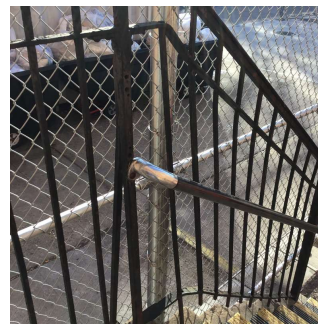
DAMAGED

30
L.F.
REPLACE
PRIORITY 4
LEVEL 2

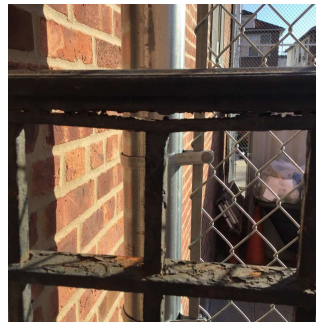
Facade C

RUST - MAJOR

10
L.F.
REPLACE
PRIORITY 4
LEVEL 2

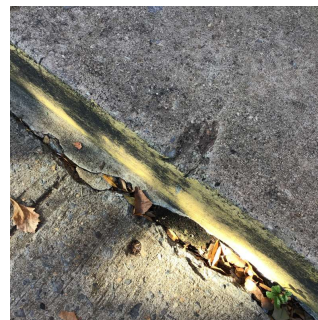
CONCRETE: WORN-OUT TREAD/RISER/NOSING

20
 S.F.
 REPLACE
 PRIORITY 4
 LEVEL 2

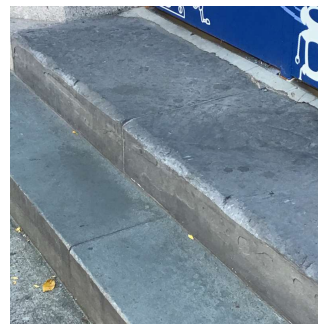
STONE: WORN-OUT TREAD/RISER/NOSING

30
S.F.
REPLACE
PRIORITY 4
LEVEL 2

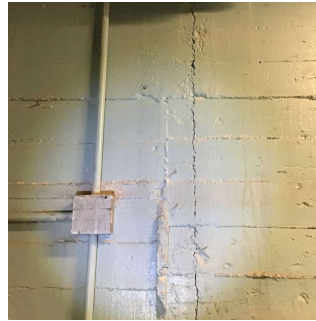
Basement - Fan Area

Basement - Lower Level - Fan Area
Violations	No violations recorded.
FOUNDATION WALLS	
	Inspected
Material Type(s)	Concrete
Condition	4 - Between Fair and Poor
Deficiency	CONCRETE: CRACKED/SPALLED/REINFORCEMENT EXPOSED
Deficiency Location/Instance	Basement - Fan Area, Basement - Lower Level - Fan Area
Deficiency Quantity	30
Quantity Uom	S.F.
Potential Action	REPAIR
Urgency of Action	PRIORITY 3

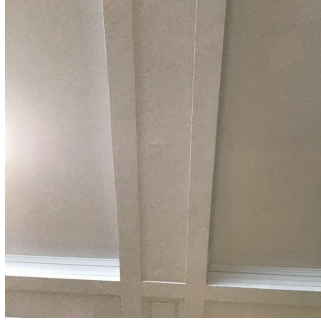
Question	Response
INTERIOR	
STRUCTURAL	
ROOF STRUCTURE	Inspected
Deficiency Photo1	 
	Roof 1 - Penthouse
Violations	No violations recorded.
VAULTS-BUNKERS	
Foundation Walls	Inspected
Condition	2 - Between Good and Fair
Deficiency	No deficiencies recorded
Slab Structure	Inspected
Condition	2 - Between Good and Fair
Deficiency	No deficiencies recorded
Vault/Ash Hoist Doors and Framing	Inspected
Condition	5 - Poor
Deficiency	WATER INFILTRATION
Deficiency Location/Instance	Basement - Ash Hoist Vault
Deficiency Quantity	10
Quantity Uom	S.F.
Potential Action	REPAIR
Urgency of Action	PRIORITY 5
Purpose of Action	LEVEL 2
Deficiency Photo1	 
	Basement - Ash Hoist Vault
Violations	No violations recorded.
AUDITORIUM	
Instance on 2nd Floor (680 Seats)	Inspected
Ceiling	Inspected
Instance on 2nd Floor (680 Seats)	Inspected
Condition	2 - Between Good and Fair
Deficiency	PLASTER: CRACKS/SPALLING
Deficiency Location/Instance	Near Stage

Potential Action	REPLACE
Urgency of Action	PRIORITY 3
Purpose of Action	LEVEL 2
Deficiency Photo1

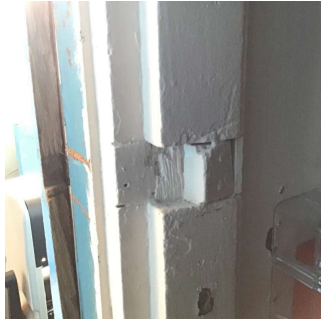
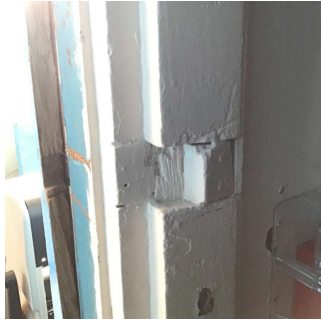
Deficiency	WOOD: DETERIORATED DOOR AND FRAME
Deficiency Location/Instance	Behind Stage Room
Deficiency Quantity	1
Quantity Uom	EACH
Potential Action	MAINTENANCE
Urgency of Action	PRIORITY 3
Purpose of Action	LEVEL 2
Deficiency Photo1

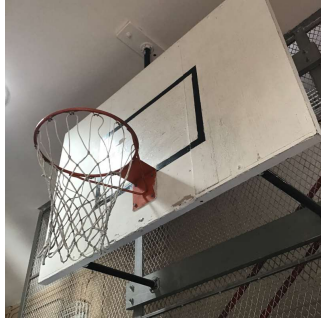
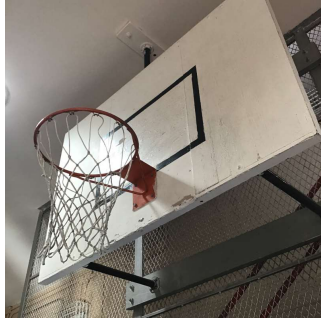
Near Entrance

Instance on 1st Floor - Lower Level	Inspected
Condition	5 - Poor
Deficiency	DAMAGED/MISSING
Deficiency Location/Instance	Near Entrance, By Lockers Room
Deficiency Quantity	2
Quantity Uom	EACH
Potential Action	REPLACE
Urgency of Action	PRIORITY 3
Purpose of Action	LEVEL 2
Deficiency Photo1

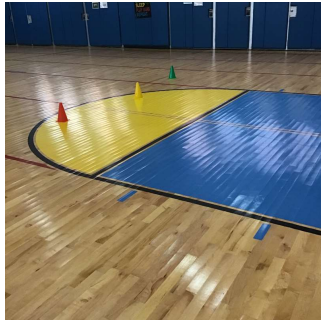
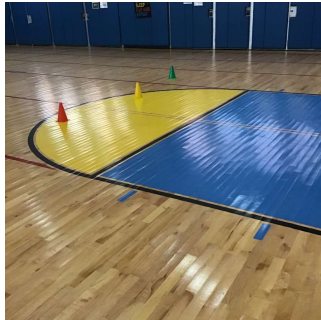
Instance on 1st Floor - Lower Level	Inspected
Condition	5 - Poor
Deficiency	WOOD: DAMAGED/DETERIORATED
Deficiency Location/Instance	Near Lockers Room
Deficiency Quantity	5,000
Quantity Uom	S.F.
Potential Action	REPLACE
Urgency of Action	PRIORITY 3
Purpose of Action	LEVEL 2
Deficiency Photo1

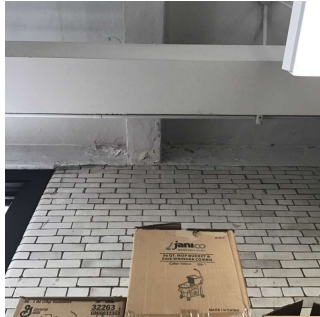
Violations	Storage Room No violations recorded.
Deficiency	PLASTER: CRACKS/SPALLING
Deficiency Location/Instance	Storage Room
Deficiency Quantity	20
Quantity Uom	S.F.
Potential Action	REPLACE
Urgency of Action	PRIORITY 3
Purpose of Action	LEVEL 2
Deficiency Photo1

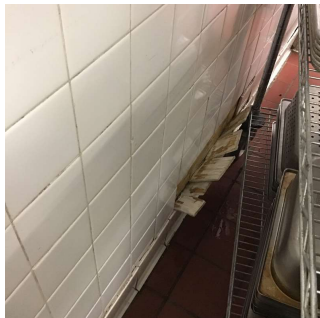
Violations	Near Windows

Violations	Storage Room No violations recorded.
Deficiency	CERAMIC TILE: BROKEN/ MISSING
Deficiency Location/Instance	Near Windows, Entrance
Deficiency Quantity	30
Quantity Uom	S.F.
Potential Action	REPLACE
Urgency of Action	PRIORITY 3
Purpose of Action	LEVEL 2
Deficiency Photo1

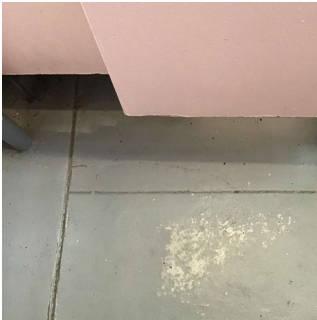
Room 557
Violations	No violations recorded.
Floor Finish	Inspected
Condition	4 - Between Fair and Poor
Deficiency	CONCRETE: CRACKS
Deficiency Location/Instance	Kitchen - Toilet, Rooms 557,360
Deficiency Quantity	30
Quantity Uom	S.F.
Potential Action	REPLACE
Urgency of Action	PRIORITY 3
Purpose of Action	LEVEL 2
Deficiency Photo1

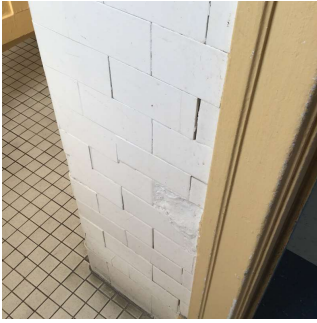
Violations	Kitchen - Toilet No violations recorded.
Walls	Inspected
Condition	4 - Between Fair and Poor
Deficiency	CERAMIC TILE: BROKEN/ MISSING
Deficiency Location/Instance	Rooms 557,351,251
Deficiency Quantity	30
Quantity Uom	S.F.
Potential Action	REPLACE
Urgency of Action	PRIORITY 3
Purpose of Action	LEVEL 2
Deficiency Photo1
