NYC Department of Education
Building Condition Assessment Survey 2023 - 2024

Architectural Inspection

Asset: P.S. 183 - BROOKLYN, 76 RIVERDALE AVENUE, New York, 11212

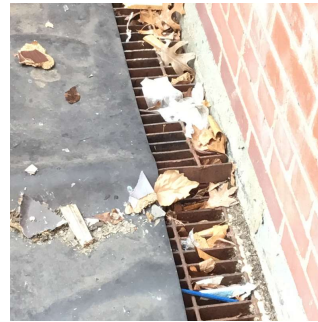
AW1
 No violations recorded.

AREAWAY GRATINGS: MAJOR RUSTING / OR BROKEN

50
 S.F.
 REPLACE
 PRIORITY 4
 LEVEL 2

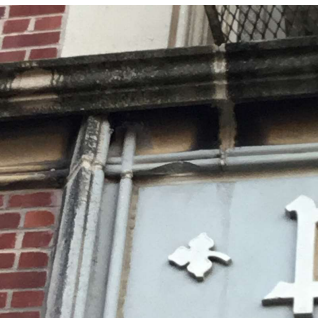
Question	Response
EXTERIOR	
EXTERIOR WALLS	
Instance Quantity	36,000
Instance Quantity Uom	S.F.
Deficiency	STONE: CHIPPED/SPALLED/BROKEN PIECES - MAJOR
Roof Plan reference	<p>K183</p>

Deficiency Quantity	10
Quantity Uom	S.F.
Potential Action	REPLACE
Urgency of Action	PRIORITY 4
Purpose of Action	LEVEL 2
Deficiency Photo1

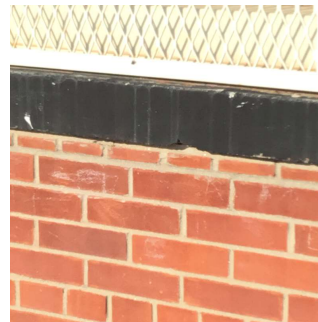
Facade G

Violations	Facade A No violations recorded.
Deficiency	BRICK: DETERIORATED MASONRY SILLS - MINOR

REPAIR

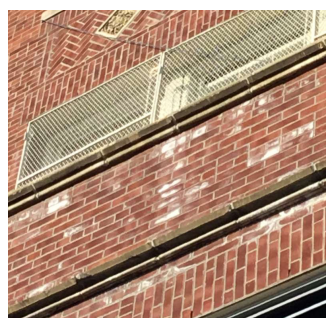
Question	Response
EXTERIOR	
EXTERIOR WALLS	Inspected
Violations	No violations recorded.
EXTERIOR SOFFITS	Does not Exist
LOADING DOCK	Does not Exist
LOUVER	Inspected
Condition	2 - Between Good and Fair
Deficiency	No deficiencies recorded
PARAPETS	Inspected
Material Type(s)	Concrete, Masonry
Replacement Quantity	6,000
Replacement Uom	C.F.
Instance on Roofs 1-7	Inspected
Instance Condition	3 - Fair
Instance Quantity	6,000
Instance Quantity Uom	C.F.
Deficiency	BRICK: EFFLORESCENCE
Roof Plan reference

Deficiency Quantity	60
Quantity Uom	S.F.
Potential Action	MAINTENANCE
Urgency of Action	PRIORITY 1
Purpose of Action	LEVEL 1
Deficiency Photo1

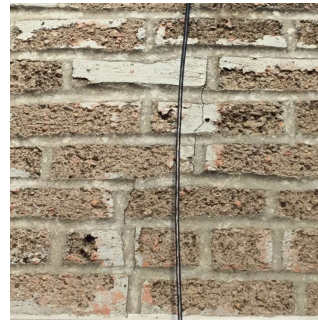
Roof 1
No violations recorded.

Violations	Roof 6 No violations recorded.
Deficiency	BRICK: MINOR CRACKS, SPALLING

100
S.F.
REPAIR
PRIORITY 3
LEVEL 2

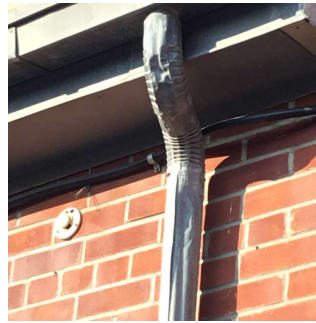
Facade L

DAMAGED/MISSING

30
L.F.
REPLACE

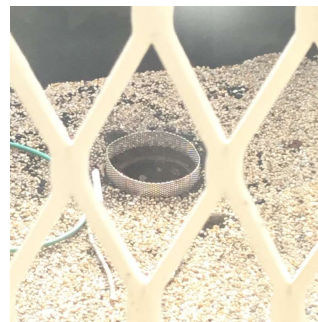
Roof 4
No violations recorded.

Question	Response
EXTERIOR	
ROOF	
Roofing	
ROOFING	
Deficiency Quantity	15
Quantity Uom	L.F.
Potential Action	REPLACE
Urgency of Action	PRIORITY 4
Purpose of Action	LEVEL 4
Deficiency Photo1	 
	Roof 1
Violations	35672695P
Instance on Metal: Roofs 8, 9	Inspected
Instance Condition	1 - Good
Instance Photo	 
	Roof 8
Instance Quantity	500
Instance Quantity Uom	S.F.
Does the roof have major mechanical equipment sitting on Dunnage Steel less than 18" above the Roofing?	No
Does this roof instance have a Sustainable Roof System?	No
Do solar panels exist on these roofs?	No
Is/Are the roof(s) suitable for Solar Panel installation?	No
Installation Year	2004
Source of Installation	Custodial Staff
Deficiency	No deficiencies recorded
ROOFING DRAINS	
Condition	3 - Fair
Deficiency	DETERIORATED

1
EACH
REPLACE
PRIORITY 4
LEVEL 2

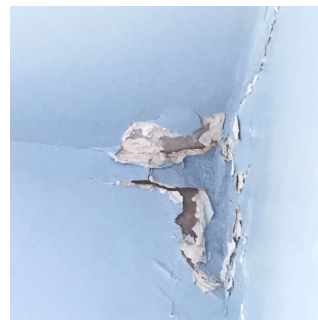
Auditorium PH

BULKHEAD/PENTHOUSE CEILING: PLASTER DAMAGED/DETERIORATED

15
 S.F.
 REPLACE
 PRIORITY 4
 LEVEL 2

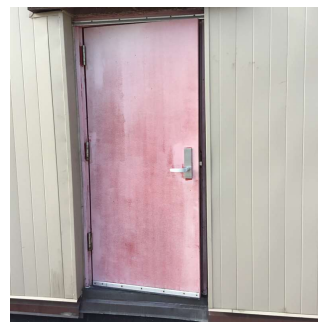
PH

BULKHEAD/PENTHOUSE DOORS: DETERIORATED DOOR AND FRAME

REPLACE DOOR AND FRAME

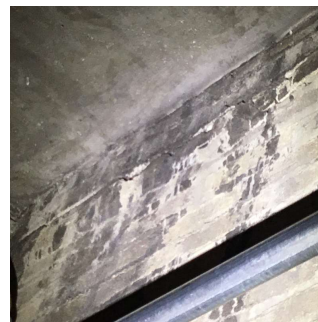
**BULKHEAD/PENTHOUSE WALLS/INTERIOR: BRICK
CRACKS/SPALLING**

85
S.F.
REPLACE
PRIORITY 4
LEVEL 2

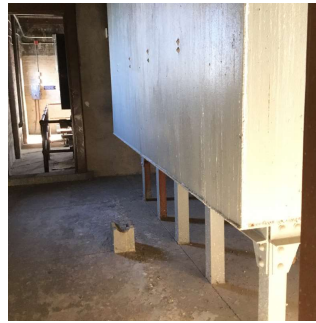
Penthouse

STEEL STRUCTURE: NOT IN USE - MAJOR DETERIORATION

PRIORITY 1
LEVEL 1

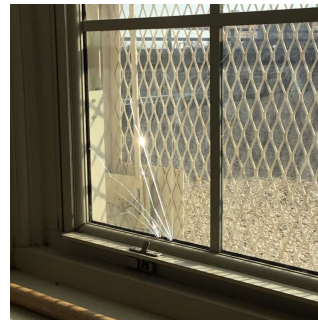
Facade G1 - Gymnasium
 No violations recorded.

30
 S.F.
 MAINTENANCE
 PRIORITY 3
 LEVEL 2

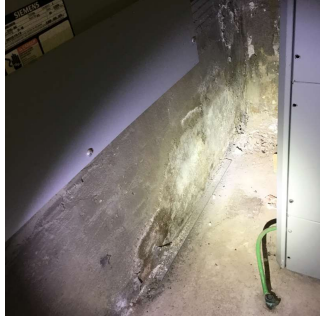
Question	Response
INTERIOR	
STRUCTURAL	
FOUNDATION WALLS	
Urgency of Action	PRIORITY 5
Purpose of Action	LEVEL 6
Deficiency Photo1

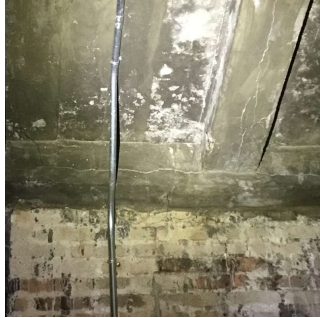
Electrical Panel Room
Violations	35672692J
ROOF STRUCTURE	
Condition	Inspected
Condition	4 - Between Fair and Poor
Deficiency	STEEL COLUMNS/BEAMS: DETERIORATED CONCRETE FIREPROOFING
Deficiency Location/Instance	PH, BH
Deficiency Quantity	100
Quantity Uom	S.F.
Potential Action	REPLACE
Urgency of Action	PRIORITY 4
Purpose of Action	LEVEL 5
Deficiency Photo1

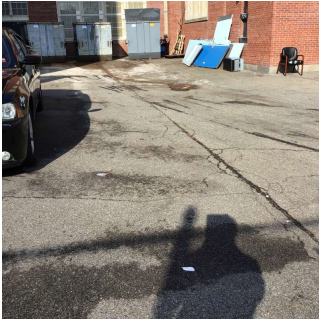
Question	Response
SITE	
PAVING	
Student Non-Use	
Asphalt	
Deficiency	CRACKS - MAJOR
Deficiency Location/Instance	Near exit 7
Deficiency Quantity	1,000
Quantity Uom	S.F.
Potential Action	REPLACE
Urgency of Action	PRIORITY 3
Purpose of Action	LEVEL 2
Deficiency Photo1

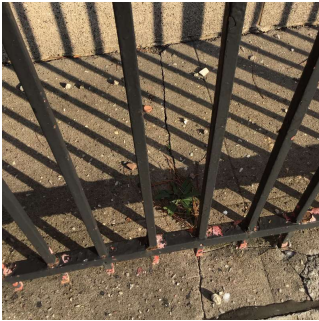
Near exit 7
Violations	No violations recorded.
Concrete	Inspected
Condition	3 - Fair
Deficiency	DAMAGED/DETERIORATED/MISSING SECTIONS
Deficiency Location/Instance	Along Strauss Street, Herzl Street
Deficiency Quantity	75
Quantity Uom	S.F.
Potential Action	REPLACE
Urgency of Action	PRIORITY 3
Purpose of Action	LEVEL 2
Deficiency Photo1
