**NYC Department of Education**  
**Building Condition Assessment Survey 2023 - 2024**

Architectural Inspection

**Asset:** P.S. 184 - BROOKLYN, 273 NEWPORT STREET, New York, 11212

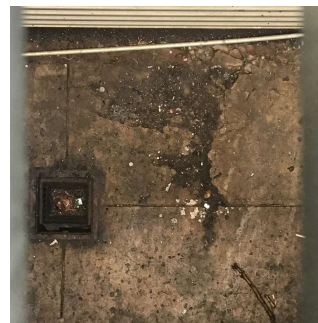
AW3

**AREAWAY SLAB: CRACKS AND SPALLING**

REPLACE

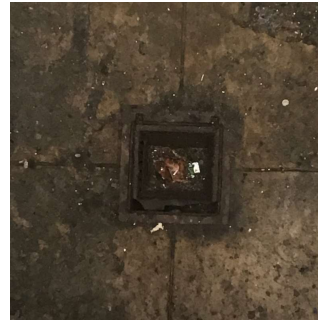
AW3

**AREAWAY DRAINS: DETERIORATED**

REPLACE

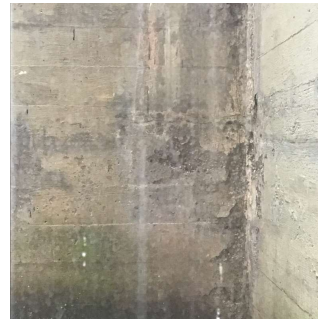
AW2

**AREAWAY WALLS: CRACKS AND SPALLING**

REPAIR

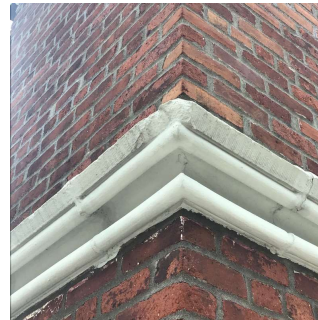
CH

STONE/TERRA COTTA BAND: MINOR DETERIORATION

REPAIR

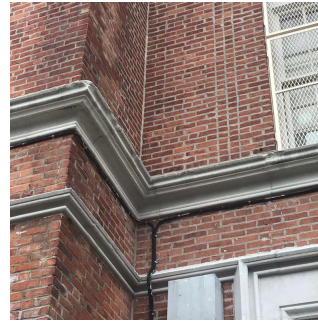
Facade A

TERRA COTTA: MINOR CRACKS, SPALLING

REPAIR

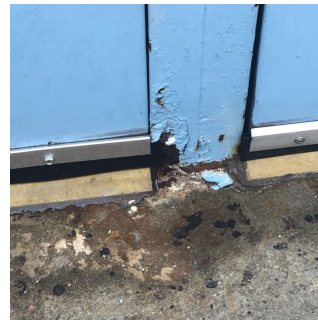
Facade B

METAL: DETERIORATED DOOR AND FRAME - MAJOR DETERIORATION

REPLACE

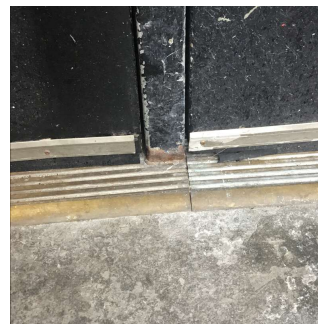
Facade E - Exit D  
No violations recorded.

METAL: DETERIORATED DOOR AND FRAME - MINOR DETERIORATION

7  
EACH  
MAINTENANCE  
PRIORITY 3  
LEVEL 2

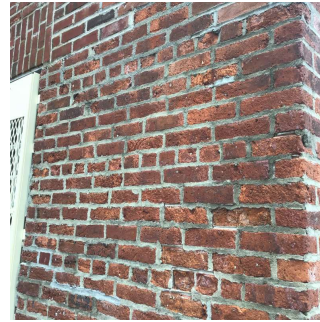
Facade G

Question	Response
<b>EXTERIOR</b>	
<b>DOORS</b>	
<b>TRANSOM/SIDE LIGHT</b>	
Urgency of Action	PRIORITY 4
Purpose of Action	LEVEL 2
Deficiency Photo1	 
	Facade B
Violations	No violations recorded.
<b>EXTERIOR WALLS</b>	
Material Type(s)	Inspected Masonry
Replacement Quantity	32,000
Replacement Uom	S.F.
Instance on All Facades	Inspected
Instance Condition	3 - Fair
Instance Quantity	32,000
Instance Quantity Uom	S.F.
Deficiency	BRICK: MAJOR / THRU CRACKS
Roof Plan reference

Deficiency Quantity	20
Quantity Uom	S.F.
Potential Action	REMOVE AND REBUILD
Urgency of Action	PRIORITY 4
Purpose of Action	LEVEL 2

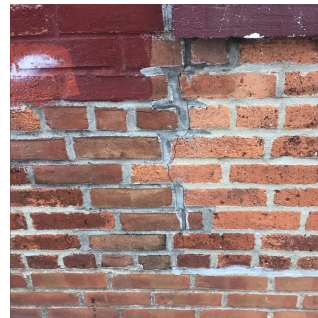
Facade G

**BRICK: MINOR CRACKS AND SPALLING**

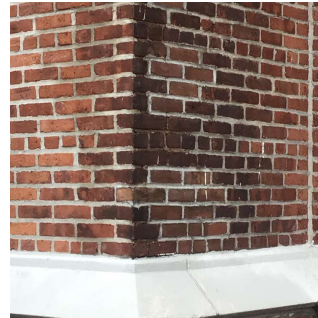
Facade A

BRICK: DETERIORATED JOINTS

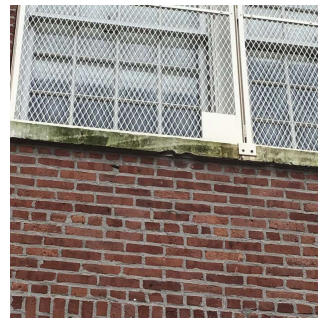
Facade E

**BRICK: DETERIORATED MASONRY SILLS - MINOR**

REPAIR

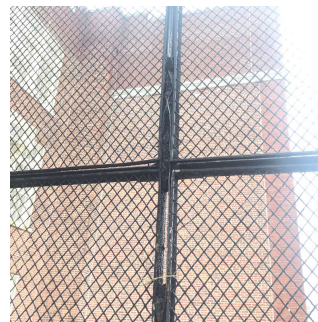
Roof 2 - Facade F

Violations	Facade C No violations recorded.
<b>ROOF BARRIER/FENCE</b>	Inspected
Condition	2 - Between Good and Fair
Deficiency	No deficiencies recorded
<b>ROOF CAGE</b>	Inspected
Condition	4 - Between Fair and Poor
Deficiency	STEEL FRAME: MAJOR RUSTING

200  
 S.F.  
 REPAIR  
 PRIORITY 4  
 LEVEL 2

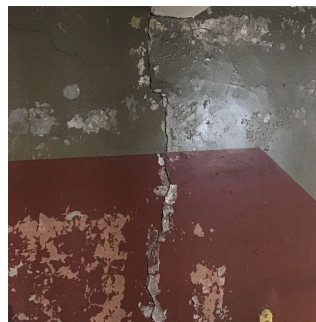
BH2 (Stair 6 and 7)

**BULKHEAD/PENTHOUSE WALLS/INTERIOR: PLASTER  
CRACKS/SPALLING**

REPLACE

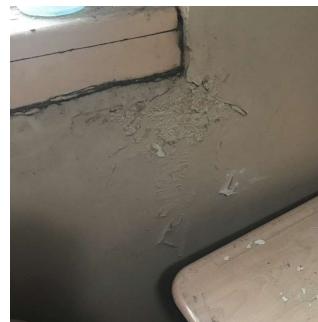
**BULKHEAD/PENTHOUSE WALLS/EXTERIOR: WATER  
INFILTRATION**

BH1  
No violations recorded.

100  
S.F.  
REPAIR  
PRIORITY 5  
LEVEL 2

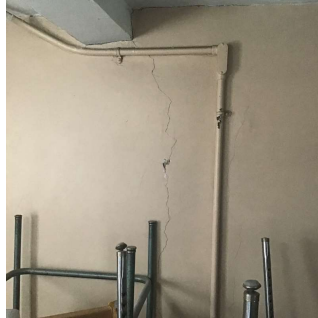
**BULKHEAD/PENTHOUSE WALLS/INTERIOR: PLASTER  
CRACKS/SPALLING**

BH1	
Violations	No violations recorded.
Deficiency	<b>BULKHEAD/PENTHOUSE WALLS/INTERIOR: BRICK CRACKS/SPALLING</b>
Roof Plan reference

50  
S.F.  
REPLACE  
PRIORITY 3  
LEVEL 2

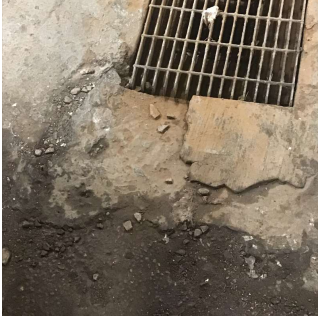
Violations	Boiler Room No violations recorded.
<b>FLOOR STRUCTURE</b>	
Condition	Inspected 3 - Fair
Deficiency	CONCRETE SLAB ON GRADE: THRU CRACKS
Deficiency Location/Instance	Basement - Boiler Room
Deficiency Quantity	20
Quantity Uom	S.F.
Potential Action	REPLACE
Urgency of Action	PRIORITY 4
Purpose of Action	LEVEL 5
Deficiency Photo1

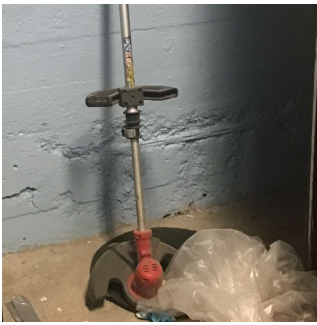
Violations	Boiler Room No violations recorded.
Deficiency	CONCRETE: CRACKED/SPALLED/REINFORCEMENT EXPOSED
Deficiency Location/Instance	Basement - North Exit
Deficiency Quantity	20
Quantity Uom	S.F.
Potential Action	REPAIR
Urgency of Action	PRIORITY 4
Purpose of Action	LEVEL 5

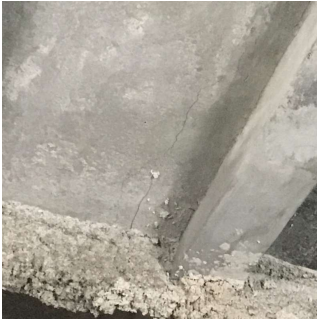
Violations	Basement - North Exit No violations recorded.
<b>ROOF STRUCTURE</b>	
Condition	Inspected 3 - Fair
Deficiency	CONCRETE: CRACKED/SPALLED/REINFORCEMENT EXPOSED
Deficiency Location/Instance	PH1
Deficiency Quantity	15
Quantity Uom	S.F.
Potential Action	REPAIR
Urgency of Action	PRIORITY 3
Purpose of Action	LEVEL 5
Deficiency Photo1

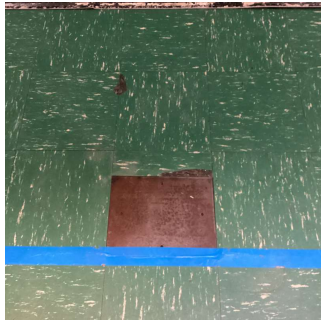
Question	Response
<b>INTERIOR</b>	
<b>AUDITORIUM</b>	
<b>Sliding-folding Partition</b>	
Instance on 2nd Floor (538 Seats)	Does not Exist
<b>Stage</b>	
Instance on 2nd Floor (538 Seats)	Inspected
<b>Stage</b>	Inspected
Instance on 2nd Floor (538 Seats)	Inspected
<b>Condition</b>	2 - Between Good and Fair
<b>Deficiency</b>	DAMAGED FLOOR
Deficiency Location/Instance	Center
Deficiency Quantity	10
Quantity Uom	S.F.
Potential Action	REPLACE
Urgency of Action	PRIORITY 3
Purpose of Action	LEVEL 2
Deficiency Photo1

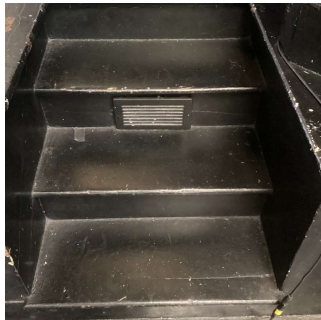
Center
<b>Violations</b>	No violations recorded.
<b>Deficiency</b>	DAMAGED STEPS
Deficiency Location/Instance	Left Side
Deficiency Quantity	10
Quantity Uom	S.F.
Potential Action	REPLACE
Urgency of Action	PRIORITY 3
Purpose of Action	LEVEL 2
Deficiency Photo1

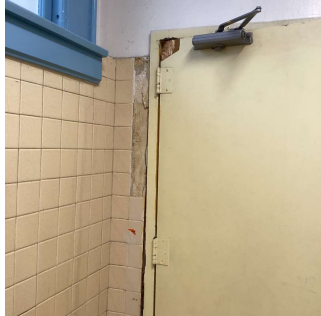
Question	Response
<b>INTERIOR</b>	
<b>TOILET ROOMS - STUDENTS</b>	
<b>Walls</b>	
Urgency of Action	PRIORITY 3
Purpose of Action	LEVEL 2
Deficiency Photo1

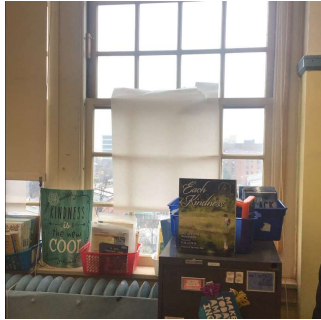
Boys Toilet Room - 1st Floor
Violations	No violations recorded.
<b>LIFE SAFETY</b>	
	Inspected
<b>F.D. HOLDING AREA</b>	
	Inspected
Condition	5 - Poor
Deficiency	HOLDING AREAS NOT IDENTIFIED
Deficiency Location/Instance	Rooms 205, 307, 405, 511
Deficiency Quantity	4
Quantity Uom	EACH
Potential Action	PROVIDE IDENTIFICATION ON EXTERIOR SIDE OF WINDOW
Urgency of Action	PRIORITY 5
Purpose of Action	LEVEL 2
Deficiency Photo1
