NYC Department of Education
Building Condition Assessment Survey 2023 - 2024

Architectural Inspection

Asset: P.S. 189 - BROOKLYN, 1100 EAST NEW YORK AVE, New York, 11212

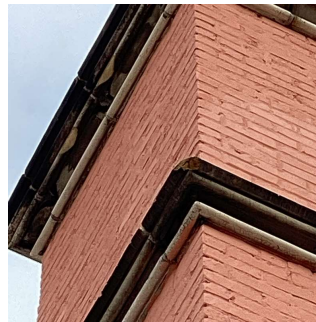
CH

STONE/TERRA COTTA BAND: MINOR DETERIORATION

REPAIR

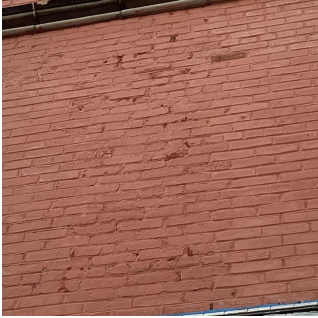
BRICK: DETERIORATED JOINTS

Question	Response
EXTERIOR	
CHIMNEY	
Quantity Uom	S.F.
Potential Action	REPOINT
Urgency of Action	PRIORITY 3
Purpose of Action	LEVEL 2
Deficiency Photo1

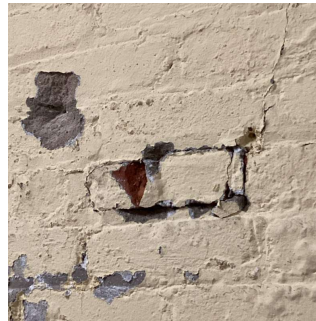
PH

ROOFING DRAINS	Under Construction
Specialties	Inspected
BULKHEAD/PENTHOUSE	Inspected
Condition	3 - Fair
Deficiency	BULKHEAD/PENTHOUSE WALLS/INTERIOR: BRICK CRACKS/SPALLING
Roof Plan reference

Deficiency Quantity	80
Quantity Uom	S.F.
Potential Action	REPLACE

PRIORITY 4
LEVEL 2

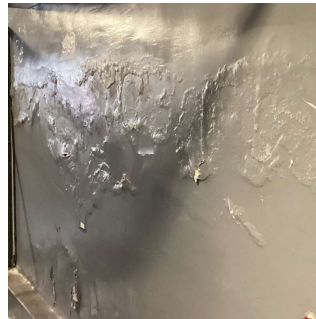
BH1

BULKHEAD/PENTHOUSE WALLS/INTERIOR: PLASTER
CRACKS/SPALLING

60
S.F.
REPLACE
PRIORITY 4
LEVEL 2

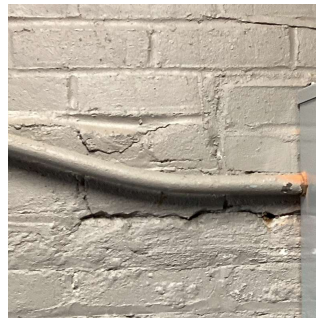
BH1
No violations recorded.

BULKHEAD/PENTHOUSE WALLS/INTERIOR: BRICK
CRACKS/SPALLING

60
S.F.
REPLACE
PRIORITY 3
LEVEL 2

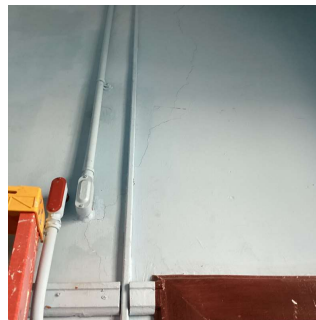
Right Side Room near Stage

PLASTER: CRACKS/SPALLING

REPLACE

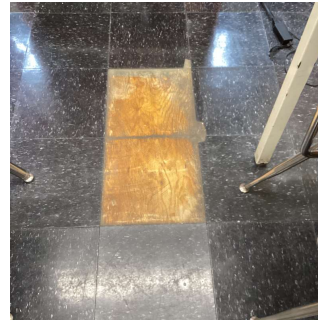
Room 512

Room 211
Violations	No violations recorded.
Deficiency	VINYL TILES: BROKEN/DETERIORATED/MISSING TILES
Deficiency Location/Instance	Rooms 503, 512, Corridor near Cafeteria, by Multipurpose Room East and West and others
Deficiency Quantity	3,200
Quantity Uom	S.F.
Potential Action	REPLACE
Urgency of Action	PRIORITY 3
Purpose of Action	LEVEL 2

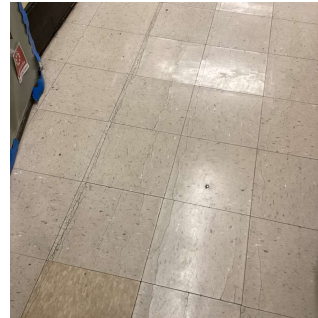
Room 402

VINYL TILES: DETERIORATED SUBSTRATE

REPLACE

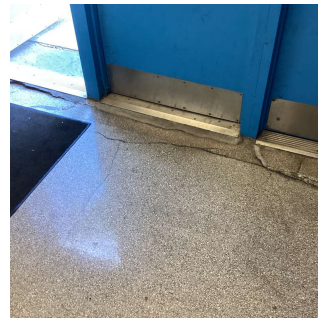
Main Entrance Vestibule

TERRAZZO: CRACKS

REPLACE

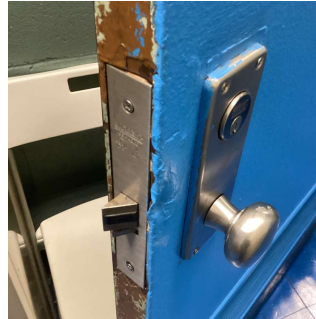
Kitchen Locker Room

METAL: DETERIORATED DOOR

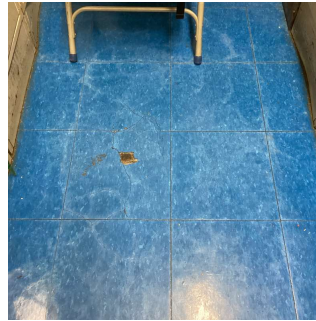
Kitchen Locker Room

VINYL TILES: BROKEN/DETERIORATED/MISSING TILES

REPLACE

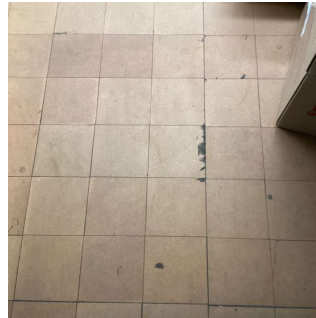
Near Main Entrance

QUARRY TILE: BROKEN/MISSING TILES

REPLACE

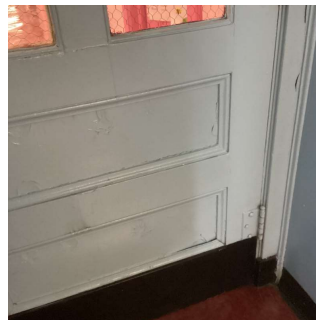
Stair AB/5

METAL CLAD WOOD: DETERIORATED DOOR
Stairs AB/5, 4, D/3, EF/3
4
EACH
MAINTENANCE
PRIORITY 3
LEVEL 2
