**NYC Department of Education
Building Condition Assessment Survey 2023 - 2024**

Architectural Inspection

Asset: P.S. 192 - BROOKLYN, 4715 18 AVENUE, New York, 11204

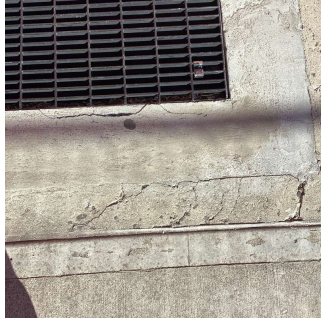
AW3
Violations	No violations recorded.
AWNINGS AND CANOPIES	
	Does not Exist
CHIMNEY	
Material Type(s)	Inspected Masonry
Condition	2 - Between Good and Fair
Deficiency	BRICK: DETERIORATED JOINTS
Roof Plan reference	K192

Question	Response
Architectural	
EXTERIOR	Inspected
AREAWAY	Inspected
Instance on AW1-AW6	Inspected
Instance Condition	3 - Fair
Instance Quantity	6
Instance Quantity Uom	EACH
Deficiency	AREAWAY WALLS: CRACKS AND SPALLING
Roof Plan reference	K192
Deficiency Quantity	25
Quantity Uom	S.F.
Potential Action	REPAIR
Urgency of Action	PRIORITY 3
Purpose of Action	LEVEL 2

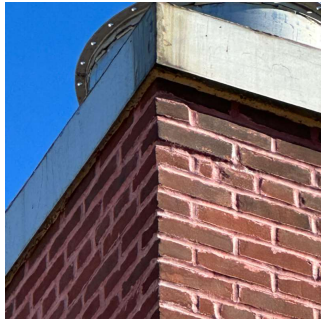
CH
Violations	No violations recorded.
COPING	
Condition	Inspected 3 - Fair
Deficiency	CAST STONE: CRACKED/BROKEN PIECES

Deficiency Quantity	10
Quantity Uom	S.F.
Potential Action	REPOINT
Urgency of Action	PRIORITY 3
Purpose of Action	LEVEL 2
Deficiency Photo1

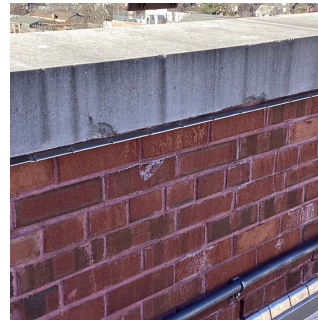
Roof 1
No violations recorded.

10
L.F.
REPLACE-IN-KIND
PRIORITY 4
LEVEL 2

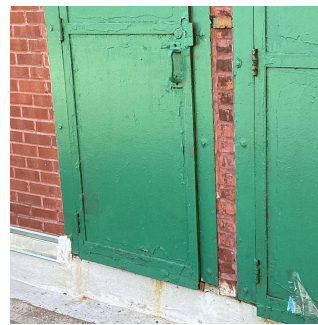
Facade F

METAL: DETERIORATED DOOR AND FRAME - MAJOR DETERIORATION

2
 EACH
 REPLACE
 PRIORITY 4
 LEVEL 2

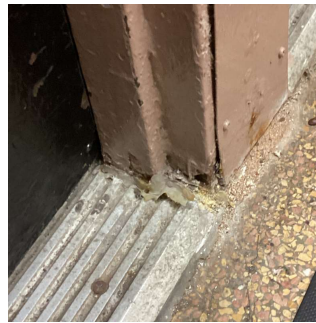
Facade A

METAL CLAD: DETERIORATED DOOR AND FRAME - MAJOR DETERIORATION

10
 EACH
 REPLACE
 PRIORITY 4
 LEVEL 2

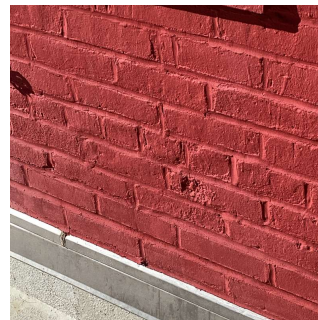
Facade G

Violations	Facade L No violations recorded.
Deficiency	BRICK: MINOR CRACKS AND SPALLING

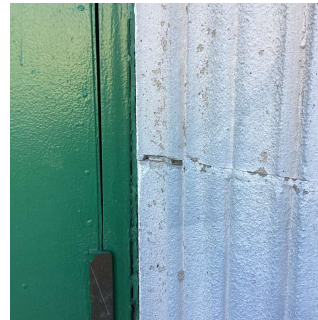
Facade B

STONE: DETERIORATED JOINTS

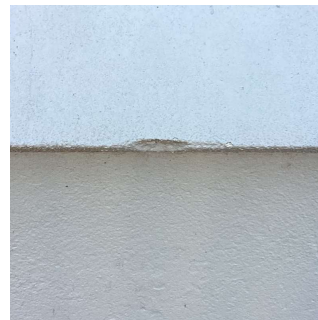
Facade B

STONE: CHIPPED/SPALLED/BROKEN PIECES - MINOR

REPAIR

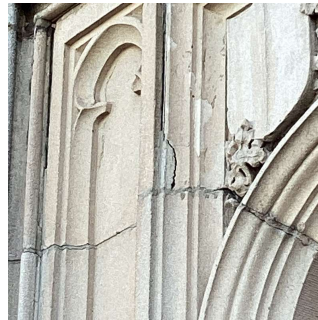
Facade A

STONE: CHIPPED/SPALLED/BROKEN PIECES - MAJOR

REPLACE

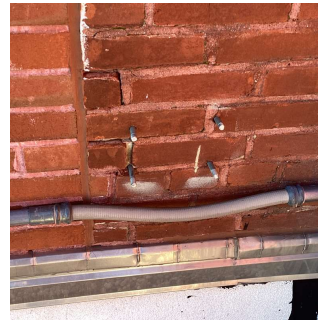
Roof 1

BRICK: DETERIORATED JOINTS

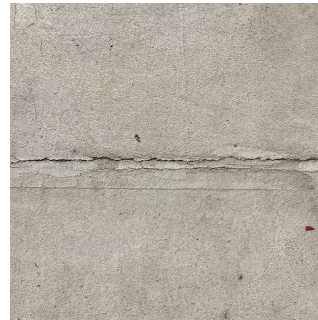
Roof 5

CONCRETE: MINOR CRACKS

REPAIR

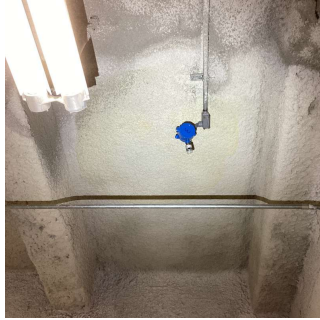
CONCRETE: MAJOR ACTIVE PLAZA DECK LEAKS IN NON-INSTRUCTIONAL SPACE

Violations	Gas Meter Room No violations recorded.
ROOF	Inspected
Roofing	Inspected
Replacement Quantity	12,800
Replacement Uom	S.F.
ROOF HATCH/SMOKE HATCH	Does not Exist
LEADERS, GUTTERS, DOWNSPOUTS, SCUPPERS	Inspected
Condition	2 - Between Good and Fair
Deficiency	No deficiencies recorded
ROOF BARRIER/FENCE	Inspected
Condition	2 - Between Good and Fair
Deficiency	No deficiencies recorded
ROOF CAGE	Inspected
Condition	5 - Poor
Deficiency	STEEL FRAME: MAJOR RUSTING
Roof Plan reference	K192
Deficiency Quantity	550
Quantity Uom	S.F.
Potential Action	REPAIR
Urgency of Action	PRIORITY 4
Purpose of Action	LEVEL 2

REPLACE

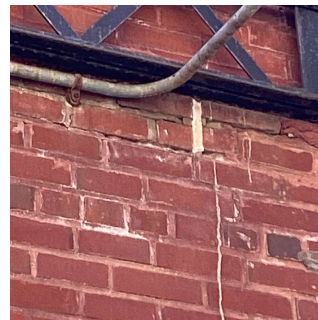
Auditorium PH

BULKHEAD/PENTHOUSE WALLS/EXTERIOR: DETERIORATED JOINTS

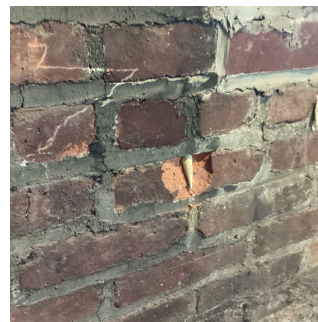
PH
No violations recorded.

BULKHEAD/PENTHOUSE WALLS/INTERIOR: BRICK CRACKS/SPALLING

80
S.F.
REPLACE
PRIORITY 4
LEVEL 2

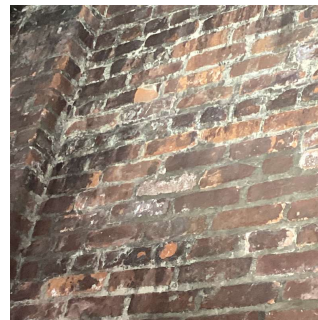
PH

BULKHEAD/PENTHOUSE WALLS/INTERIOR: BRICK CRACKS/SPALLING

REPLACE

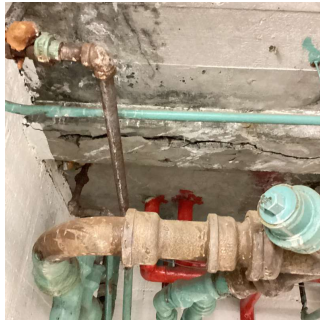
Violations	Oil Tank Room (Boiler Room, Basement Corridor, Basement Fan Area East and West similar) No violations recorded.
Deficiency	STEEL COLUMNS/BEAMS: DETERIORATED CONCRETE FIREPROOFING
Deficiency Location/Instance	Basement
Deficiency Quantity	70
Quantity Uom	S.F.

Potential Action	REPLACE
Urgency of Action	PRIORITY 5
Purpose of Action	LEVEL 6

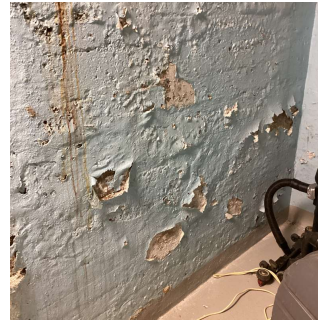
Basement Corridor

Violations	PH (BH2, Auditorium PH similar) No violations recorded.
FOUNDATION WALLS	
Material Type(s)	Inspected Concrete
Condition	4 - Between Fair and Poor
Deficiency	CONCRETE: CRACKED/SPALLED/REINFORCEMENT EXPOSED
Deficiency Location/Instance	Basement
Deficiency Quantity	75
Quantity Uom	S.F.
Potential Action	REPAIR
Urgency of Action	PRIORITY 3
Purpose of Action	LEVEL 5

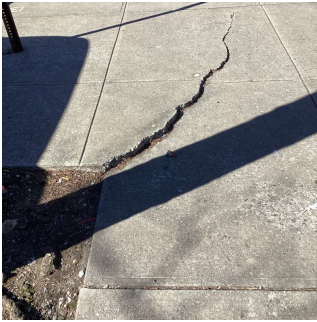
48th Street
Violations	No violations recorded.
Deficiency	HEAVING
Deficiency Location/Instance	48th Street
Deficiency Quantity	150
Quantity Uom	S.F.
Potential Action	REPLACE
Urgency of Action	PRIORITY 3
Purpose of Action	LEVEL 2
Deficiency Photo1

Question	Response
SITE	
PAVING	
DOT Sidewalk	Inspected
Asphalt	Does not Exist
Concrete	Inspected
Condition	4 - Between Fair and Poor
Deficiency	HEAVING
Deficiency Location/Instance	48th Street
Deficiency Quantity	50
Quantity Uom	S.F.
Potential Action	REPLACE
Urgency of Action	PRIORITY 5
Purpose of Action	LEVEL 6
Deficiency Photo1
