**NYC Department of Education**  
**Building Condition Assessment Survey 2023 - 2024**

Architectural Inspection

**K193**

**Asset: P.S. 193 - BROOKLYN, 2515 AVENUE L, New York, 11210**

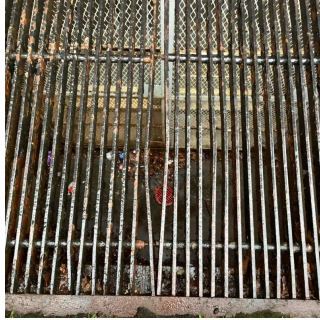
Question	Response
<b>Architectural</b>	
<b>EXTERIOR</b>	Inspected
<b>AREAWAY</b>	Inspected
Instance on AW1 - AW4	Inspected
Instance Condition	3 - Fair
Instance Quantity	4
Instance Quantity Uom	EACH
Deficiency	AREAWAY WALLS: CRACKS AND SPALLING
Roof Plan reference

Deficiency Quantity	20
Quantity Uom	S.F.
Potential Action	REPLACE
Urgency of Action	PRIORITY 4
Purpose of Action	LEVEL 2
Deficiency Photo1

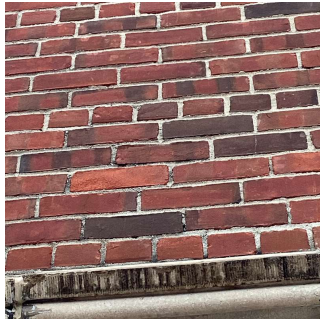
Violations	AW4 No violations recorded.
<b>AWNINGS AND CANOPIES</b>	
	Does not Exist
<b>CHIMNEY</b>	
Material Type(s)	Inspected Masonry
Condition	3 - Fair
Deficiency	BRICK: DETERIORATED JOINTS
Roof Plan reference

Deficiency Quantity	30
Quantity Uom	S.F.
Potential Action	REPOINT
Urgency of Action	PRIORITY 3
Purpose of Action	LEVEL 2
Deficiency Photo1

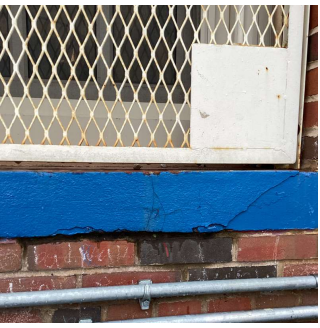
Violations	Facade G No violations recorded.

Question	Response
<b>EXTERIOR</b>	
<b>DOORS</b>	Inspected
<b>LINTELS</b>	Inspected
Condition	2 - Between Good and Fair
Deficiency	No deficiencies recorded
<b>TRANSOM/SIDE LIGHT</b>	Does not Exist
<b>EXTERIOR WALLS</b>	Inspected
Material Type(s)	Masonry
Replacement Quantity	33,000
Replacement Uom	S.F.
Instance on All Facades	Inspected
Instance Condition	4 - Between Fair and Poor
Instance Quantity	33,000
Instance Quantity Uom	S.F.
Deficiency	BRICK: DETERIORATED MASONRY SILLS - MINOR
Roof Plan reference

Deficiency Quantity	10
Quantity Uom	L.F.
Potential Action	REPAIR
Urgency of Action	PRIORITY 3
Purpose of Action	LEVEL 2
Deficiency Photo1

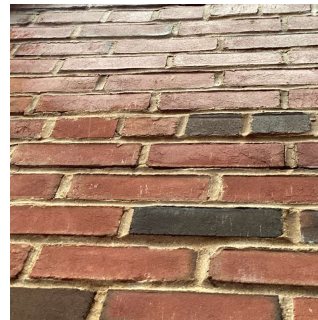
Facade K

**BRICK: DETERIORATED JOINTS**

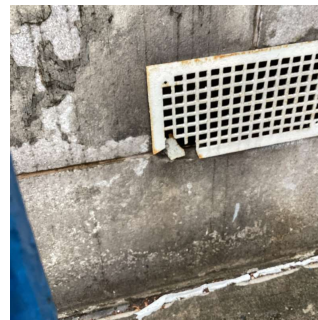
Facade M

Deficiency Quantity	100
Quantity Uom	S.F.
Potential Action	MAINTENANCE
Urgency of Action	PRIORITY 1
Purpose of Action	LEVEL 1
Deficiency Photo1	No photo recorded
Violations	No violations recorded.
<b>EXTERIOR SOFFITS</b>	Does not Exist
<b>LOADING DOCK</b>	Does not Exist
<b>LOUVER</b>	Inspected
Condition	3 - Fair
Deficiency	MAJOR RUSTING

REPLACE

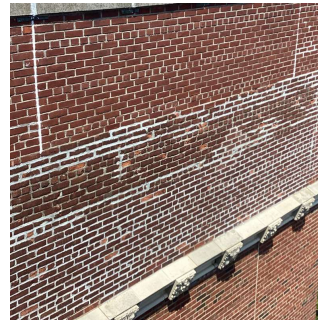
Facade D

BRICK: DETERIORATED JOINTS

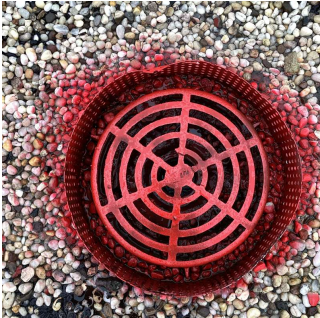
PH1

Condition	Inspected
Deficiency	5 - Poor
Roof Plan reference	DETERIORATED

Deficiency Quantity	3
Quantity Uom	EACH
Potential Action	REPLACE
Urgency of Action	PRIORITY 4
Purpose of Action	LEVEL 2
Deficiency Photo1

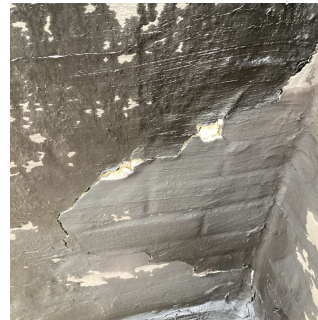
BH2

**BULKHEAD/PENTHOUSE WALLS/EXTERIOR:  
CRACKS/SPALLING - MAJOR**

REPLACE

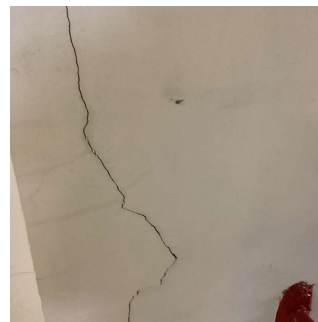
BH2  
No violations recorded.

BH2
Violations	No violations recorded.
Deficiency	<b>BULKHEAD/PENTHOUSE WALLS/INTERIOR: PLASTER CRACKS/SPALLING</b>

30  
S.F.  
REPLACE  
PRIORITY 4  
LEVEL 2

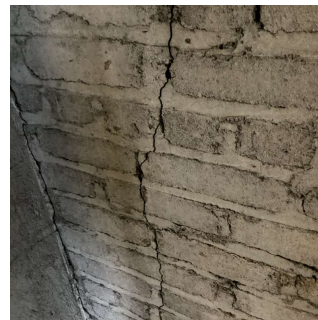
PH2

**BULKHEAD/PENTHOUSE WALLS/INTERIOR: BRICK  
CRACKS/SPALLING**

REPLACE

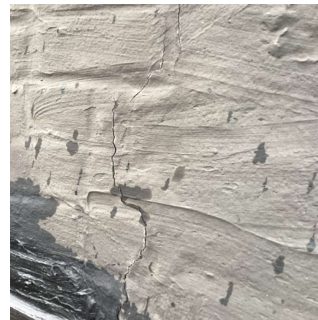
BH2  
 No violations recorded.

**BULKHEAD/PENTHOUSE WALLS/EXTERIOR:  
CRACKS/SPALLING - MINOR**

30  
 S.F.  
 REPAIR  
 PRIORITY 3  
 LEVEL 2

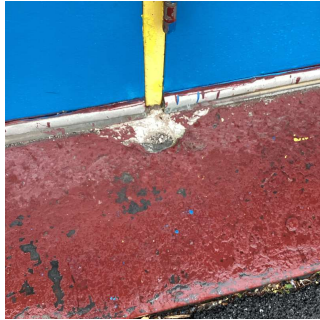
Deficiency	<b>STONE: CRACKS/SPALLING - MAJOR</b>
Roof Plan reference

Facade G
Violations	No violations recorded.
Deficiency	<b>STONE: DETERIORATED JOINTS</b>
Roof Plan reference

Question	Response
<b>EXTERIOR</b>	
<b>STAIRS/RAMPS: EXTERIOR</b>	Inspected
<b>STAIRS/RAMPS</b>	
Potential Action	REPLACE
Urgency of Action	PRIORITY 4
Purpose of Action	LEVEL 2
Deficiency Photo1

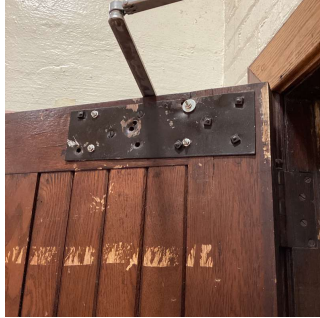
Entrance from Multipurpose Room East
Violations	No violations recorded.
<b>Fixed Equipment</b>	
Instance on 1st Floor	Does not Exist
<b>Floor Finish</b>	
Instance on 1st Floor	Inspected
Condition	1 - Good
Deficiency	No deficiencies recorded
<b>Sliding-folding Partition</b>	
Instance on 1st Floor	Does not Exist
<b>Stage</b>	
Instance on 1st Floor	Does not Exist
<b>Walls</b>	
Instance on 1st Floor	Inspected
Condition	2 - Between Good and Fair
Deficiency	No deficiencies recorded
<b>Window Curtains/Shades/Blinds</b>	
Instance on 1st Floor	Does not Exist
<b>CLASSROOMS/CORRIDORS/ADMIN SPACES</b>	
<b>Ceiling</b>	Inspected
Condition	2 - Between Good and Fair
Deficiency	PLASTER: CRACKS/SPALLING - ACTIVE LEAK
Deficiency Location/Instance	Rooms 502, 504, 506, 512, 513
Deficiency Quantity	50

Question	Response
<b>INTERIOR</b>	
<b>CAFETERIA</b>	
<b>Door(s)</b>	
Urgency of Action	PRIORITY 3
Purpose of Action	LEVEL 2
Deficiency Photo1

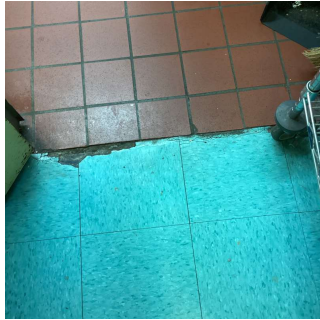
Violations	Storage Room No violations recorded.
Deficiency	QUARRY TILE: BROKEN/MISSING TILES
Deficiency Location/Instance	Food Preparation Area
Deficiency Quantity	10
Quantity Uom	S.F.
Potential Action	REPLACE
Urgency of Action	PRIORITY 3
Purpose of Action	LEVEL 2

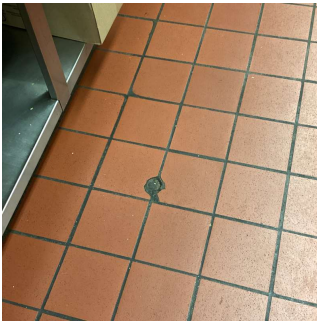
Violations	Food Preparation Area No violations recorded.
<b>Walls</b>	
Instance on 1st Floor	Inspected
Condition	2 - Between Good and Fair
Deficiency	No deficiencies recorded
<b>LIBRARY</b>	
Instance on Room 309	Inspected
<b>Built-in Furnishing</b>	
Instance on Room 309	Does not Exist
<b>Ceiling</b>	
Instance on Room 309	Inspected
Condition	1 - Good
Deficiency	No deficiencies recorded
<b>Door(s)</b>	
Instance on Room 309	Inspected
Condition	2 - Between Good and Fair
Deficiency	No deficiencies recorded
<b>Floor Finish</b>	
Instance on Room 309	Inspected
Condition	1 - Good
Deficiency	No deficiencies recorded
<b>Walls</b>	
Instance on Room 309	Inspected
Condition	1 - Good
Deficiency	No deficiencies recorded
<b>LOCKER ROOM</b>	
<b>MULTI-PURPOSE ROOM</b>	
Instance on 1st Floor - East	Inspected
Instance on 1st Floor - West	Inspected

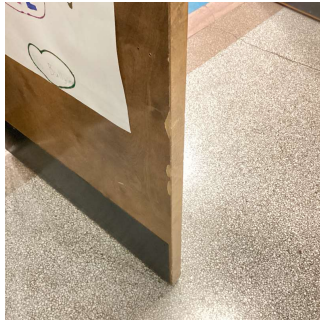
Question	Response
<b>INTERIOR</b>	
<b>MULTI-PURPOSE ROOM</b>	
<b>Door(s)</b>	
Instance on 1st Floor - West	Inspected
Condition	4 - Between Fair and Poor
Deficiency	WOOD: DETERIORATED DOOR
Deficiency Location/Instance	Main Entrance
Deficiency Quantity	2
Quantity Uom	EACH
Potential Action	MAINTENANCE
Urgency of Action	PRIORITY 3
Purpose of Action	LEVEL 2
Deficiency Photo1

Violations	Main Entrance No violations recorded.
Instance on 1st Floor - East	Inspected
Condition	3 - Fair
Deficiency	WOOD: DETERIORATED DOOR
Deficiency Location/Instance	Main Entrance
Deficiency Quantity	1
Quantity Uom	EACH
Potential Action	MAINTENANCE
Urgency of Action	PRIORITY 3
Purpose of Action	LEVEL 2
Deficiency Photo1

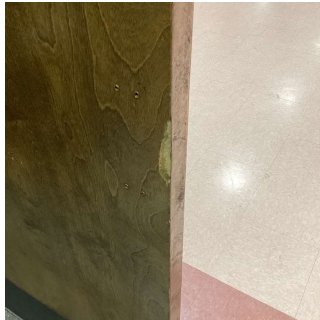
Violations	Main Entrance No violations recorded.
<b>Fixed Equipment</b>	
Instance on 1st Floor - East	Inspected
Condition	3 - Fair
Deficiency	DAMAGED/MISSING
Deficiency Location/Instance	Near Room 188
Deficiency Quantity	1

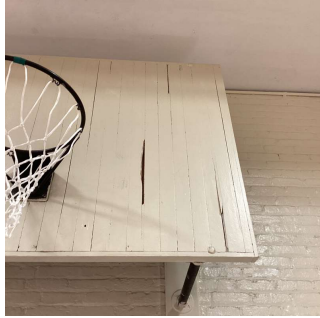
Near Room 188
Violations	No violations recorded.
Instance on 1st Floor - West	Inspected
Condition	3 - Fair
Deficiency	DAMAGED/MISSING
Deficiency Location/Instance	Near Room 173
Deficiency Quantity	1
Quantity Uom	EACH
Potential Action	REPLACE
Urgency of Action	PRIORITY 3
Purpose of Action	LEVEL 2
Deficiency Photo1

Question	Response
<b>INTERIOR</b>	
<b>MULTI-PURPOSE ROOM</b>	
<b>Fixed Equipment</b>	
Potential Action	REPLACE
Urgency of Action	PRIORITY 3
Purpose of Action	LEVEL 2
Deficiency Photo1

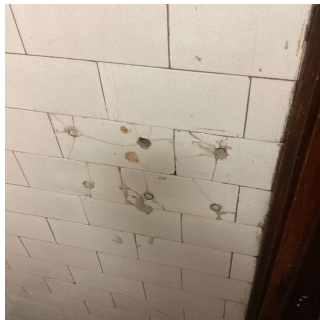
Violations	Room 251 No violations recorded.
<b>TOILET ROOMS - STUDENTS</b>	
<b>Ceiling</b>	Inspected
Condition	2 - Between Good and Fair
Deficiency	No deficiencies recorded
<b>Door(s)</b>	Inspected
Condition	5 - Poor
Deficiency	WOOD: MISSING DOOR
Deficiency Location/Instance	3rd Floor Boys
Deficiency Quantity	1
Quantity Uom	EACH
Potential Action	MAINTENANCE

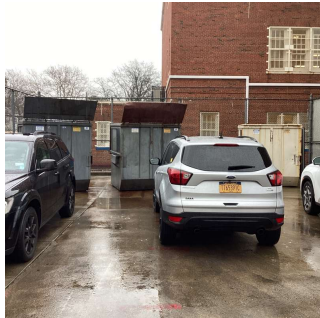
Bedford Avenue
Violations	No violations recorded.
Deficiency	CONTAINER DAMAGED
Deficiency Location/Instance	Bedford Avenue
Deficiency Quantity	1
Quantity Uom	EACH
Potential Action	REPLACE
Urgency of Action	PRIORITY 3
Purpose of Action	LEVEL 2

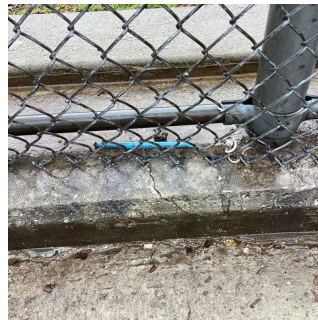
Bedford Avenue

CONCRETE CURB: DAMAGED/DETERIORATED  
Bedford Avenue, East 26th Street  
50  
S.F.  
REPLACE  
PRIORITY 3  
LEVEL 2

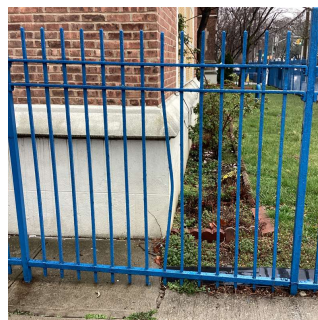
WROUGHT IRON: DAMAGED/DETERIORATED  
Avenue L, Bedford Avenue, East 26th Street  
240  
S.F.  
REPLACE  
PRIORITY 3  
LEVEL 2

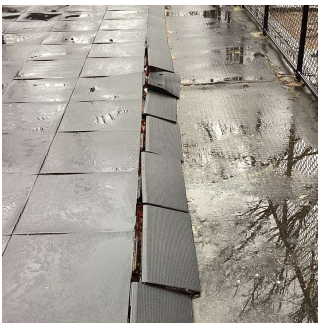
Violations	South side of playground No violations recorded.
<b>Unpaved Area</b>	
Instance on Playground East	Inspected
Condition	2 - Between Good and Fair
Deficiency	No deficiencies recorded
Instance on Playground West	Does not Exist
<b>PLAYING SURFACE</b>	Does not Exist
<b>RETAINING WALLS</b>	Does not Exist
<b>SEATING</b>	Inspected
<b>Benches</b>	Inspected
<b>Concrete</b>	Does not Exist
<b>Metal/Wood/Plastic</b>	Inspected
Condition	5 - Poor
Deficiency	DAMAGED/DETERIORATED
Deficiency Location/Instance	Schoolyard - Northeast, Gazebo, near Playground West
Deficiency Quantity	3
Quantity Uom	EACH
Potential Action	REPLACE
Urgency of Action	PRIORITY 3
Purpose of Action	LEVEL 2
Deficiency Photo1

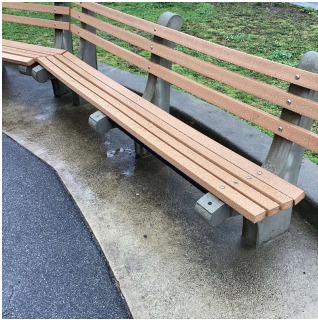
Violations	Schoolyard - Northeast No violations recorded.
<b>Bleachers</b>	Does not Exist
<b>SITE WALLS (NOT RETAINING WALLS)</b>	Does not Exist
