NYC Department of Education
Building Condition Assessment Survey 2023 - 2024

Architectural Inspection

Asset: P.S. 195 - BROOKLYN, 131 IRWIN STREET, New York, 11235

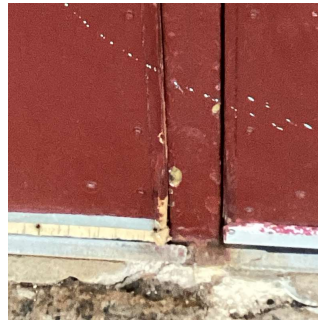
Facade A

METAL CLAD: DETERIORATED DOOR AND FRAME - MAJOR DETERIORATION

Deficiency Quantity	4
Quantity Uom	EACH
Potential Action	REPLACE
Urgency of Action	PRIORITY 4
Purpose of Action	LEVEL 2
Deficiency Photo1

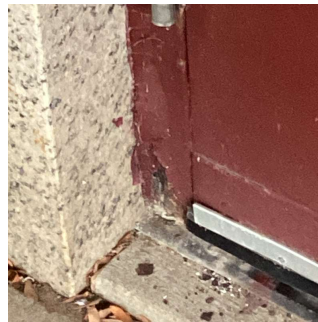
Facade A

Deficiency METAL: DETERIORATED DOOR AND FRAME - MAJOR DETERIORATION

Deficiency Quantity	10
Quantity Uom	EACH
Potential Action	REPLACE
Urgency of Action	PRIORITY 4
Purpose of Action	LEVEL 2
Deficiency Photo1

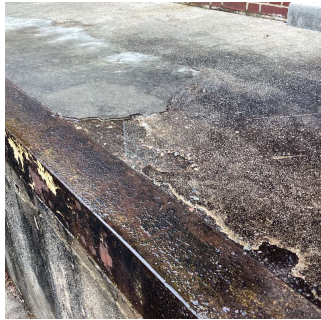
Violations	Loading Dock No violations recorded.
Deficiency	CHEEK WALL/CRACKS, SPALLING - MAJOR

40
S.F.
REPLACE
PRIORITY 4
LEVEL 2

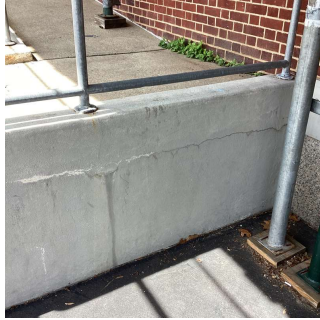
ROOF/GRAVITY TANK	Does not Exist
STAIRS/RAMPS: EXTERIOR	Inspected
BUILDING CHEEK/FLANK WALLS	Inspected
Condition	3 - Fair
Deficiency	CAST IN PLACE CONCRETE: CRACKS/SPALLING - MINOR
Roof Plan reference	K195

Violations	Facade J - Exit 6 No violations recorded.
RAILINGS	
Condition	Inspected 4 - Between Fair and Poor
Deficiency	RUST - MAJOR
Roof Plan reference	K195

Deficiency Quantity	60
Quantity Uom	S.F.

Question	Response
EXTERIOR	
STAIRS/RAMPS: EXTERIOR	
BUILDING CHEEK/FLANK WALLS	
Potential Action	REPAIR
Urgency of Action	PRIORITY 3
Purpose of Action	LEVEL 2
Deficiency Photo1

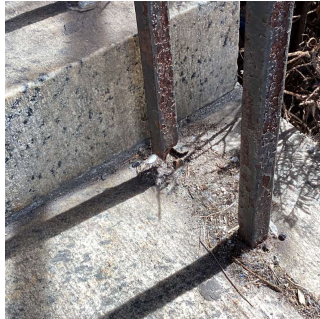
Violations	Facade A - Main Entrance No violations recorded.
STAIRS/RAMPS	
Condition	Inspected 4 - Between Fair and Poor
Deficiency	CONCRETE: CRACKS/SPALLING - MINOR

Deficiency Quantity	20
Quantity Uom	L.F.
Potential Action	REPLACE
Urgency of Action	PRIORITY 4
Purpose of Action	LEVEL 2
Deficiency Photo1

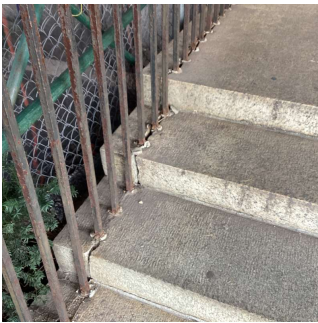
STONE: CRACKS/SPALLING - MAJOR

Violations	Facade A - Main Entrance No violations recorded.
WINDOWS	Inspected
Replacement Quantity	6,900
Replacement Uom	S.F.
EXTERIOR GUARDS	Inspected
Condition	5 - Poor
Deficiency	RUST - MAJOR
Roof Plan reference	K195
Elevation

20
 S.F.
 REPLACE
 PRIORITY 4
 LEVEL 2

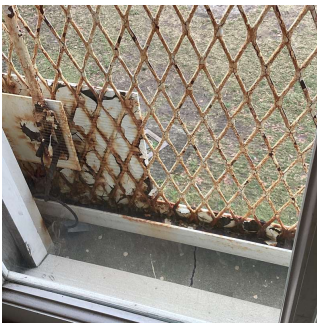
Violations	Facade D No violations recorded.
LINTELS	Inaccessible
WINDOWS	Inspected
Material Type(s)	Solid Wood, Steel
Instance on Wood: 1992 Addition	Inspected
Instance Condition	5 - Poor
Instance Quantity	2,500
Instance Quantity Uom	S.F.
Are these windows insulated	No
Installation Year	1992
Source of Installation	Custodial Staff
Deficiency	WOOD: DETERIORATED
Roof Plan reference	K195
Elevation

Deficiency Quantity	800
Quantity Uom	S.F.
Potential Action	REPLACE
Urgency of Action	PRIORITY 4
Purpose of Action	LEVEL 2

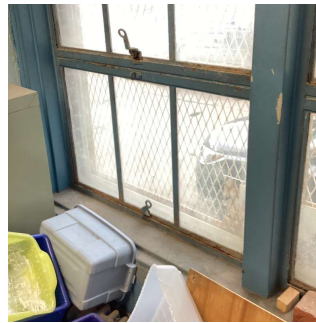
Facade E - Boiler Room

STEEL: DETERIORATED

REPLACE WINDOW

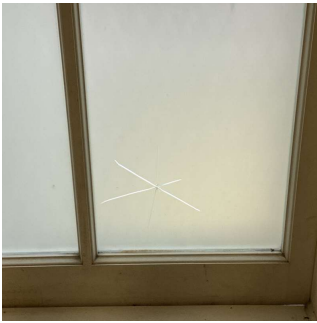
Deficiency	WOOD: BROKEN PANE
------------	-------------------

Violations	Facade A - Room 120 No violations recorded.
INTERIOR	
POOLS	Does not Exist
STRUCTURAL	Inspected
COLUMNS/BEAMS/BEARING WALLS	Inspected
Condition	3 - Fair
Deficiency	STEEL COLUMNS/BEAMS: DETERIORATED CONCRETE FIREPROOFING
Deficiency Location/Instance	Basement
Deficiency Quantity	20
Quantity Uom	S.F.
Potential Action	REPLACE
Urgency of Action	PRIORITY 3
Purpose of Action	LEVEL 5
Deficiency Photo1

Deficiency Quantity	60
Quantity Uom	S.F.
Potential Action	MAINTENANCE
Urgency of Action	PRIORITY 3
Purpose of Action	LEVEL 2

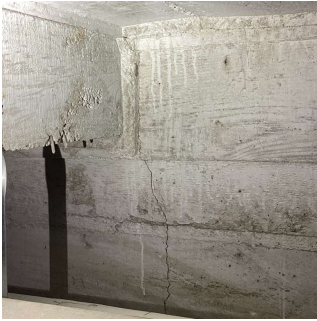
Violations	Crawl Space No violations recorded.
Deficiency	STEEL COLUMNS/BEAMS: DETERIORATED/MISSING SPRAY-ON FIREPROOFING
Deficiency Location/Instance	1st Floor
Deficiency Quantity	30
Quantity Uom	S.F.
Potential Action	REPLACE
Urgency of Action	PRIORITY 4
Purpose of Action	LEVEL 5

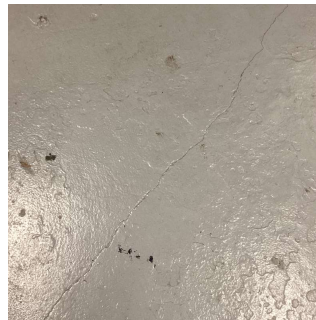
Boiler Room (Crawl Space similar)

CONCRETE SLAB ON GRADE: THRU CRACKS

REPAIR

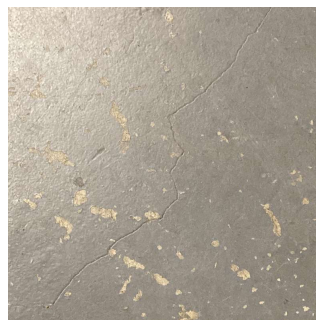
CONCRETE: CRACKS/SPALLED/REINFORCEMENT EXPOSED

REPAIR

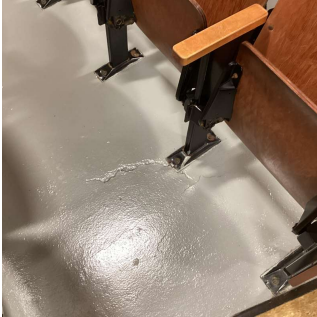
Question	Response
INTERIOR	
AUDITORIUM	
Floor Finish	
Deficiency Location/Instance	Seat D/2
Deficiency Quantity	15
Quantity Uom	S.F.
Potential Action	REPLACE
Urgency of Action	PRIORITY 3
Purpose of Action	LEVEL 2
Deficiency Photo1

Violations	Seat D/2 No violations recorded.
Sliding-folding Partition	
Instance on 1st Floor	Does not Exist
Stage	
Instance on 1st Floor	Inspected
Stage	Inspected
Instance on 1st Floor	Inspected
Condition	2 - Between Good and Fair
Deficiency	No deficiencies recorded
Stage Curtain Rigging	
Instance on 1st Floor	Inspected
Condition	2 - Between Good and Fair
Deficiency	No deficiencies recorded
Stage Curtains	
Instance on 1st Floor	Inspected
Condition	3 - Fair
Deficiency	WORN/DETERIORATED
Deficiency Location/Instance	Left Side
Deficiency Quantity	100
Quantity Uom	S.F.
Potential Action	REPLACE
Urgency of Action	PRIORITY 3
Purpose of Action	LEVEL 2

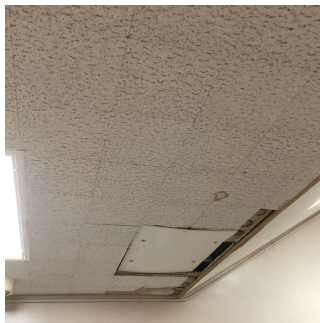
Violations	Right Side No violations recorded.
Sliding-folding Partition	
Instance on 1st Floor	Does not Exist
Stage	
Instance on 1st Floor	Does not Exist
Walls	
Instance on 1st Floor	Inspected
Condition	2 - Between Good and Fair
Deficiency	No deficiencies recorded
Window Curtains/Shades/Blinds	
Instance on 1st Floor	Does not Exist
CLASSROOMS/CORRIDORS/ADMIN SPACES	
Ceiling	
Instance on 1st Floor	Inspected
Condition	2 - Between Good and Fair
Deficiency	ACOUSTIC TILES ON PLASTER: DAMAGED/MISSING
Deficiency Location/Instance	Corridor near room 139A

Violations	Corridor near room 139A No violations recorded.
Door(s)	Inspected
Condition	5 - Poor
Deficiency	WOOD: DETERIORATED DOOR
Deficiency Location/Instance	Rooms 135A, 127, 110, Exit 8 (2 Doors), Main Entrance Vestibule (2 Doors)
Deficiency Quantity	7
Quantity Uom	EACH
Potential Action	MAINTENANCE
Urgency of Action	PRIORITY 3
Purpose of Action	LEVEL 2
Deficiency Photo1

Deficiency Quantity	15
Quantity Uom	S.F.
Potential Action	REPLACE
Urgency of Action	PRIORITY 3
Purpose of Action	LEVEL 2

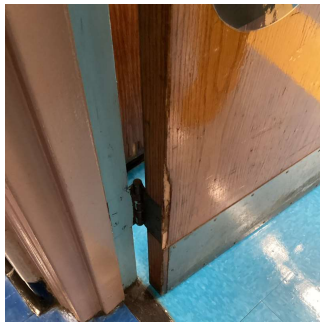
Violations	Room 135A No violations recorded.
Floor Finish	Inspected
Condition	2 - Between Good and Fair
Deficiency	TERRAZZO: CRACKS
Deficiency Location/Instance	Exit 8, Main Entrance Vestibule
Deficiency Quantity	15
Quantity Uom	S.F.
Potential Action	REPLACE
Urgency of Action	PRIORITY 3
Purpose of Action	LEVEL 2

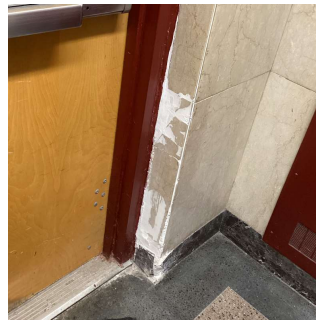
Main Entrance Vestibule

STONE: CRACKS/SPALLING

REPLACE

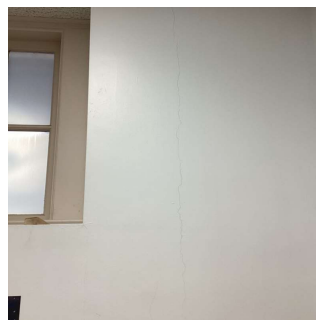
GYPSON BOARD: DETERIORATED

REPLACE

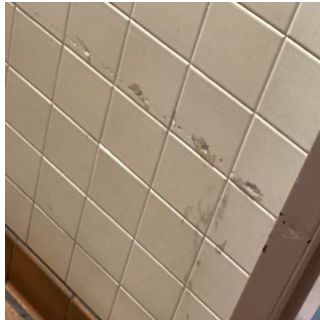
Question	Response
INTERIOR	
GYMNASIUM	
Walls	
Condition	2 - Between Good and Fair
Deficiency	No deficiencies recorded
Window Curtains/Shades/Blinds	
Instance on 2nd Floor	Does not Exist
INTERIOR DOOR HARDWARE	
Condition	Inspected
Deficiency	3 - Fair
Deficiency	No deficiencies recorded
INTERIOR GUARDS	
Condition	Inspected
Deficiency	2 - Between Good and Fair
Deficiency	No deficiencies recorded
KITCHEN	
Instance on 1st Floor	Inspected
Ceiling	
Instance on 1st Floor	Inspected
Condition	2 - Between Good and Fair
Deficiency	No deficiencies recorded
Door(s)	
Instance on 1st Floor	Inspected
Condition	2 - Between Good and Fair
Deficiency	No deficiencies recorded
Floor Finish	
Instance on 1st Floor	Inspected
Condition	2 - Between Good and Fair
Deficiency	No deficiencies recorded
Walls	
Instance on 1st Floor	Inspected
Condition	2 - Between Good and Fair
Deficiency	CERAMIC TILE: BROKEN/ MISSING
Deficiency Location/Instance	Near servery, by the windows

Near the servery
Violations	No violations recorded.
LIBRARY	
Instance on Room 116	Inspected
	Inspected

Deficiency Quantity	20
Quantity Uom	S.F.
Potential Action	REPLACE
Urgency of Action	PRIORITY 3
Purpose of Action	LEVEL 2
Deficiency Photo1

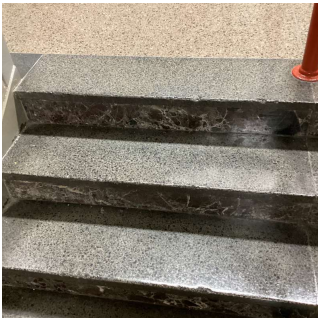
Question	Response
INTERIOR	
STAIRS/RAMPS: INTERIOR	
Door(s)	Inspected
Deficiency	No deficiencies recorded
Partition	Does not Exist
Railings	Inspected
Condition	2 - Between Good and Fair
Deficiency	No deficiencies recorded
Stairs and Landings	Inspected
Condition	3 - Fair
Deficiency	TERRAZZO: CRACKS
Deficiency Location/Instance	Stair A/1
Deficiency Quantity	40
Quantity Uom	S.F.
Potential Action	REPLACE
Urgency of Action	PRIORITY 3
Purpose of Action	LEVEL 2
Deficiency Photo1

Violations	Stair A/1 No violations recorded.
Deficiency	STONE: BROKEN/MISSING
Deficiency Location/Instance	Stair C/1, 2, B/1, Main Entrance Vestibule
Deficiency Quantity	50
Quantity Uom	S.F.
Potential Action	REPLACE
Urgency of Action	PRIORITY 3
Purpose of Action	LEVEL 2
Deficiency Photo1

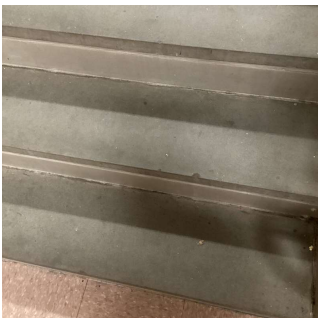
Violations	Stair C/1 No violations recorded.
Deficiency	VINYL TILES: DETERIORATED SUBSTRATE
Deficiency Location/Instance	Exit 5
Deficiency Quantity	10
Quantity Uom	S.F.

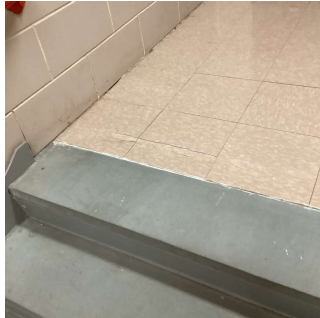
Exit 5
Violations	No violations recorded.
Walls	Inspected
Condition	2 - Between Good and Fair
Deficiency	STONE: CRACKS/SPALLING
Deficiency Location/Instance	Stairs A/1 Vestibule, B/1 Vestibule
Deficiency Quantity	20
Quantity Uom	S.F.
Potential Action	REPLACE
Urgency of Action	PRIORITY 3
Purpose of Action	LEVEL 2
Deficiency Photo1

Question	Response
INTERIOR	
STAIRS/RAMPS: INTERIOR	
Stairs and Landings	
Potential Action	REPLACE
Urgency of Action	PRIORITY 3
Purpose of Action	LEVEL 2
Deficiency Photo1

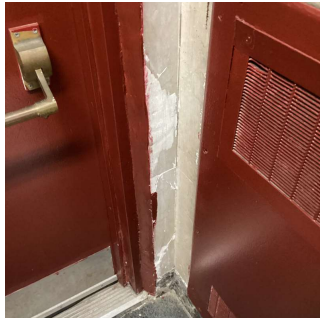
Stair B/1 Vestibule
Violations	No violations recorded.
TOILET ROOMS - STAFF	
	Inspected
Ceiling	Inspected
Condition	2 - Between Good and Fair
Deficiency	No deficiencies recorded
Door(s)	Inspected
Condition	5 - Poor
Deficiency	WOOD: DETERIORATED DOOR
Deficiency Location/Instance	Room 120
Deficiency Quantity	1
Quantity Uom	EACH
Potential Action	MAINTENANCE
Urgency of Action	PRIORITY 3
Purpose of Action	LEVEL 2

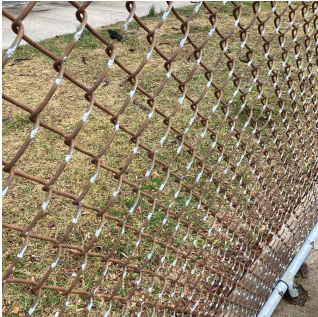
Schoolyard
Violations	No violations recorded.
Deficiency	CHAIN LINK: RUST - MAJOR
Deficiency Location/Instance	Schoolyard
Deficiency Quantity	1,500
Quantity Uom	S.F.
Potential Action	REPLACE
Urgency of Action	PRIORITY 3
Purpose of Action	LEVEL 2
Deficiency Photo1

Schoolyard
Violations	No violations recorded.
IRRIGATION SYSTEM	Does not Exist
PAVING	Inspected
Student Non-Use	Inspected
Gravel Exists?	No
Asphalt	Inspected
Condition	3 - Fair
Deficiency	CRACKS - MAJOR
Deficiency Location/Instance	Near Parking Lot
Deficiency Quantity	150
Quantity Uom	S.F.
Potential Action	REPLACE
Urgency of Action	PRIORITY 3

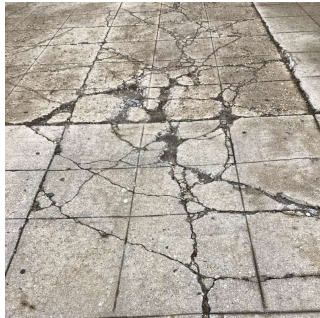
Violations	Near Parking Lot No violations recorded.
Concrete	
Condition	Inspected 4 - Between Fair and Poor
Deficiency	CRACKS - MAJOR
Deficiency Location/Instance	Parking Lot
Deficiency Quantity	800
Quantity Uom	S.F.
Potential Action	REPLACE
Urgency of Action	PRIORITY 3
Purpose of Action	LEVEL 2
Deficiency Photo1

Violations	Parking Lot No violations recorded.
Pavers	
	Does not Exist
Student Use	
Gravel Exists?	Inspected No
Asphalt	
Condition	Inspected 4 - Between Fair and Poor
Deficiency	CRACKS - MAJOR
Deficiency Location/Instance	Schoolyard
Deficiency Quantity	1,500
Quantity Uom	S.F.
Potential Action	REPLACE
Urgency of Action	PRIORITY 3
Purpose of Action	LEVEL 2

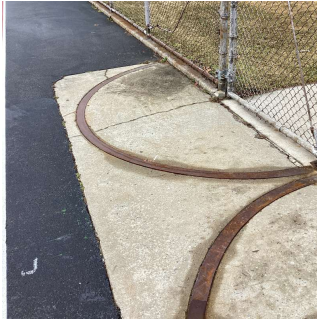
Violations	Schoolyard No violations recorded.
Concrete	Inspected
Condition	3 - Fair
Deficiency	CRACKS - MAJOR
Deficiency Location/Instance	Schoolyard
Deficiency Quantity	50
Quantity Uom	S.F.
Potential Action	REPLACE
Urgency of Action	PRIORITY 3
Purpose of Action	LEVEL 2
Deficiency Photo1

Violations	Schoolyard No violations recorded.
Pavers	Does not Exist
Site Sidewalks & Walkways	Inspected
Asphalt	Does not Exist
Concrete	Inspected
Condition	3 - Fair
Deficiency	HEAVING
Deficiency Location/Instance	Near Exit 9
Deficiency Quantity	25
Quantity Uom	S.F.
Potential Action	REPLACE
Urgency of Action	PRIORITY 3
Purpose of Action	LEVEL 2

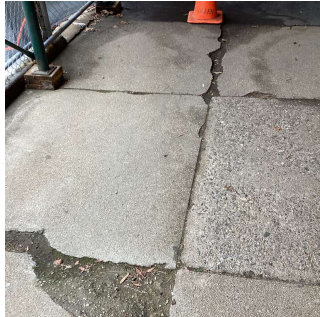
Violations	Near Exit 9 No violations recorded.
Deficiency	CRACKS - MAJOR
Deficiency Location/Instance	Near Exit 8
Deficiency Quantity	125
Quantity Uom	S.F.
Potential Action	REPLACE
Urgency of Action	PRIORITY 3
Purpose of Action	LEVEL 2
Deficiency Photo1

Violations	Near Exit 8 No violations recorded.
Pavers	Does not Exist
DOT Sidewalk	Inspected
Asphalt	Does not Exist
Concrete	Inspected
Condition	4 - Between Fair and Poor
Deficiency	HEAVING
Deficiency Location/Instance	Irwin Street, Shore Boulevard, Jaffray Street
Deficiency Quantity	150
Quantity Uom	S.F.
Potential Action	REPLACE
Urgency of Action	PRIORITY 3
Purpose of Action	LEVEL 2
