NYC Department of Education
Building Condition Assessment Survey 2023 - 2024

Architectural Inspection

Asset: P.S. 197 - BROOKLYN, 1599 EAST 22 STREET, New York, 11210

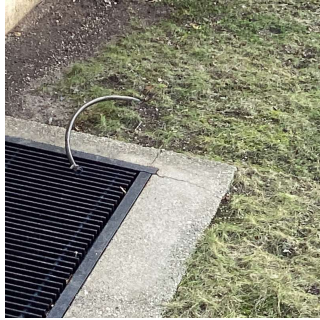
| Question | Response |
|---|---|
| Deficiency | AREAWAY WALLS: CRACKS AND SPALLING |

| Potential Action | REPAIR |

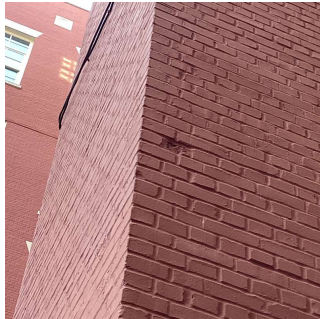
| Question | Response |
|---|--|
| Violations | CH2 No violations recorded. |

| Question | Response |
|---|--|
| Deficiency | BRICK: MINOR CRACKS AND SPALLING |

| Question | Response |
|---|--|
| Urgency of Action | PRIORITY 3 |

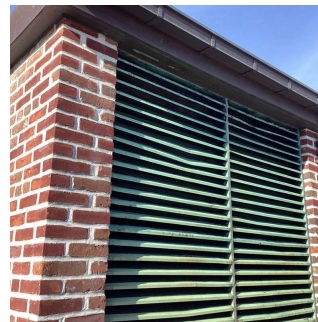
Roof 1 - RV

BROKEN/ DENTED BLADES

REPLACE

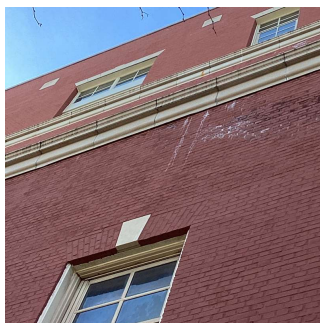
| Question | Response |
|---|---|
| Violations | Facade G No violations recorded. |

| Question | Response |
|---|---|
| Deficiency | BRICK: EFFLORESCENCE |

| Question | Response |
|---|---|
| Urgency of Action | PRIORITY 1 |

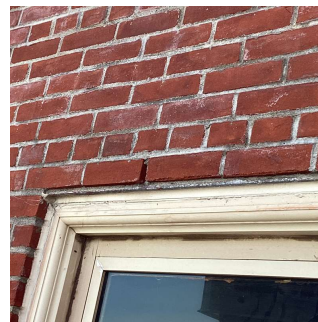
Roof 1 - BH1

**BULKHEAD/PENTHOUSE WALLS/EXTERIOR: DETERIORATED
JOINTS**

10
 S.F.
 REPOINT
 PRIORITY 4
 LEVEL 2

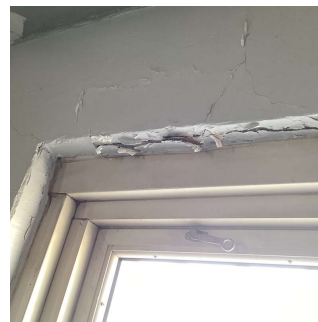
Roof 1 - BH1

**BULKHEAD/PENTHOUSE WINDOWS: AIR/WATER
INFILTRATION WITH DAMAGED TRIM OR SILLS**

30
L.F.
MAINTENANCE
PRIORITY 3
LEVEL 2

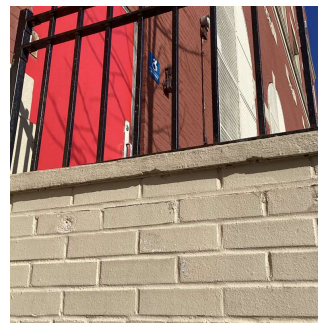
Facade H - HC Ramp
No violations recorded.

BRICK: DETERIORATED COPING STONE

10
S.F.
REPAIR
PRIORITY 3
LEVEL 2

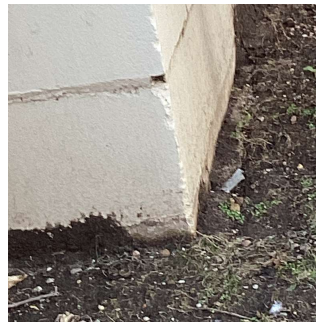
Facade A - Main Entrance

STONE: CRACKS/SPALLING - MINOR

10
S.F.
REPAIR
PRIORITY 3
LEVEL 2

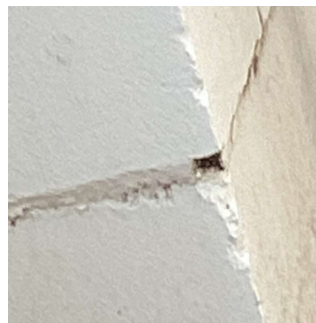
Facade A - Main Entrance

STONE: DETERIORATED JOINTS

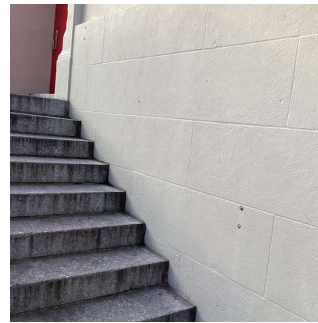
Facade C - Exit 4

MISSING RAILING

20
L.F.
REPLACE
PRIORITY 5
LEVEL 6

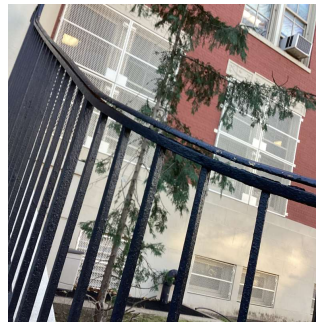
Facade A - Main Entrance

DAMAGED

60
L.F.
REPLACE
PRIORITY 4
LEVEL 2

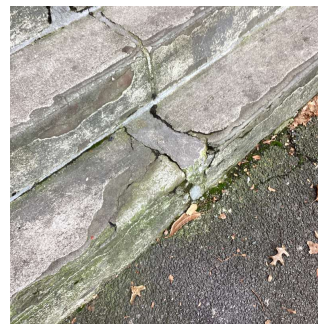
Facade E - Exit 7

CONCRETE: WORN-OUT TREAD/RISER/NOSING

40
 S.F.
 REPLACE
 PRIORITY 4
 LEVEL 2

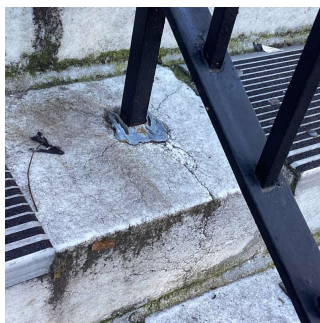
| Question | Response |
|---|---|
| Violations | Facade A - Main Entrance No violations recorded. |

| Question | Response |
|---|---|
| Deficiency | STONE: CRACKS/SPALLING - MINOR |

| Question | Response |
|---|---|
| Potential Action | REPAIR |

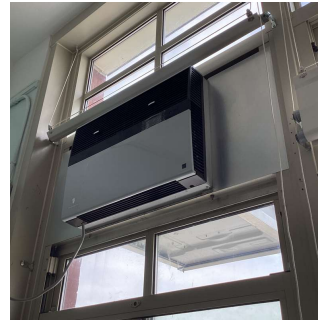
| Question | Response |
|--|---|
| Deficiency | ALUMINUM - DOUBLE HUNG: AIR/WATER INFILTRATION, DETERIORATED JOINTS WITH DAMAGED CAULKING |

Facade B - Room 503 shown, Facade D - Room 204 similar (Sheet metal panels not sealed around A/C units)

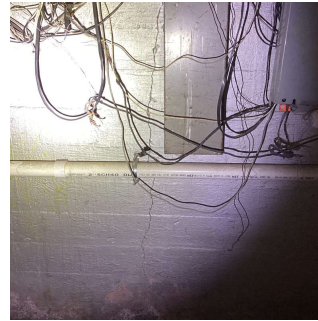
Basement - Corridor near Crawlspace

| Question | Response |
|---|--|
| Deficiency | CONCRETE: CRACKED/SPALLED/REINFORCEMENT EXPOSED |
