**NYC Department of Education**  
**Building Condition Assessment Survey 2023 - 2024**

Architectural Inspection

**Asset: P.S. 200 - BROOKLYN, 1940 BENSON AVENUE, New York, 11214**

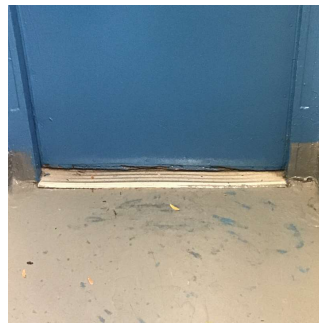
Question	Response
<b>EXTERIOR</b>	
<b>CHIMNEY</b>	
Condition	2 - Between Good and Fair
Deficiency	No deficiencies recorded
<b>COPING</b>	Inspected
Condition	1 - Good
Deficiency	No deficiencies recorded
<b>CORNICE</b>	Inspected
Condition	2 - Between Good and Fair
Deficiency	No deficiencies recorded
<b>DOORS</b>	Inspected
<b>DOORS AND FRAMES</b>	Inspected
Condition	4 - Between Fair and Poor
Deficiency	METAL CLAD: DETERIORATED DOOR - MAJOR DETERIORATION
Roof Plan reference

Violations	Facade G - Exit 8 No violations recorded.
Deficiency	METAL: DETERIORATED DOOR AND FRAME - MINOR DETERIORATION

Deficiency Quantity	1
Quantity Uom	EACH
Potential Action	REPLACE
Urgency of Action	PRIORITY 4
Purpose of Action	LEVEL 2
Deficiency Photo1

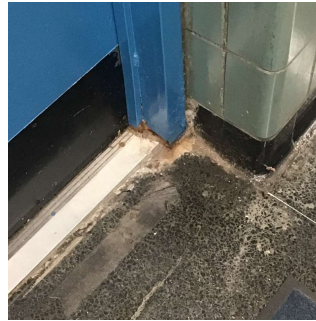
Facade A - Exit 2

**METAL CLAD: DETERIORATED DOOR AND FRAME - MINOR DETERIORATION**

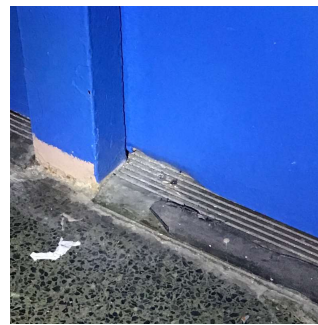
Facade H - Exit 6

**METAL: DETERIORATED DOOR - MAJOR DETERIORATION**

1  
EACH  
REPLACE  
PRIORITY 4  
LEVEL 2

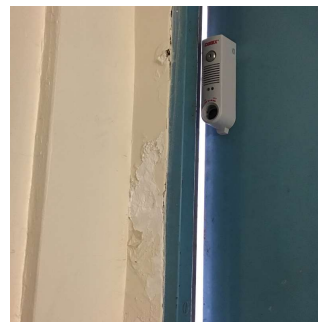
BH2  
No violations recorded.

Instance Quantity Uom	S.F.
<b>ROOFING DRAINS</b>	Inspected
Condition	1 - Good
Deficiency	No deficiencies recorded
<b>Specialties</b>	Inspected
<b>BULKHEAD/PENTHOUSE</b>	Inspected
Condition	3 - Fair
Deficiency	BULKHEAD/PENTHOUSE WALLS/INTERIOR: PLASTER CRACKS/SPALLING

10  
S.F.  
REPLACE  
PRIORITY 3  
LEVEL 2

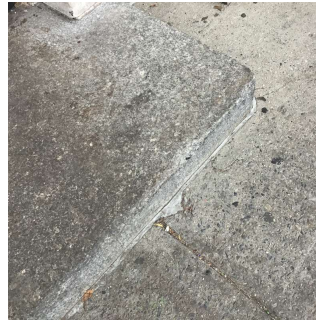
Facade C - Exit 10

STONE: CRACKS/SPALLING - MINOR

REPAIR

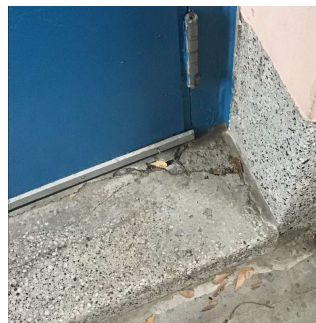
Facade A - Exit 2

**CONCRETE: CRACKS/SPALLING - MAJOR**

REPLACE

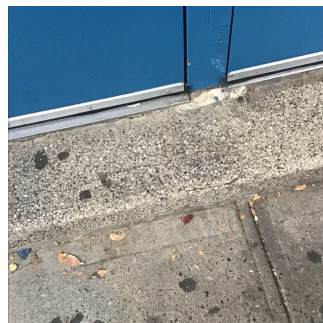
**CONCRETE: CRACKS/SPALLING - MINOR**

Violations	Facade A - Main Entrance No violations recorded.
<b>WINDOWS</b>	Inspected
Replacement Quantity	18,000
Replacement Uom	S.F.
<b>EXTERIOR GUARDS</b>	Inspected
Condition	2 - Between Good and Fair
Deficiency	No deficiencies recorded
<b>LINTELS</b>	Inspected
Condition	2 - Between Good and Fair
Deficiency	No deficiencies recorded
<b>WINDOWS</b>	Inspected
Material Type(s)	Aluminum
Instance on Aluminum - Double Hung: All Facades	Inspected
Instance Condition	3 - Fair
Instance Quantity	18,000
Instance Quantity Uom	S.F.
Are these windows insulated	No
Installation Year	1999
Source of Installation	Custodial Staff
Deficiency	ALUMINUM - DOUBLE HUNG: INOPERABLE BALANCE

Deficiency Quantity	10
Quantity Uom	S.F.
Potential Action	REPAIR
Urgency of Action	PRIORITY 3
Purpose of Action	LEVEL 2
Deficiency Photo1

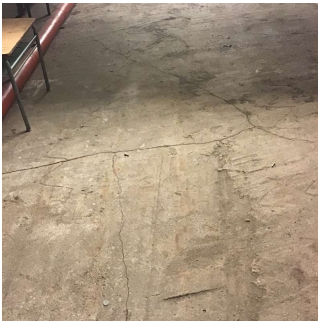
<p>Boiler Room</p> <p>No violations recorded.</p>
<b>FLOOR STRUCTURE</b>	
Condition	Inspected
Condition	3 - Fair
Deficiency Deficiency Location/Instance Deficiency Quantity Quantity Uom Potential Action Urgency of Action Purpose of Action	<p><b>CONCRETE SLAB ON GRADE: THRU CRACKS</b></p> <p>Basement - Crawlspace North, Mechanical Equipment Room North</p> <p>300</p> <p>S.F.</p> <p>REPAIR</p> <p>PRIORITY 3</p> <p>LEVEL 5</p>

Crawlspace North
Violations	No violations recorded.
Deficiency	CONCRETE: CRACKS/SPALLED/REINFORCEMENT EXPOSED
Deficiency Location/Instance	Basement - Boiler Room, South Side Storage Area, Mechanical Equipment Room North
Deficiency Quantity	50
Quantity Uom	S.F.
Potential Action	REPAIR
Urgency of Action	PRIORITY 4
Purpose of Action	LEVEL 5
Deficiency Photo1

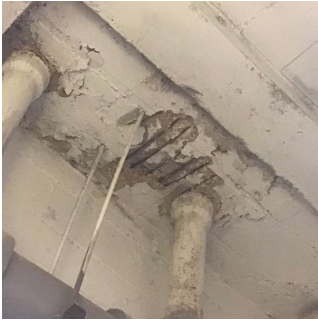
Basement - South Side Storage Area
Violations	No violations recorded.
<b>FOUNDATION WALLS</b>	
	Inspected
Material Type(s)	Concrete, Masonry
Condition	5 - Poor
Deficiency	CONCRETE: CRACKED/SPALLED/REINFORCEMENT EXPOSED
Deficiency Location/Instance	Basement - Boiler Room, Crawlspace North
Deficiency Quantity	30
Quantity Uom	S.F.
Potential Action	REPAIR
Urgency of Action	PRIORITY 3
Purpose of Action	LEVEL 5

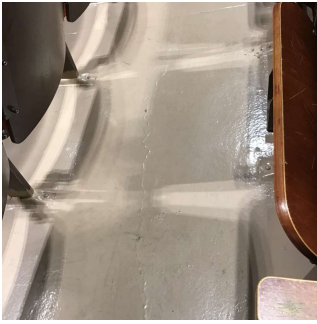
Near H Row
Violations	No violations recorded.
<b>Sliding-folding Partition</b>	
Instance on 1st Floor (549 Seats)	Does not Exist
<b>Stage</b>	
Instance on 1st Floor (549 Seats)	Inspected
<b>Stage</b>	
Instance on 1st Floor (549 Seats)	Inspected
Condition	2 - Between Good and Fair
Deficiency	No deficiencies recorded
<b>Stage Curtain Rigging</b>	
Instance on 1st Floor (549 Seats)	Inspected
Condition	2 - Between Good and Fair
Deficiency	No deficiencies recorded
<b>Stage Curtains</b>

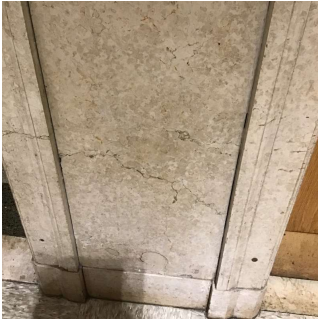
Near Main Entrance
Violations	No violations recorded.
Deficiency	STONE MOLDINGS: CRACKS/SPALLING
Deficiency Location/Instance	Near Main Entrance, Next to Exit 8, By Stage

Deficiency Quantity	100
Quantity Uom	L.F.
Potential Action	REPLACE
Urgency of Action	PRIORITY 3

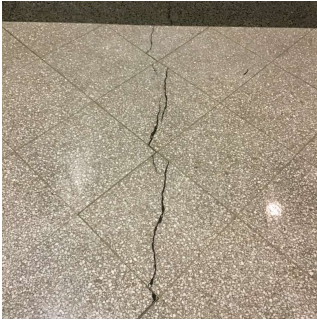
Violations	Corridor near Room 103 No violations recorded.
Deficiency	VINYL TILES: BROKEN/DETERIORATED/MISSING TILES
Deficiency Location/Instance	Rooms 430,427, Corridors on 4th,3rd,2nd Floor and others
Deficiency Quantity	5,000
Quantity Uom	S.F.
Potential Action	REPLACE
Urgency of Action	PRIORITY 3
Purpose of Action	LEVEL 2
Deficiency Photo1

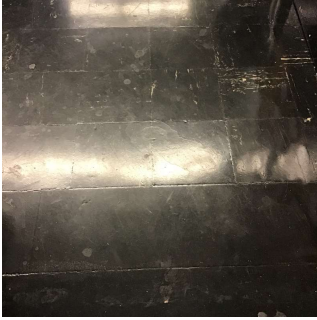
Violations	Room 430 No violations recorded.
Deficiency	VINYL TILES: DETERIORATED SUBSTRATE
Deficiency Location/Instance	Rooms 432,421,415,413,403 and others

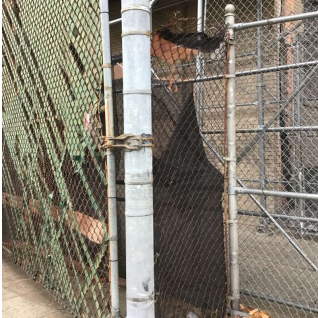
Violations	Bay 23rd Street No violations recorded.
Deficiency	CHAIN LINK: RUST - MAJOR
Deficiency Location/Instance	Bay 23rd Street
Deficiency Quantity	200
Quantity Uom	S.F.
Potential Action	REPLACE
Urgency of Action	PRIORITY 3
Purpose of Action	LEVEL 2
Deficiency Photo1
