NYC Department of Education
Building Condition Assessment Survey 2023 - 2024

Architectural Inspection

Asset: P.S. 207 - BROOKLYN, 4011 FILLMORE AVENUE, New York, 11234

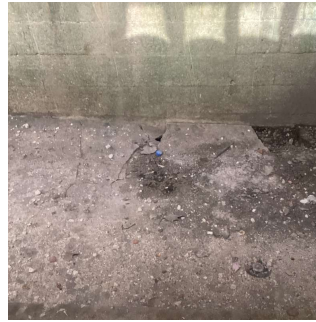
AREAWAY SLAB: CRACKS AND SPALLING

REPLACE

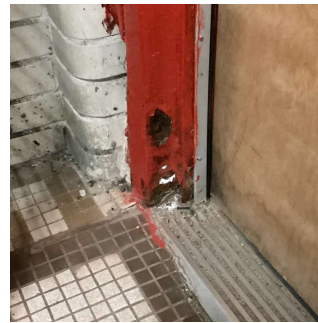
Facade C - Exit 3

METAL CLAD: DETERIORATED DOOR AND FRAME - MAJOR DETERIORATION

REPLACE

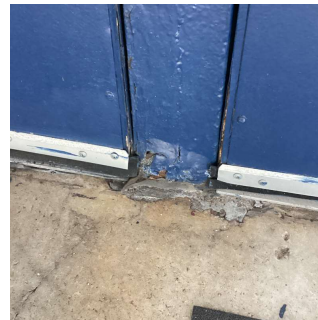
Facade A - Main Entrance

METAL CLAD: DETERIORATED DOOR AND FRAME - MINOR DETERIORATION

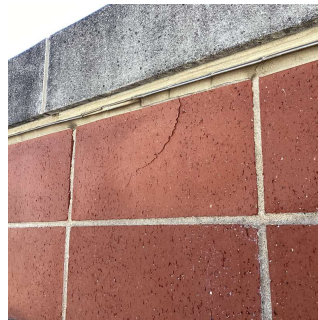
Facade A

Replacement Quantity	7,000
Replacement Uom	C.F.
Instance on All Facades	Inspected
Instance Condition	3 - Fair
Instance Quantity	7,000
Instance Quantity Uom	C.F.
Deficiency	CONCRETE MASONRY UNITS: MINOR CRACKS, SPALLING
Roof Plan reference	K207

10
 S.F.
 REPAIR
 PRIORITY 3
 LEVEL 2

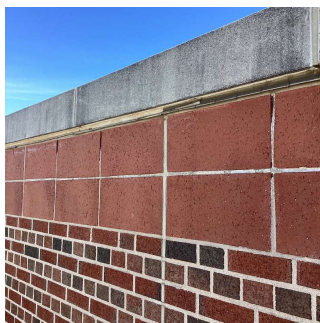
Violations	Facade E No violations recorded.
Deficiency	CONCRETE MASONRY UNITS: DETERIORATED JOINTS
Roof Plan reference	K207

Deficiency Quantity	50
Quantity Uom	S.F.
Potential Action	REPOINT
Urgency of Action	PRIORITY 3
Purpose of Action	LEVEL 2
Deficiency Photo1

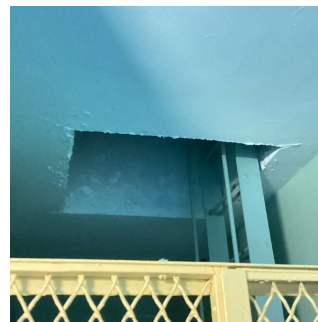
RH - Stair I (Non-instructional space)

Violations	Facade D No violations recorded.
PLAZA DECK	Does not Exist
ROOF	Inspected
Roofing	Inspected
Replacement Quantity	24,000
Replacement Uom	S.F.
ROOF HATCH/SMOKE HATCH	Inspected
Condition	5 - Poor
Deficiency	WATER INFILTRATION

1
EACH
REPAIR
PRIORITY 5
LEVEL 2

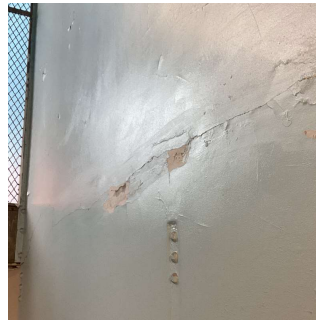
BH2

BULKHEAD/PENTHOUSE WALLS/INTERIOR: PLASTER
CRACKS/SPALLING

REPLACE

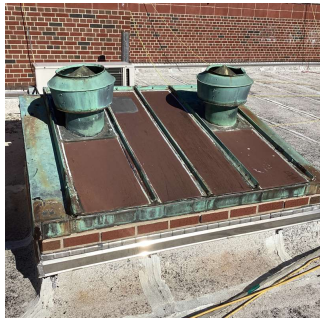
Violations	BH2 No violations recorded.
CUPOLA/ SPIRES/ TOWERS	Does not Exist
DORMER	Does not Exist
DUNNAGE STEEL	Does not Exist
SKYLIGHT/ROOF VENT	Inspected
Material Type(s)	Glass
Condition	3 - Fair
Deficiency	BROKEN GLASS
Roof Plan reference	K207

Deficiency Quantity	40
Quantity Uom	S.F.
Potential Action	MAINTENANCE
Urgency of Action	PRIORITY 3
Purpose of Action	LEVEL 2
Deficiency Photo1

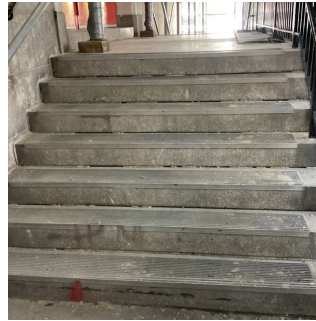
Facade C - Exit 3

Deficiency	STONE: DETERIORATED JOINTS
------------	----------------------------

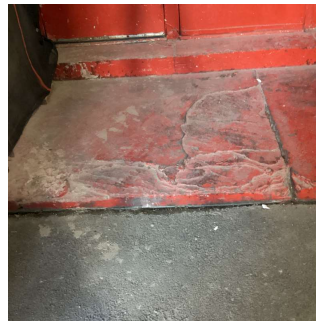
Facade E - Exit 4

STONE: CRACKS/SPALLING - MAJOR

REPLACE

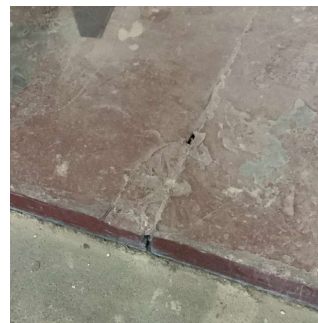
Facade E - Exit 5

STONE: DETERIORATED JOINTS

10
L.F.
REPOINT
PRIORITY 3
LEVEL 2

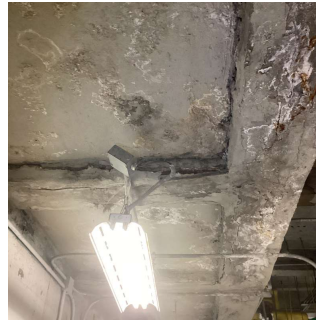
Basement - Under Main Entrance Stairs

STONE: WATER INFILTRATION IN NON-INSTRUCTIONAL SPACE BELOW

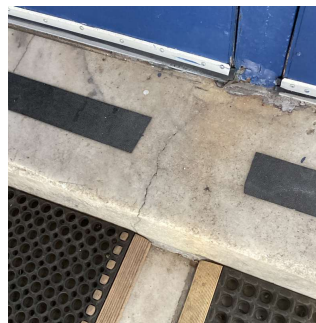
Facade A - Main Entrance

STONE: CRACKS/SPALLING - MINOR

REPAIR

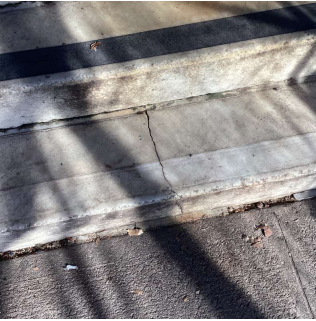
STONE: CRACKS/SPALLING - MAJOR

Deficiency Quantity	10
Quantity Uom	S.F.
Potential Action	REPLACE
Urgency of Action	PRIORITY 4
Purpose of Action	LEVEL 2
Deficiency Photo1

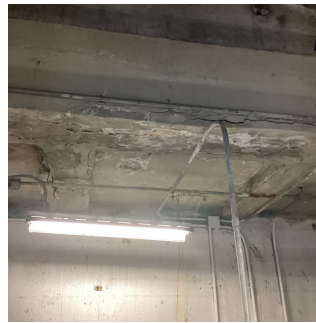
Basement - Under Main Entrance Stairs

Violations	Near Paint Storage Room No violations recorded.
Deficiency	STEEL COLUMNS/BEAMS: DETERIORATED CONCRETE FIREPROOFING
Deficiency Location/Instance	Basement - Under Main Entrance Stairs, North Side under Exit 6
Deficiency Quantity	80
Quantity Uom	S.F.
Potential Action	REPLACE
Urgency of Action	PRIORITY 5
Purpose of Action	LEVEL 6

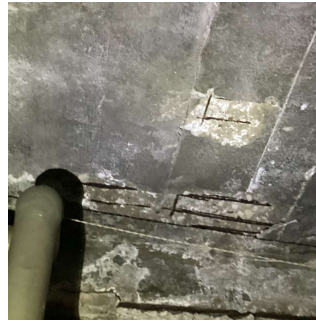
Basement - North Side

CONCRETE: CRACKS/SPALLED/REINFORCEMENT EXPOSED

REPAIR

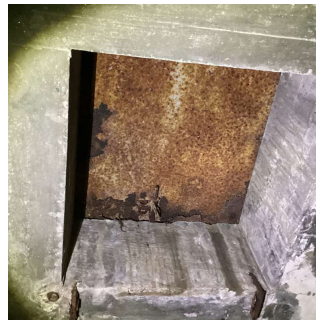
Ash Hoist Vault

DETERIORATED/DAMAGED VAULT/ASH HOIST DOORS AND FRAMING

REPLACE

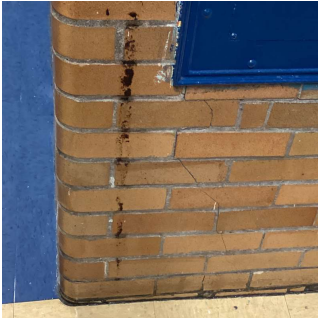
Question	Response
INTERIOR	
CAFETERIA	
Walls	
Deficiency	SALT GLAZED BRICK: CRACKS/SPALLING
Deficiency Location/Instance	Near the Electrical Panel
Deficiency Quantity	10
Quantity Uom	S.F.
Potential Action	REPLACE
Urgency of Action	PRIORITY 3
Purpose of Action	LEVEL 2
Deficiency Photo1

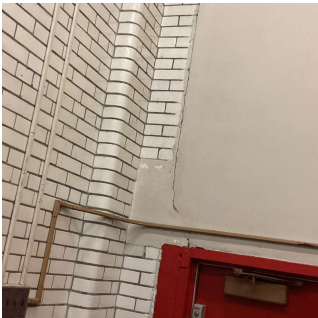
Near the Electrical Panel
Violations	No violations recorded.
Deficiency	PLASTER: CRACKS/SPALLING
Deficiency Location/Instance	Exit AB Vestibule
Deficiency Quantity	15
Quantity Uom	S.F.
Potential Action	REPLACE
Urgency of Action	PRIORITY 3
Purpose of Action	LEVEL 2
Deficiency Photo1

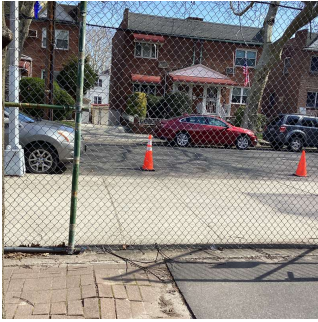
Violations	Schoolyard No violations recorded.
Deficiency	CHAIN LINK: DAMAGED POST/RAIL
Deficiency Location/Instance	Schoolyard
Deficiency Quantity	30
Quantity Uom	L.F.
Potential Action	REPLACE
Urgency of Action	PRIORITY 3
Purpose of Action	LEVEL 2
Deficiency Photo1

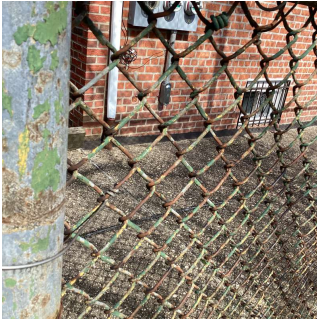
Violations	Schoolyard No violations recorded.
Deficiency	CHAIN LINK: RUST - MAJOR
Deficiency Location/Instance	Schoolyard
Deficiency Quantity	1,500
Quantity Uom	S.F.
Potential Action	REPLACE
Urgency of Action	PRIORITY 3
Purpose of Action	LEVEL 2
