NYC Department of Education
Building Condition Assessment Survey 2023 - 2024

Architectural Inspection

Asset: P.S. 208 - BROOKLYN, 4801 AVENUE D, New York, 11203

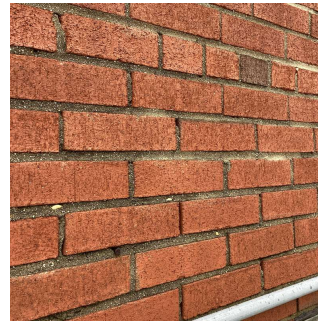
CH
No violations recorded.

BRICK: DETERIORATED JOINTS

20
S.F.
REPOINT
PRIORITY 3
LEVEL 2

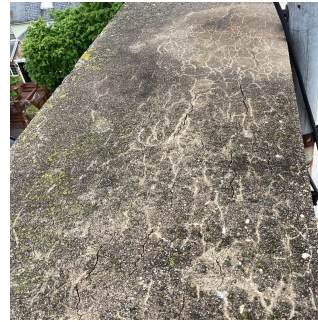
Roof 4

CAST STONE: DISINTEGRATING / FREEZE THAW

10
L.F.
REPLACE-IN-KIND
PRIORITY 4
LEVEL 2

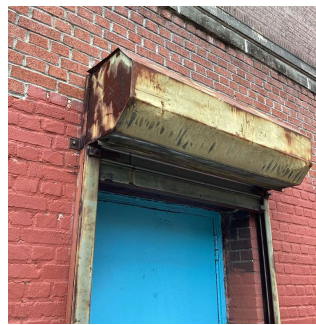
Violations	Facade F No violations recorded.
Deficiency	ROLL-UP DOOR: DETERIORATED DOOR AND FRAME - MAJOR DETERIORATION

300
S.F.
REPLACE
PRIORITY 4
LEVEL 2

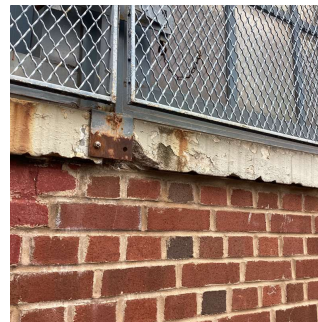
Facade D

Deficiency
 BRICK: DETERIORATED MASONRY SILLS - MAJOR

50

REMOVE AND REPLACE

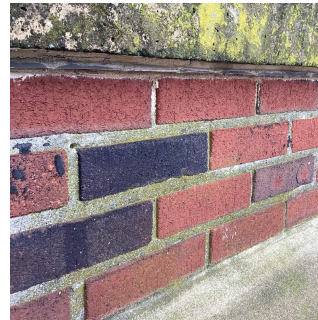
Roof 4

BRICK: DETERIORATED JOINTS

60

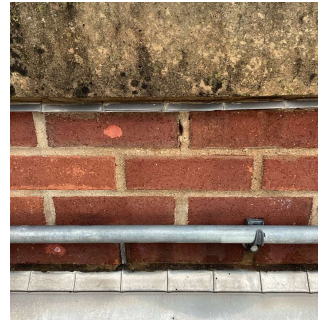
Roof 3

BRICK: DETERIORATED JOINTS

20

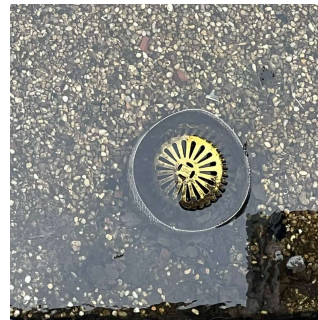
Roof 7
 No violations recorded.

1
 EACH
 MAINTENANCE
 PRIORITY 5
 LEVEL 2

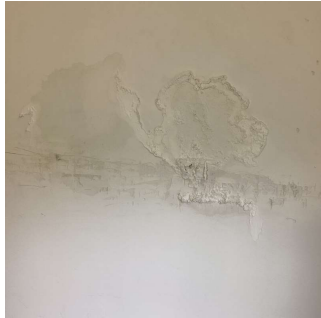
Violations	Roof 5 No violations recorded.
Specialties	Inspected
BULKHEAD/PENTHOUSE	Inspected
Condition	3 - Fair
Deficiency	BULKHEAD/PENTHOUSE WALLS/EXTERIOR: WATER INFILTRATION
Roof Plan reference	<p>K208</p>

Deficiency Quantity	50
Quantity Uom	S.F.
Potential Action	REPAIR
Urgency of Action	PRIORITY 5
Purpose of Action	LEVEL 2
Deficiency Photo1

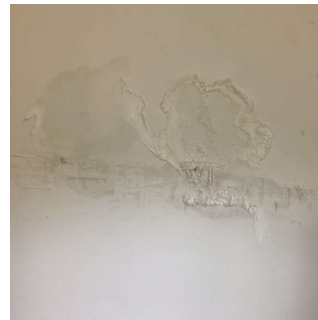
Violations	BH1 No violations recorded.
Deficiency	BULKHEAD/PENTHOUSE WALLS/INTERIOR: PLASTER CRACKS/SPALLING

20
S.F.
REPLACE
PRIORITY 3
LEVEL 2

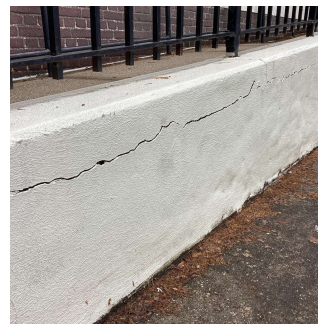
Facade B
No violations recorded.

CAST IN PLACE CONCRETE: CRACKS/SPALLING - MAJOR

30
S.F.
REPLACE
PRIORITY 4
LEVEL 2

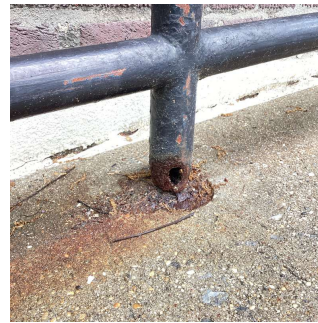
Facade B

RUST - MAJOR

10
L.F.
REPLACE
PRIORITY 4
LEVEL 4

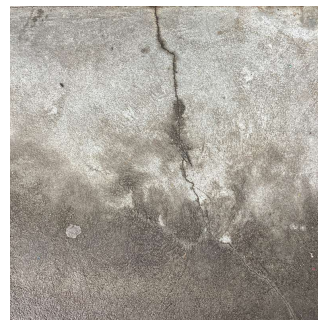
Facade B

CONCRETE: CRACKS/SPALLING - MINOR

10

REPAIR

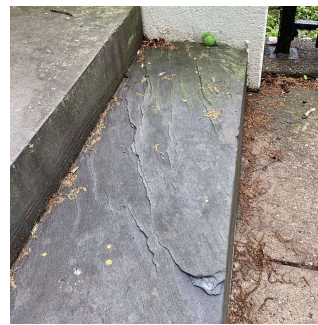
Facade B

STONE: WORN-OUT TREAD/RISER/NOSING

K208
 30
 S.F.
 REPLACE
 PRIORITY 4
 LEVEL 2

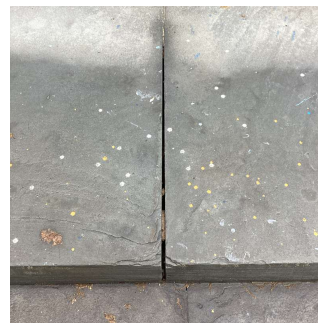
Facade B

STONE: DETERIORATED JOINTS

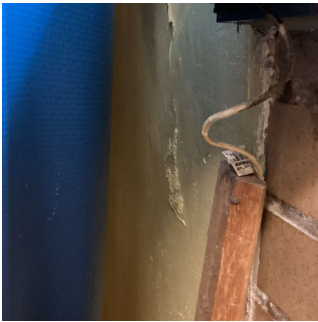
Question	Response
INTERIOR	
GYMNASIUM	
Door(s)	
Violations	No violations recorded.
Fixed Equipment	
Instance on 3rd Floor	Inspected
Condition	2 - Between Good and Fair
Deficiency	No deficiencies recorded
Floor Finish	
Instance on 3rd Floor	Inspected
Condition	2 - Between Good and Fair
Deficiency	No deficiencies recorded
Seating	
Instance on 3rd Floor	Inspected
Condition	2 - Between Good and Fair
Deficiency	No deficiencies recorded
Sliding-folding Partition	
Instance on 3rd Floor	Does not Exist
Stage	
Instance on 3rd Floor	Does not Exist
Walls	
Instance on 3rd Floor	Inspected
Condition	5 - Poor
Deficiency	PLASTER: CRACKS/SPALLING
Deficiency Location/Instance	Office
Deficiency Quantity	10
Quantity Uom	S.F.
Potential Action	REPLACE
Urgency of Action	PRIORITY 3
Purpose of Action	LEVEL 2
Deficiency Photo1

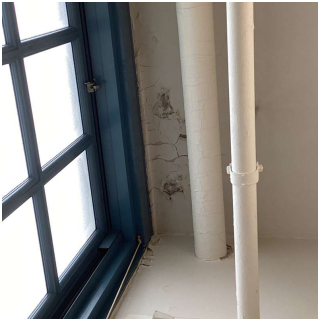
Violations	Stair C/2 No violations recorded.
TOILET ROOMS - STAFF	
Ceiling	Inspected
Condition	3 - Fair
Deficiency	PLASTER: CRACKS/SPALLING - ACTIVE LEAK
Deficiency Location/Instance	Principal Toilet Room
Deficiency Quantity	10
Quantity Uom	S.F.
Potential Action	REPLACE
Urgency of Action	PRIORITY 5
Purpose of Action	LEVEL 2
Deficiency Photo1

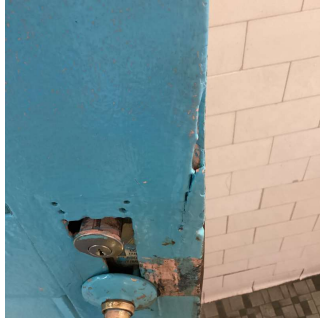
Violations	Principal Toilet Room No violations recorded.
Door(s)	Inspected
Condition	5 - Poor
Deficiency	WOOD: DETERIORATED DOOR
Deficiency Location/Instance	Rooms 258, 356, 1st Floor Staff
Deficiency Quantity	3
Quantity Uom	EACH
Potential Action	MAINTENANCE

Question	Response
INTERIOR	
TOILET ROOMS - STAFF	
Door(s)	
Urgency of Action	PRIORITY 3
Purpose of Action	LEVEL 2
Deficiency Photo1

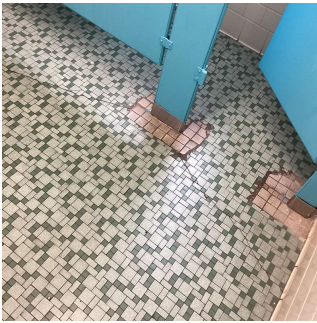
1st Floor Staff
Violations	No violations recorded.
Deficiency	CERAMIC TILE: BROKEN/MISSING TILES
Deficiency Location/Instance	Rooms 315, 353A
Deficiency Quantity	20
Quantity Uom	S.F.
Potential Action	REPLACE
Urgency of Action	PRIORITY 3
Purpose of Action	LEVEL 2

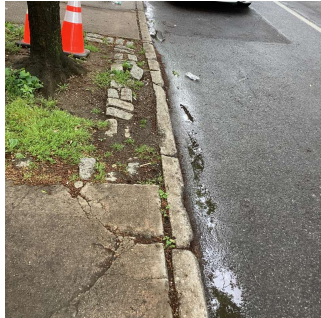
Violations	Avenue D No violations recorded.
Pavers	Does not Exist
DOT Sidewalk	Inspected
Asphalt	Does not Exist
Concrete	Inspected
Condition	4 - Between Fair and Poor
Deficiency	DAMAGED CURBS
Deficiency Location/Instance	E.48th Street, E.49th Street, Avenue D
Deficiency Quantity	250
Quantity Uom	L.F.
Potential Action	REPLACE
Urgency of Action	PRIORITY 3
Purpose of Action	LEVEL 2
Deficiency Photo1
