NYC Department of Education
Building Condition Assessment Survey 2023 - 2024

Architectural Inspection

K209

Asset: P.S. 209 - BROOKLYN, 2609 EAST 7TH ST, New York, 11235

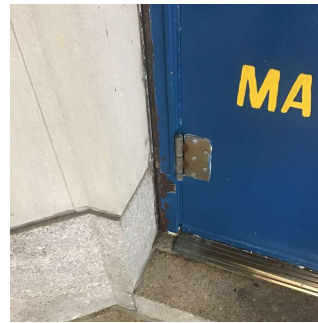
Facade A - Main Entrance

METAL: DETERIORATED DOOR AND FRAME - MAJOR DETERIORATION

REPLACE

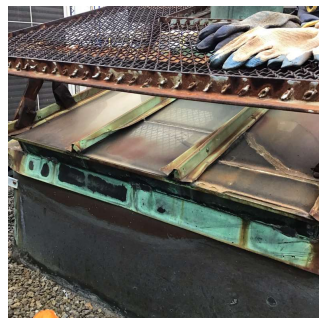
Question	Response
EXTERIOR	
ROOF	
Specialties	
SKYLIGHT/ROOF VENT	Inspected
Material Type(s)	Glass
Condition	3 - Fair
Deficiency	BROKEN FRAMING
Roof Plan reference

Deficiency Quantity	10
Quantity Uom	L.F.
Potential Action	MAINTENANCE
Urgency of Action	PRIORITY 3
Purpose of Action	LEVEL 2
Deficiency Photo1

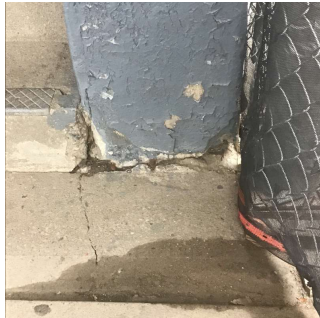
Violations	Roof 1 - SK No violations recorded.
ROOF/GRAVITY TANK	Does not Exist
STAIRS/RAMPS: EXTERIOR	Inspected
BUILDING CHEEK/FLANK WALLS	Inspected
Condition	5 - Poor
Deficiency	CAST IN PLACE CONCRETE: CRACKS/SPALLING - MAJOR
Roof Plan reference

Deficiency Quantity	10
Quantity Uom	S.F.
Potential Action	REPLACE
Urgency of Action	PRIORITY 4
Purpose of Action	LEVEL 2
Deficiency Photo1

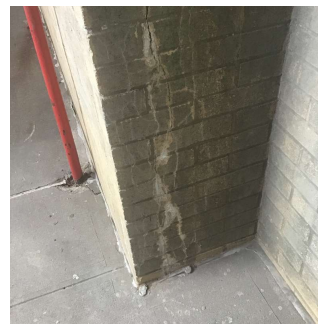
Facade D - HC Ramp
 No violations recorded.

10
 S.F.
 REPAIR
 PRIORITY 3
 LEVEL 2

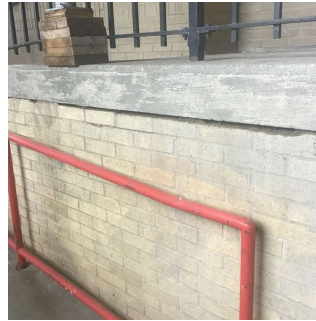
Facade D - HC Ramp

BRICK: DETERIORATED CONTROL/EXPANSION JOINT

REPLACE

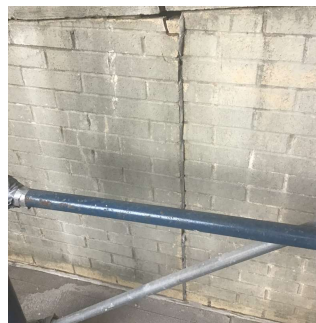
Facade D - HC Ramp

BRICK: CRACKS/SPALLING - MAJOR

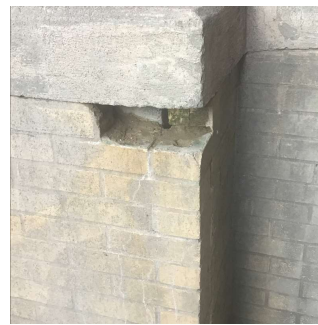
Facade D - HC Ramp
No violations recorded.

STONE: CRACKS/SPALLING - MINOR

10
S.F.
REPAIR
PRIORITY 3
LEVEL 2

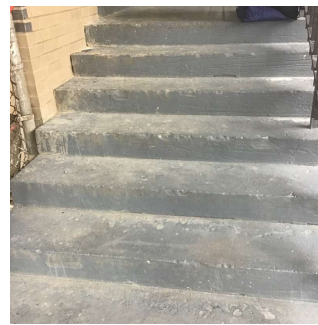
Facade E - Exit 6
 No violations recorded.

STONE: CRACKS/SPALLING - MAJOR

10
 S.F.
 REPLACE
 PRIORITY 4
 LEVEL 2

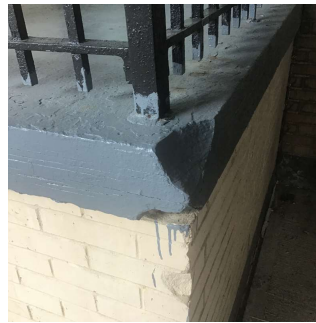
Facade E - Exit 6

CONCRETE: WORN-OUT TREAD/RISER/NOSING

REPLACE

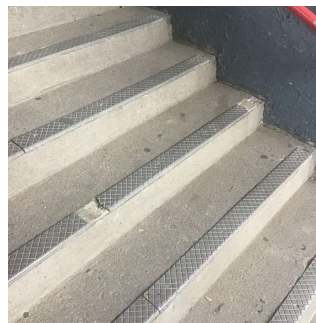
Facade D - Exit 5

CONCRETE: CRACKS/SPALLING - MAJOR

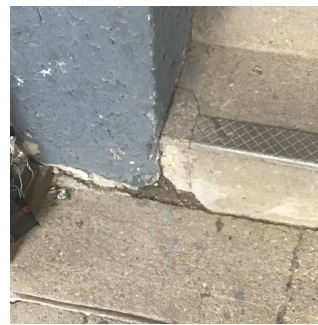
Facade D - Exit 5

CONCRETE: CRACKS/SPALLING - MINOR

40
 S.F.
 REPAIR
 PRIORITY 3
 LEVEL 2

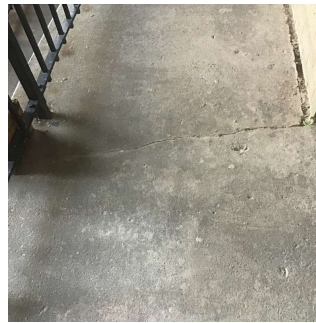
Facade D - HC Ramp

STONE: DETERIORATED JOINTS

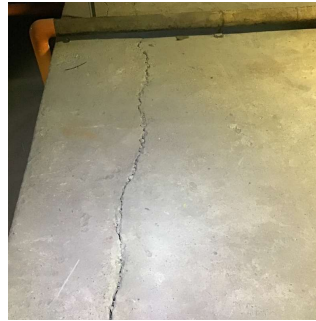
South Crawlspace

CONCRETE: CRACKS/SPALLED/REINFORCEMENT EXPOSED

REPAIR

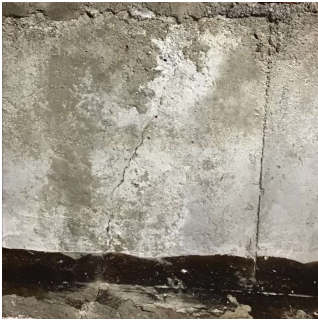
Question	Response
INTERIOR	
STRUCTURAL	
FOUNDATION WALLS	Inspected
Material Type(s)	Concrete, Masonry
Condition	3 - Fair
Deficiency	CONCRETE: CRACKED/SPALLED/REINFORCEMENT EXPOSED
Deficiency Location/Instance	South Crawlspace
Deficiency Quantity	10
Quantity Uom	S.F.
Potential Action	REPAIR
Urgency of Action	PRIORITY 3
Purpose of Action	LEVEL 5
Deficiency Photo1

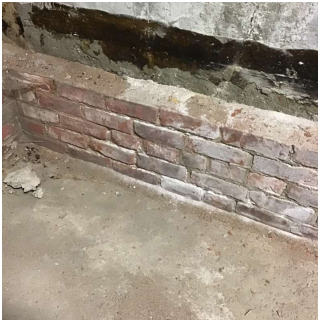
Violations	South Crawlspace No violations recorded.
Deficiency	BRICK: DETERIORATED JOINTS
Deficiency Location/Instance	Basement - South Crawlspace, Work Shop
Deficiency Quantity	40
Quantity Uom	S.F.
Potential Action	REPOINT
Urgency of Action	PRIORITY 3
Purpose of Action	LEVEL 5
Deficiency Photo1

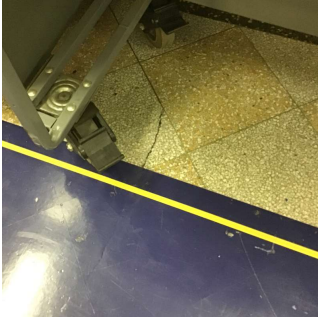
Question	Response
INTERIOR	
CLASSROOMS/CORRIDORS/ADMIN SPACES	
Floor Finish	Inspected
Condition	3 - Fair
Deficiency	TERRAZZO: CRACKS
Deficiency Location/Instance	Corridor near Rooms 105,153, Main Entrance Vestibule
Deficiency Quantity	30
Quantity Uom	S.F.
Potential Action	REPLACE
Urgency of Action	PRIORITY 3
Purpose of Action	LEVEL 2
Deficiency Photo1

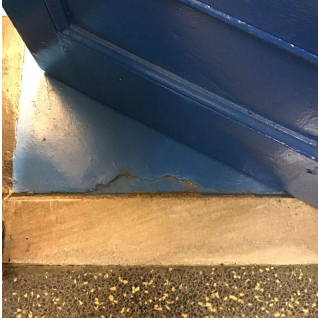
Corridor near Room 153
Violations	No violations recorded.
Deficiency	CONCRETE: CRACKS
Deficiency Location/Instance	Room 153
Deficiency Quantity	10
Quantity Uom	S.F.
Potential Action	REPLACE
Urgency of Action	PRIORITY 3
Purpose of Action	LEVEL 2
Deficiency Photo1

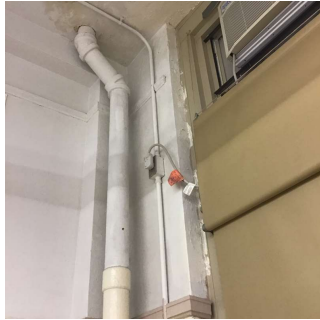
Corridor near Auditorium
Violations	No violations recorded.
Deficiency	PLASTER: CRACKS/SPALLING
Deficiency Location/Instance	Rooms 402,219, Corridor near Rooms 451,359
Deficiency Quantity	40
Quantity Uom	S.F.
Potential Action	REPLACE
Urgency of Action	PRIORITY 3
Purpose of Action	LEVEL 2
Deficiency Photo1

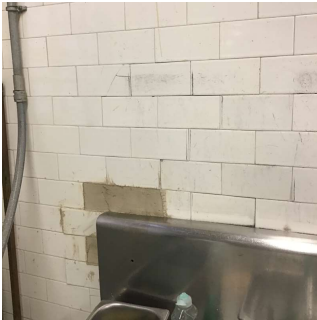
Violations	Near Fridges No violations recorded.
Walls	
Instance on 1st Floor	Inspected
Condition	2 - Between Good and Fair
Deficiency	CERAMIC TILE: BROKEN/ MISSING
Deficiency Location/Instance	Near Windows
Deficiency Quantity	10
Quantity Uom	S.F.
Potential Action	REPLACE
Urgency of Action	PRIORITY 3
Purpose of Action	LEVEL 2
Deficiency Photo1

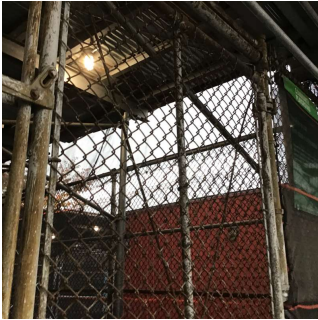
Manor Ct
Violations	No violations recorded.
Deficiency	CHAIN LINK: RUST - MAJOR
Deficiency Location/Instance	Manor Court, Coney Island Avenue, Avenue Z
Deficiency Quantity	5,000
Quantity Uom	S.F.
Potential Action	REPLACE
Urgency of Action	PRIORITY 3
Purpose of Action	LEVEL 2
Deficiency Photo1

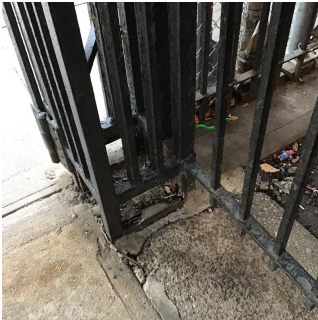
Manor Court
Violations	No violations recorded.
Deficiency	WROUGHT IRON: RUST - MAJOR
Deficiency Location/Instance	Manor Court
Deficiency Quantity	80
Quantity Uom	S.F.
Potential Action	REPLACE
Urgency of Action	PRIORITY 3
Purpose of Action	LEVEL 2
Deficiency Photo1

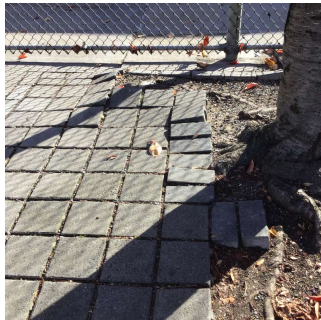
Deficiency	DAMAGED/MISSING
Deficiency Location/Instance	Near TCU Units
Deficiency Quantity	50
Quantity Uom	S.F.
Potential Action	REPLACE
Urgency of Action	PRIORITY 5
Purpose of Action	LEVEL 6
Deficiency Photo1

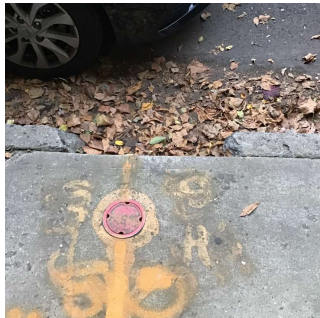
Violations	Avenue Z No violations recorded.
Deficiency	DAMAGED CURBS
Deficiency Location/Instance	Avenue Z, E. 7th Street, Manor Court, Coney Island Avenue
Deficiency Quantity	700
Quantity Uom	L.F.
Potential Action	REPLACE
Urgency of Action	PRIORITY 3
Purpose of Action	LEVEL 2
Deficiency Photo1

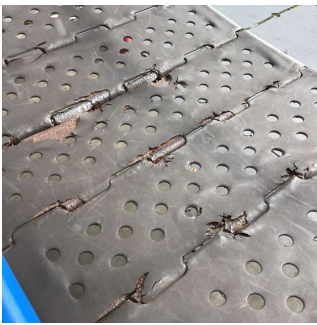
Stairs
Violations	No violations recorded.
Deficiency	BROKEN/DETERIORATED/MISSING
Deficiency Location/Instance	Bridge
Deficiency Quantity	1
Quantity Uom	EACH
Potential Action	REPLACE
Urgency of Action	PRIORITY 5
Purpose of Action	LEVEL 6
