**NYC Department of Education**  
**Building Condition Assessment Survey 2023 - 2024**

Architectural Inspection

**Asset: P.S. 219 - BROOKLYN, 1060 CLARKSON AVENUE, New York, 11212**

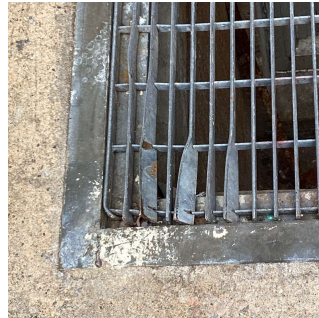
Question	Response
<b>EXTERIOR</b>	
<b>AREAWAY</b>	
Instance Condition	3 - Fair
Instance Quantity	7
Instance Quantity Uom	EACH
Deficiency	AREAWAY GRATINGS: MAJOR RUSTING / OR BROKEN
Roof Plan reference	<p>K219</p>

Deficiency Quantity	50
Quantity Uom	S.F.
Potential Action	REPLACE
Urgency of Action	PRIORITY 4
Purpose of Action	LEVEL 2
Deficiency Photo1

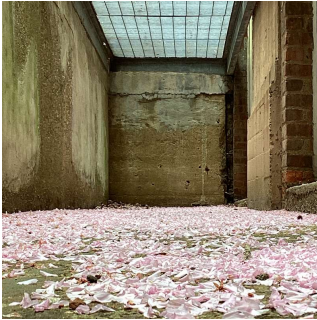
Violations	No violations recorded.
Deficiency	AREAWAY WALLS: CRACKS AND SPALLING
Roof Plan reference	<p>K219</p>

Deficiency Quantity	20
Quantity Uom	S.F.
Potential Action	REPLACE
Urgency of Action	PRIORITY 4
Purpose of Action	LEVEL 2

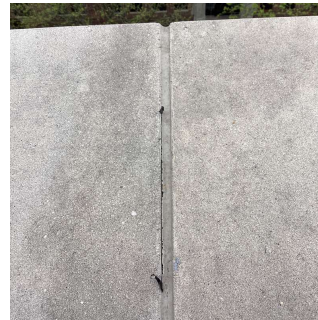
Violations	Roof 1 No violations recorded.
Deficiency	CAST STONE: DETERIORATED TRANSVERSE JOINTS

30  
 L.F.  
 MAINTENANCE  
 PRIORITY 3  
 LEVEL 2

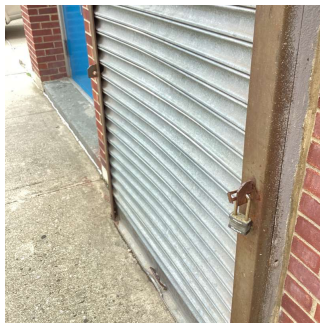
ROLL-UP DOOR: DETERIORATED DOOR - MINOR DETERIORATION

60  
 S.F.  
 MAINTENANCE  
 PRIORITY 3  
 LEVEL 2

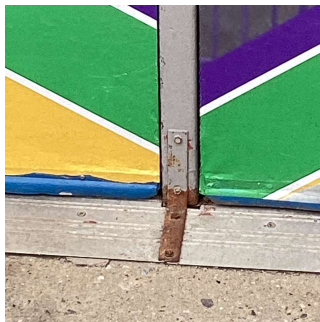
Violations	Facade G No violations recorded.
Deficiency	METAL: DETERIORATED DOOR AND FRAME - MINOR DETERIORATION
Roof Plan reference	K219

Deficiency Quantity	2
Quantity Uom	EACH
Potential Action	MAINTENANCE
Urgency of Action	PRIORITY 3
Purpose of Action	LEVEL 2
Deficiency Photo1

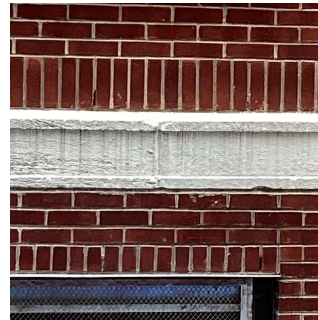
Facade B

STONE: CHIPPED/SPALLED/BROKEN PIECES - MINOR

REPAIR

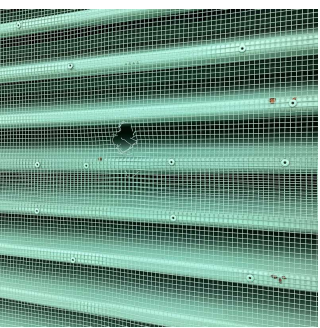
Question	Response
<b>EXTERIOR</b>	
<b>EXTERIOR WALLS</b>	Inspected
Violations	No violations recorded.
<b>EXTERIOR SOFFITS</b>	Does not Exist
<b>LOADING DOCK</b>	Does not Exist
<b>LOUVER</b>	Inspected
Condition	3 - Fair
Deficiency	MISSING/DAMAGED SCREEN
Roof Plan reference	<p>K219</p>

Deficiency Quantity	10
Quantity Uom	S.F.
Potential Action	REPLACE
Urgency of Action	PRIORITY 4
Purpose of Action	LEVEL 2
Deficiency Photo1

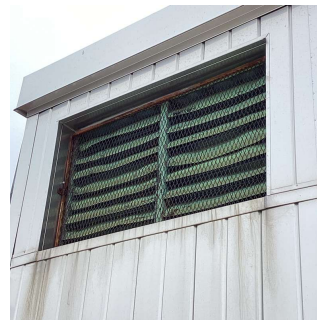
Roof 1	Roof 1
Violations	No violations recorded.
Deficiency	BROKEN/ DENTED BLADES

REPLACE

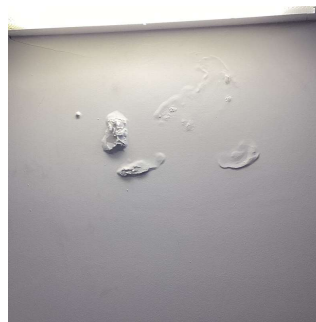
Deficiency	BULKHEAD/PENTHOUSE WALLS/INTERIOR: PLASTER CRACKS/SPALLING
------------	--

25  
 S.F.  
 REPLACE  
 PRIORITY 4  
 LEVEL 2

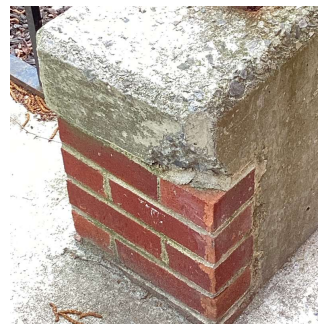
CAST IN PLACE CONCRETE: CRACKS/SPALLING - MAJOR

20  
 S.F.  
 REPLACE  
 PRIORITY 4  
 LEVEL 2

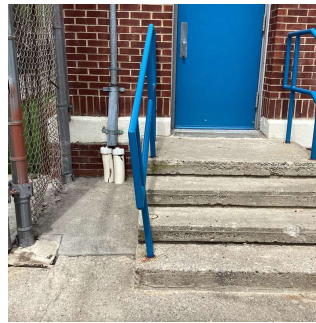
Facade H

DAMAGED

10  
 L.F.  
 REPLACE  
 PRIORITY 4  
 LEVEL 2

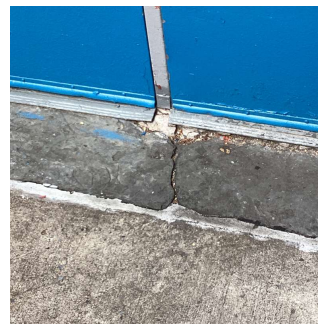
Facade F

STONE: CRACKS/SPALLING - MAJOR

10  
S.F.  
REPLACE  
PRIORITY 4  
LEVEL 2

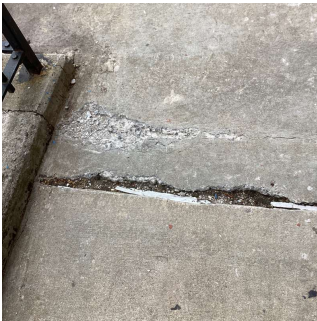
**CONCRETE: CRACKS/SPALLING - MAJOR**

30  
S.F.  
REPLACE  
PRIORITY 4  
LEVEL 2

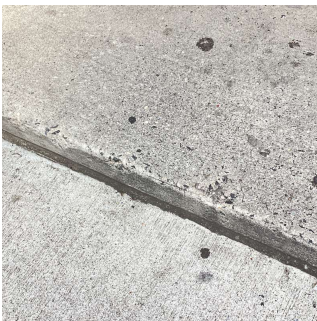
Violations	Facade C No violations recorded.
Deficiency	<b>CONCRETE: CRACKS/SPALLING - MINOR</b>
Roof Plan reference	K219

Deficiency Quantity	75
Quantity Uom	S.F.
Potential Action	REPAIR
Urgency of Action	PRIORITY 3
Purpose of Action	LEVEL 2
Deficiency Photo1

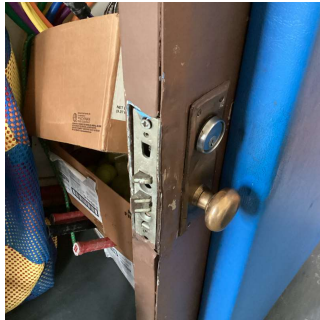
Main Entrance
Violations	No violations recorded.
Instance on 3rd Floor	Inspected
Condition	5 - Poor
Deficiency	METAL: DETERIORATED DOOR
Deficiency Location/Instance	Room 361
Deficiency Quantity	1
Quantity Uom	EACH
Potential Action	MAINTENANCE
Urgency of Action	PRIORITY 3
Purpose of Action	LEVEL 2
Deficiency Photo1

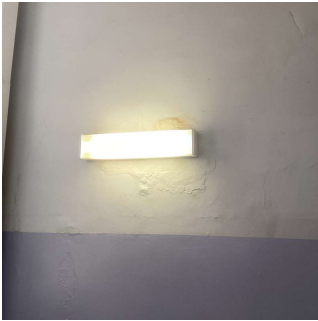
Violations	Stair A/1 No violations recorded.
Deficiency	PLASTER: CRACKS/SPALLING - ACTIVE LEAK
Deficiency Location/Instance	Stair E/3
Deficiency Quantity	20
Quantity Uom	S.F.
Potential Action	REPLACE
Urgency of Action	PRIORITY 5
Purpose of Action	LEVEL 2
Deficiency Photo1

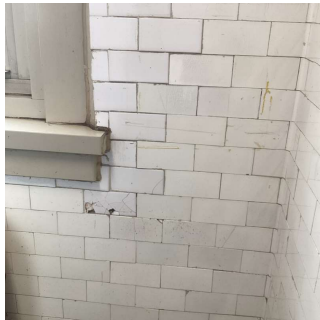
Violations	Room 450 No violations recorded.
Deficiency	CERAMIC TILE: BROKEN/ MISSING
Deficiency Location/Instance	Room 450
Deficiency Quantity	10
Quantity Uom	S.F.
Potential Action	REPLACE
Urgency of Action	PRIORITY 3
Purpose of Action	LEVEL 2
Deficiency Photo1
