NYC Department of Education
Building Condition Assessment Survey 2023 - 2024

Architectural Inspection

Asset: I.S. 223 - BROOKLYN, 4200 16 AVENUE, New York, 11204

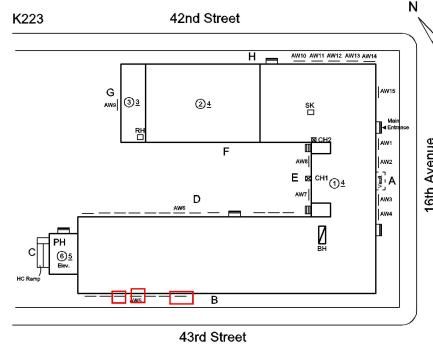
Deficiency	AREAWAY DRAINS: DETERIORATED
Roof Plan reference	K223

Deficiency Quantity	3
Quantity Uom	EACH
Potential Action	REPLACE
Urgency of Action	PRIORITY 4
Purpose of Action	LEVEL 2
Deficiency Photo1

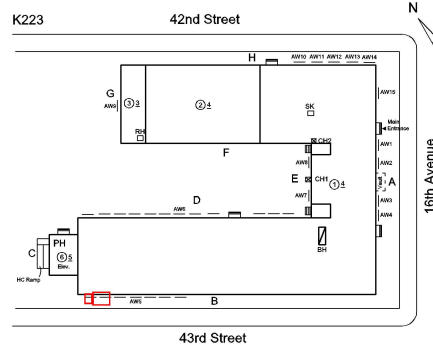
Deficiency	AREAWAY WALLS: CRACKS AND SPALLING
Roof Plan reference	K223

Deficiency Quantity	40
Quantity Uom	S.F.
Potential Action	REPLACE
Urgency of Action	PRIORITY 4
Purpose of Action	LEVEL 2

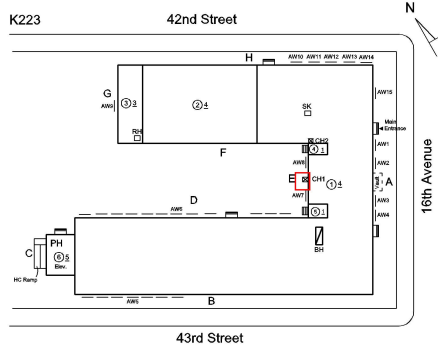
AW5
Violations	No violations recorded.
Instance on AW1-AW4, AW6-AW15	Inspected
Instance Condition	2 - Between Good and Fair
Instance Quantity	11
Instance Quantity Uom	EACH
Deficiency	No deficiencies recorded
AWNINGS AND CANOPIES	Does not Exist
CHIMNEY	Inspected
Material Type(s)	Masonry
Condition	3 - Fair
Deficiency	BRICK: DETERIORATED JOINTS
Roof Plan reference

Deficiency Quantity	100
Quantity Uom	S.F.
Potential Action	REPOINT
Urgency of Action	PRIORITY 3
Purpose of Action	LEVEL 2
Deficiency Photo1

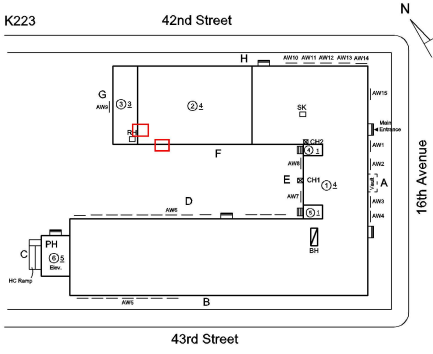
Question	Response
EXTERIOR	
COPING	
Condition	3 - Fair
Deficiency	TERRA COTTA: CRACKED/BROKEN PIECES
Roof Plan reference

Deficiency Quantity	10
Quantity Uom	L.F.
Potential Action	REPLACE-IN-KIND
Urgency of Action	PRIORITY 4
Purpose of Action	LEVEL 2
Deficiency Photo1

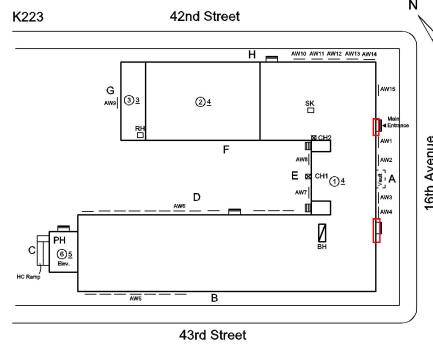
METAL: BROKEN GLASS

20
S.F.
MAINTENANCE
PRIORITY 3
LEVEL 2

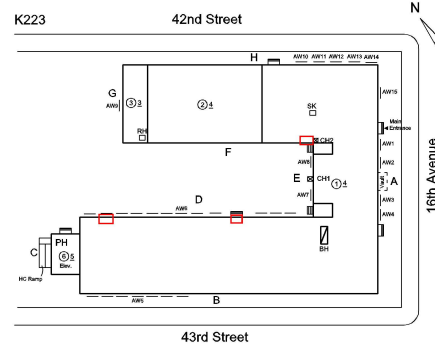
BRICK: MAJOR / THRU CRACKS

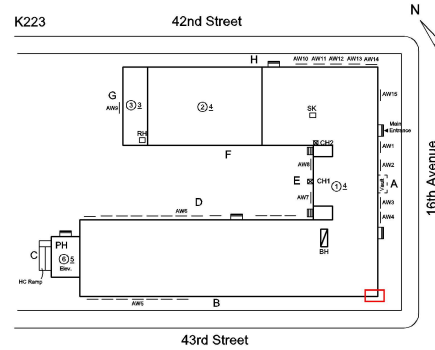
BRICK: CRACKS/DISPLACED/SPALLED BRICK AT BUILDING CORNERS

20
S.F.
REMOVE AND REBUILD
PRIORITY 4
LEVEL 2

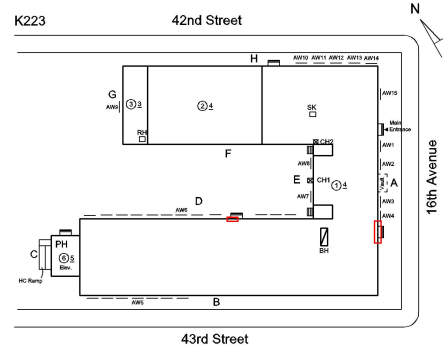
STONE: CHIPPED/SPALLED/BROKEN PIECES - MINOR

20
 S.F.
 REPAIR
 PRIORITY 3
 LEVEL 2

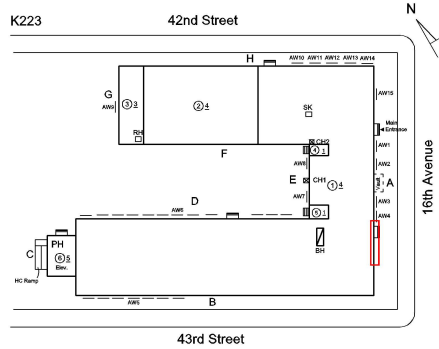
Deficiency	BRICK: OUT OF PLUMB
Roof Plan reference

Deficiency Quantity	20
Quantity Uom	C.F.
Potential Action	REMOVE AND REBUILD
Urgency of Action	PRIORITY 4
Purpose of Action	LEVEL 2
Deficiency Photo1

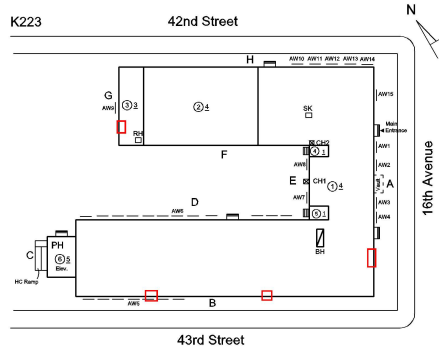
Deficiency	BRICK: MINOR CRACKS, SPALLING
Roof Plan reference

Deficiency Quantity	30
Quantity Uom	S.F.
Potential Action	REPAIR
Urgency of Action	PRIORITY 3
Purpose of Action	LEVEL 2

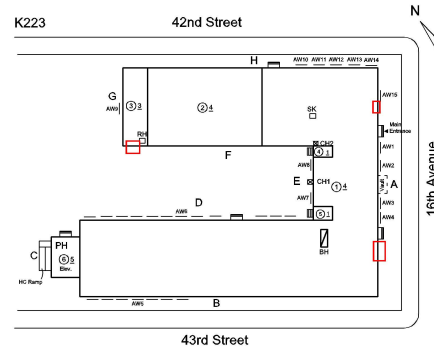
BRICK: MAJOR DETERIORATION/CRACKS

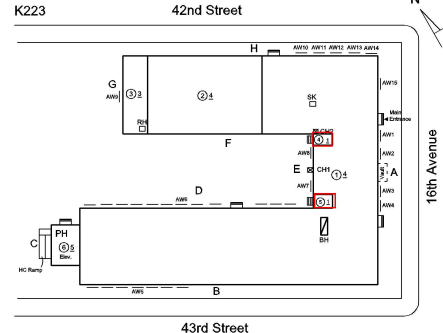
Deficiency	MODIFIED BITUMEN: FLASHING: CAP FLASHING DAMAGED
------------	--

L.F.
REPLACE
PRIORITY 4
LEVEL 2

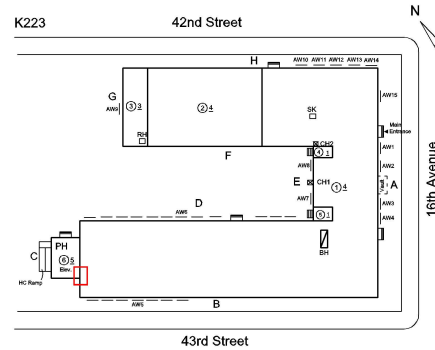
Inspected
3 - Fair
BULKHEAD/PENTHOUSE WALLS/EXTERIOR:
CRACKS/SPALLING - MINOR

10
S.F.
REPAIR
PRIORITY 3
LEVEL 2

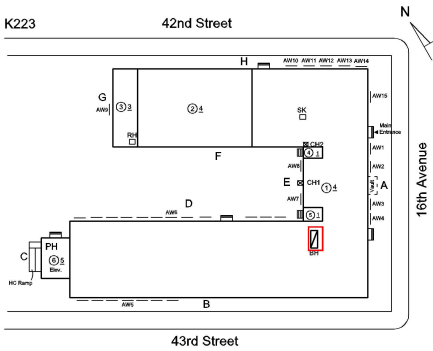
Question	Response
EXTERIOR	
ROOF	
Specialties	
BULKHEAD/PENTHOUSE	
Violations	PH No violations recorded.
Deficiency	BULKHEAD/PENTHOUSE WALLS/EXTERIOR: DETERIORATED JOINTS
Roof Plan reference

Deficiency Quantity	20
Quantity Uom	S.F.
Potential Action	REPOINT
Urgency of Action	PRIORITY 4
Purpose of Action	LEVEL 2
Deficiency Photo1

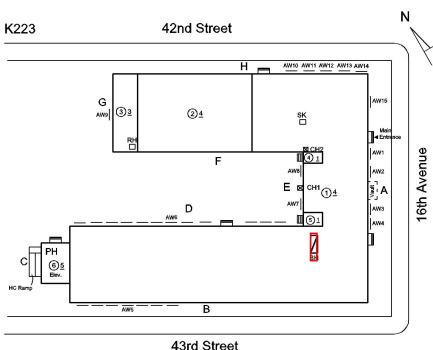
Violations	BH No violations recorded.
Deficiency	BULKHEAD/PENTHOUSE WALLS/EXTERIOR: DETERIORATED JOINTS
Roof Plan reference

Deficiency Quantity	100
Quantity Uom	S.F.
Potential Action	REPOINT
Urgency of Action	PRIORITY 3
Purpose of Action	LEVEL 2

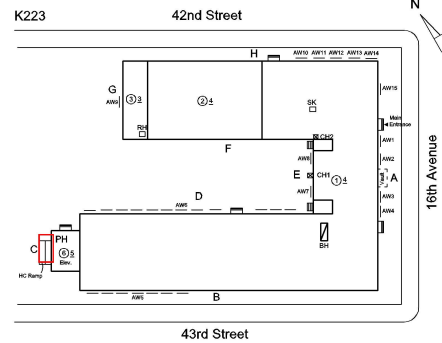
CAST IN PLACE CONCRETE: CRACKS/SPALLING - MAJOR

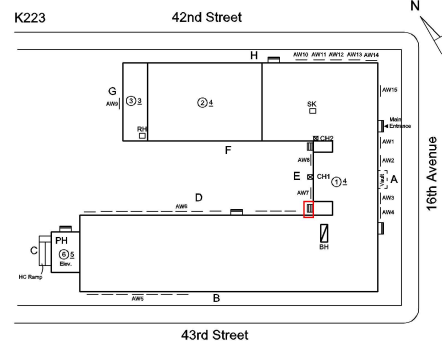
BROKEN BRACKET

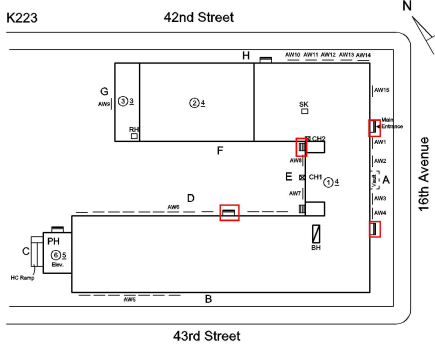
Violations	Facade E No violations recorded.
STAIRS/RAMPS	
Condition	Inspected 5 - Poor
Deficiency	CONCRETE: CRACKS/SPALLING - MAJOR
Roof Plan reference

Deficiency Quantity	20
Quantity Uom	S.F.
Potential Action	REPLACE
Urgency of Action	PRIORITY 4
Purpose of Action	LEVEL 2
Deficiency Photo1

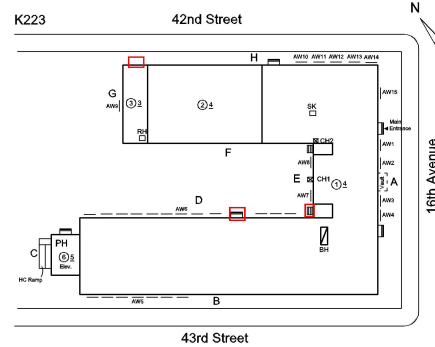
Violations	Facade A No violations recorded.
Deficiency	STONE: CRACKS/SPALLING - MAJOR

30
S.F.
REPLACE
PRIORITY 4
LEVEL 2

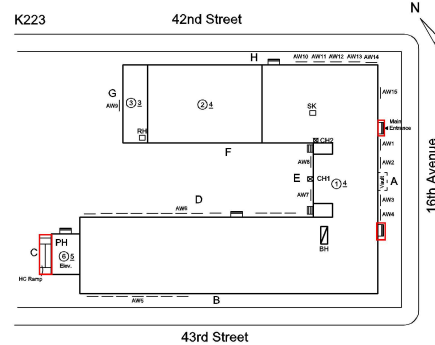
CONCRETE: CRACKS/SPALLING - MINOR

20
S.F.
REPAIR
PRIORITY 3
LEVEL 2

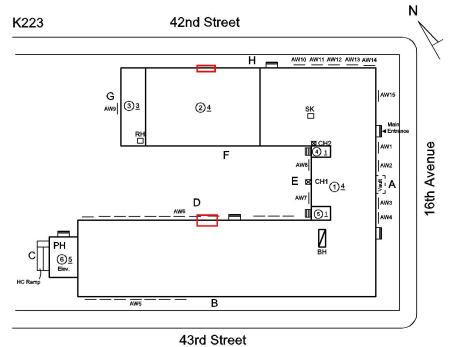
ALUMINUM - DOUBLE HUNG: BROKEN PANE

150
S.F.
MAINTENANCE
PRIORITY 3
LEVEL 2

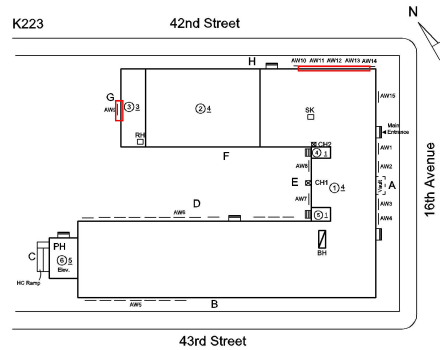
Deficiency	WOOD: DETERIORATED
------------	--------------------

Potential Action	REPLACE WINDOW
------------------	----------------

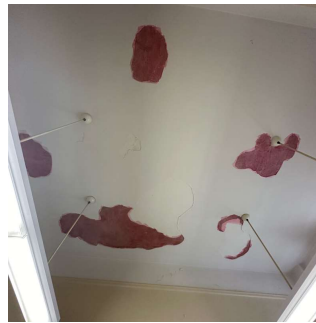
Room 107

Violations	Room 203 No violations recorded.
Deficiency	PLASTER: CRACKS/SPALLING
Deficiency Location/Instance	Room 107, Corridor near 4th Floor Gymnasium
Deficiency Quantity	110
Quantity Uom	S.F.
Potential Action	REPLACE
Urgency of Action	PRIORITY 3
Purpose of Action	LEVEL 2
