**NYC Department of Education**  
**Building Condition Assessment Survey 2023 - 2024**

Architectural Inspection

**Asset: P.S. 229 - BROOKLYN, 1400 BENSON AVENUE, New York, 11228**

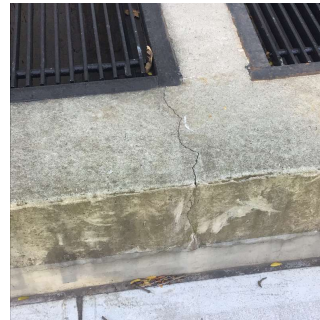
Facade G - AW6  
No violations recorded.

| Question | Response |
|---|---|
| Deficiency | AREAWAY WALLS: CRACKS AND SPALLING |

10  
S.F.  
REPAIR  
PRIORITY 3  
LEVEL 2

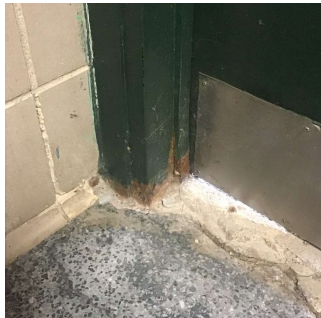
| Question | Response |
|---|--|
| Violations | Facade G - Exit 11<br>No violations recorded. |

| Question | Response |
|---|--|
| Deficiency | METAL CLAD: DETERIORATED DOOR AND FRAME - MAJOR DETERIORATION |

| Question | Response |
|---|--|
| Potential Action | REPLACE |

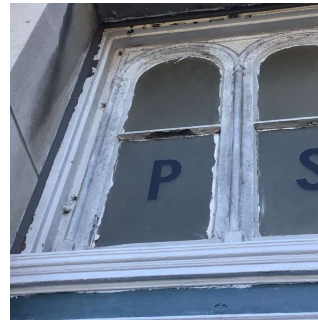
Facade H - Exit 9

WOOD: EXCESSIVELY WEATHERED

REPLACE

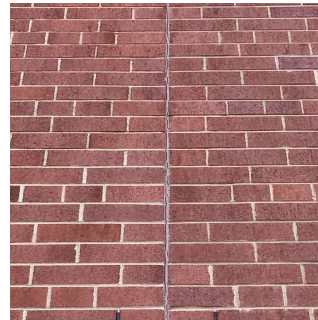
Facade C

BRICK: DETERIORATED CONTROL/EXPANSION JOINTS

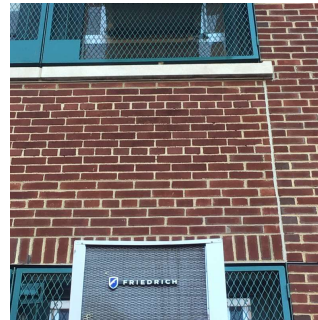
Facade C

BRICK: DETERIORATED JOINTS

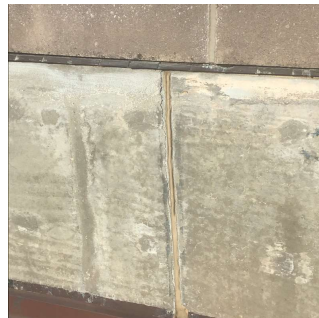
| Question | Response |
|---|--|
| Deficiency | CONCRETE: MINOR CRACKS, SPALLING |

| Question | Response |
|---|--|
| Potential Action | REPAIR |

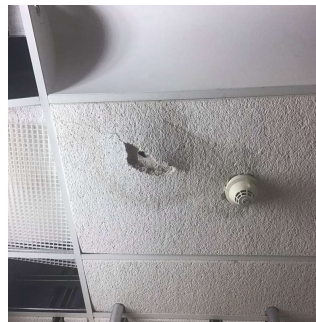
| Deficiency | IRMA: ROOFING: MAJOR ACTIVE ROOF LEAKS IN NON-INSTRUCTIONAL SPACE |

Roof 4 - Room 450 shown, Roof 3 - Room 449 similar

REPLACE ROOFING WITHOUT MAJOR EQUIPMENT REMOVAL

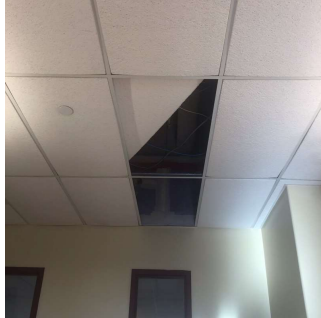
| Deficiency | IRMA: ROOFING: MAJOR ACTIVE ROOF LEAKS IN INSTRUCTIONAL SPACE |

| Question | Response |
|---|---|
| Violations | Roof 4 - Room 469 shown, Roof 4 - Rooms 458, 459, 468, 471, Corridor near Rooms 452, 459 similar<br>No violations recorded. |

REPLACE ROOFING WITHOUT MAJOR EQUIPMENT REMOVAL

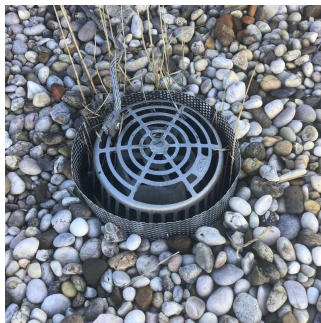
| Question | Response |
|---|---|
| Roof Plan reference | DETERIORATED |
| Violations | Roof 4<br>No violations recorded. |

| Question | Response |
|---|---|
| Potential Action | REPLACE |

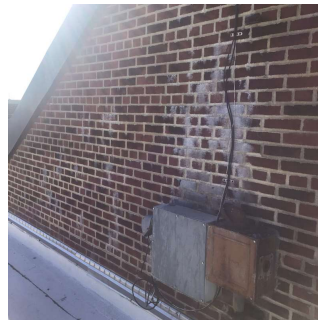
Roof 1 - BH1

| Question | Response |
|---|---|
| Deficiency | 3 - Fair<br>BULKHEAD/PENTHOUSE WALLS/EXTERIOR:<br>EFFLORESCENCE |

60  
 S.F.  
 MAINTENANCE  
 PRIORITY 1  
 LEVEL 1

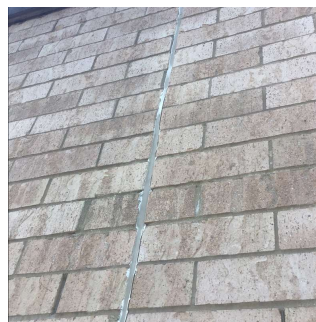
Roof 4 - BH2

**BULKHEAD/PENTHOUSE WALLS/EXTERIOR: DETERIORATED JOINTS**

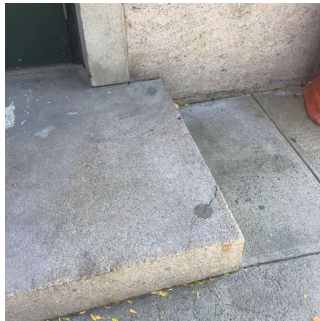
| Question | Response |
|---|--|
| Violations | Facade G - Exit 11<br>No violations recorded. |

| Question | Response |
|---|--|
| Deficiency | MISSING RAILING |

| Question | Response |
|---|--|
| Potential Action | REPLACE |

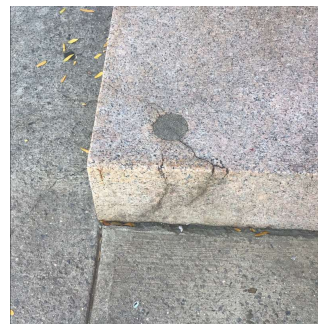
Facade G - Exit 11

| Question | Response |
|---|--|
| Deficiency | STONE: CRACKS/SPALLING - MINOR |

10  
S.F.  
REPAIR  
PRIORITY 3  
LEVEL 2

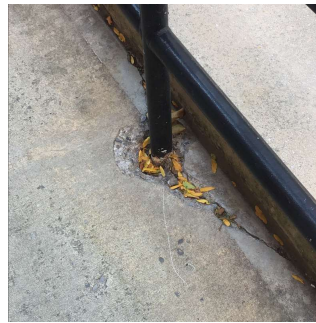
Facade G - Ramp

**CONCRETE: CRACKS/SPALLING - MAJOR**

10  
S.F.  
REPLACE  
PRIORITY 4  
LEVEL 2

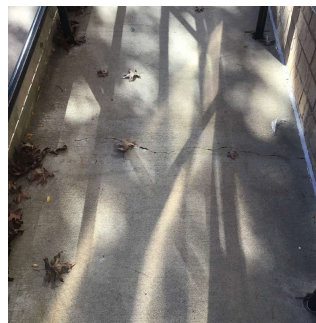
Facade A - HC Ramp

**CONCRETE: CRACKS/SPALLING - MINOR**

REPAIR

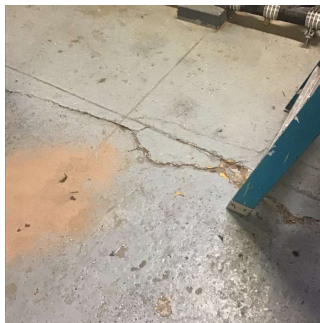
| Question | Response |
|---|--|
| Violations | Boiler Room<br>No violations recorded. |

| Question | Response |
|---|--|
| Deficiency | CONCRETE SLAB ON GRADE: THRU CRACKS |
| Deficiency Location/Instance | Basement - Boiler Room |

| Question | Response |
|---|--|
| Potential Action | REPAIR |

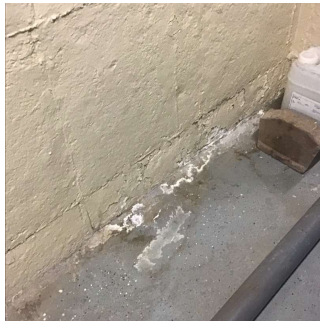
| Question | Response |
|---|--|
| Violations | Boiler Room<br>No violations recorded. |

| Question | Response |
|---|--|
| Deficiency | CONCRETE: WATER INFILTRATION IN NON- INSTRUCTIONAL SPACE |
| Deficiency Location/Instance | Basement - Boiler Room |

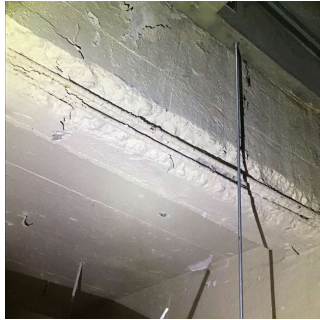
| Question | Response |
|--|--|
| | Ash Hoist Vault |

| Question | Response |
|---|--|
| Deficiency | CONCRETE BEAMS: CRACKS/SPALLED/REINFORCEMENT EXPOSED |
| Deficiency Location/Instance | Basement - Ash Hoist Vault |

| Question | Response |
|---|--|
| Potential Action | REPLACE |

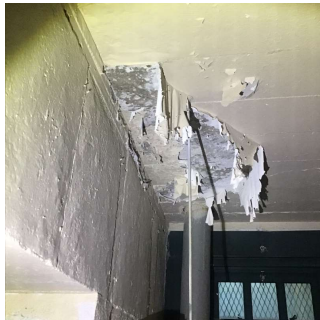
| Question | Response |
|--|--|
| | Ash Hoist Vault |

| Question | Response |
|--|--|
| Deficiency | CONCRETE: WATER INFILTRATION IN NON- INSTRUCTIONAL SPACE |
| Deficiency Location/Instance | Basement - Ash Hoist Vault |
