**NYC Department of Education**  
**Building Condition Assessment Survey 2023 - 2024**

Architectural Inspection

**Asset: P.S. 230 - BROOKLYN, 1 ALBEMARLE ROAD, New York, 11218**

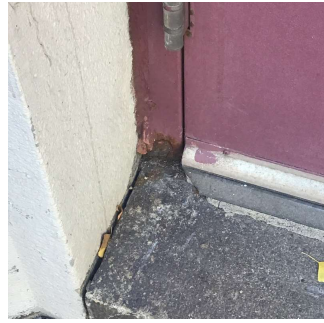
Question	Response
<b>EXTERIOR</b>	
<b>DOORS</b>	Inspected
<b>DOORS AND FRAMES</b>	Inspected
Condition	4 - Between Fair and Poor
Deficiency	METAL: DETERIORATED DOOR AND FRAME - MAJOR DETERIORATION
Roof Plan reference

Deficiency Quantity	2
Quantity Uom	EACH
Potential Action	REPLACE
Urgency of Action	PRIORITY 4
Purpose of Action	LEVEL 2
Deficiency Photo1

Violations	Facade H - Exit 8 No violations recorded.
Deficiency	METAL: DETERIORATED DOOR AND FRAME - MINOR DETERIORATION
Roof Plan reference

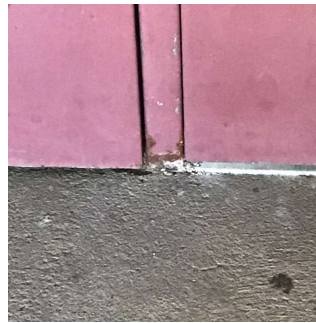
Facade C - Exit 6

Deficiency Quantity	3
Quantity Uom	EACH
Potential Action	MAINTENANCE
Urgency of Action	PRIORITY 3
Purpose of Action	LEVEL 2

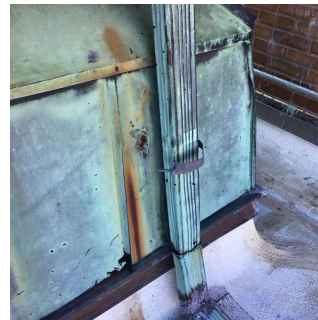
Roof 1 - Near BH

Condition	1 - Good
Deficiency	No deficiencies recorded
<b>LEADERS, GUTTERS, DOWNSPOUTS, SCUPPERS</b>	Inspected
Condition	3 - Fair
Deficiency	LOOSE

1  
EACH  
MAINTENANCE  
PRIORITY 3  
LEVEL 2

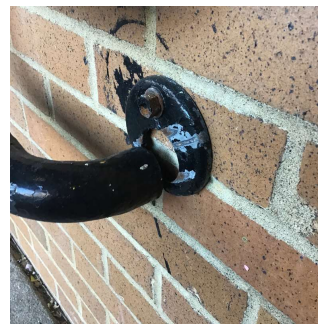
Question	Response
<b>EXTERIOR</b>	
<b>STAIRS/RAMPS: EXTERIOR</b>	Inspected
<b>BUILDING CHEEK/FLANK WALLS</b>	Inspected
Purpose of Action	LEVEL 2
Deficiency Photo1	 
	Facade A - Exit 2
Violations	No violations recorded.
<b>RAILINGS</b>	Inspected
Condition	3 - Fair
Deficiency	DAMAGED
Roof Plan reference	 
Deficiency Quantity	10
Quantity Uom	L.F.
Potential Action	REPLACE
Urgency of Action	PRIORITY 4
Purpose of Action	LEVEL 2
Deficiency Photo1	 
	Facade C - HC Ramp
Violations	No violations recorded.
Deficiency	BROKEN BRACKET

1  
EACH  
REPLACE  
PRIORITY 4  
LEVEL 2

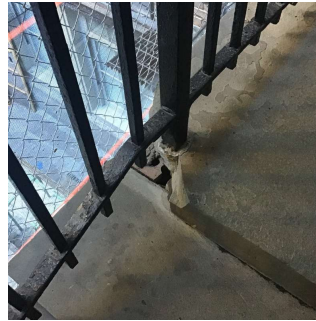
Facade E - Exit 4

STONE: CRACKS/SPALLING - MAJOR

20  
S.F.  
REPLACE  
PRIORITY 4  
LEVEL 2

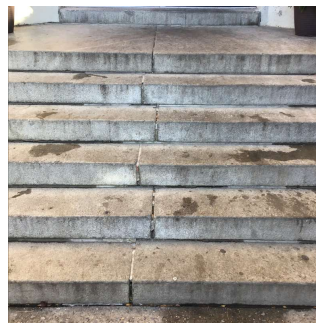
Facade A - Exit 2

**STONE: DETERIORATED JOINTS**

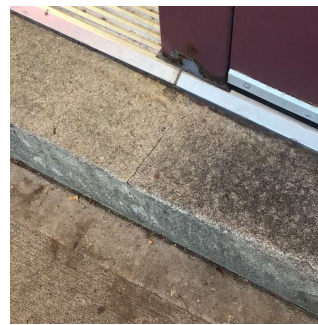
Facade A - Main Entrance  
 No violations recorded.

**STONE: CRACKS/SPALLING - MINOR**

30  
 S.F.  
 REPAIR  
 PRIORITY 3  
 LEVEL 2

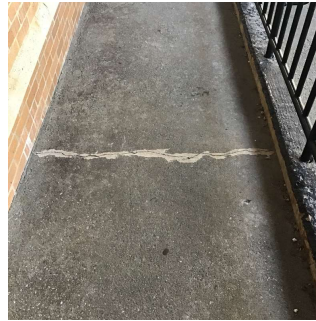
Facade C - HC Ramp

**CONCRETE: CRACKS/SPALLING - MINOR**

50  
 S.F.  
 REPAIR  
 PRIORITY 3  
 LEVEL 2

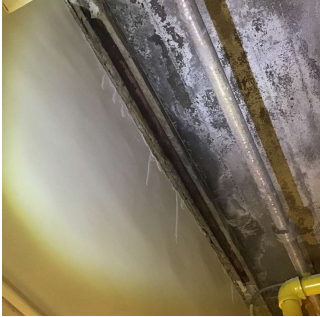
<b>Question</b>	<b>Response</b>
<b>INTERIOR</b>	
<b>STRUCTURAL</b>	
<b>COLUMNS/BEAMS/BEARING WALLS</b>	
Violations	Shop Room No violations recorded.
Deficiency	<b>STEEL COLUMNS/BEAMS: DETERIORATED CONCRETE FIREPROOFING</b>
Deficiency Location/Instance	Basement - Gas Meter Room, Room C06, Shop Room
Deficiency Quantity	40
Quantity Uom	S.F.
Potential Action	REPLACE
Urgency of Action	PRIORITY 4
Purpose of Action	LEVEL 5
Deficiency Photo1

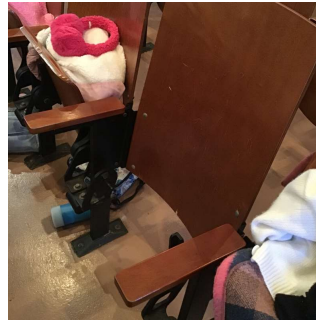
Seat D/19

Violations	Mechanical Equipment Room No violations recorded.
<b>FOUNDATION WALLS</b>	
	Under Construction
<b>ROOF STRUCTURE</b>	
Condition	Inspected
	2 - Between Good and Fair
Deficiency	No deficiencies recorded
<b>VAULTS-BUNKERS</b>	
	Under Construction
<b>AUDITORIUM</b>	
Instance on 1st Floor (507 Seats)	Inspected
	Inspected
<b>Ceiling</b>	
Instance on 1st Floor (507 Seats)	Inspected
Condition	2 - Between Good and Fair
Deficiency	No deficiencies recorded
<b>Door(s)</b>	
Instance on 1st Floor (507 Seats)	Inspected
Condition	2 - Between Good and Fair
Deficiency	No deficiencies recorded
<b>Fixed H/C Lift</b>	
Instance on 1st Floor (507 Seats)	Does not Exist
<b>Fixed Seating</b>	
Instance on 1st Floor (507 Seats)	Inspected
Condition	4 - Between Fair and Poor
Deficiency	DAMAGED/BROKEN/INOPERABLE
Deficiency Location/Instance	Seats D/19, E/13, F/8, H/13

Deficiency Quantity	4
Quantity Uom	EACH
Potential Action	REPLACE
Urgency of Action	PRIORITY 5
Purpose of Action	LEVEL 6

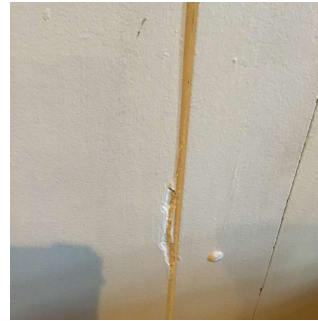
Right Side
Violations	No violations recorded.
<b>Walls</b>	
Instance on 1st Floor (507 Seats)	Inspected
Condition	2 - Between Good and Fair
Deficiency	PLASTER: CRACKS/SPALLING
Deficiency Location/Instance	Near Entrance
Deficiency Quantity	10
Quantity Uom	S.F.
Potential Action	REPLACE
Urgency of Action	PRIORITY 3
Purpose of Action	LEVEL 2

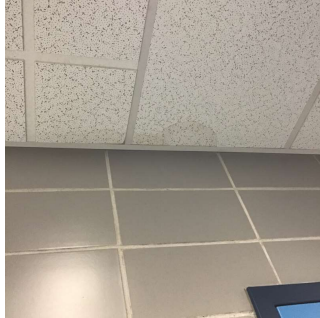
Question	Response
<b>INTERIOR</b>	
<b>CLASSROOMS/CORRIDORS/ADMIN SPACES</b>	
<b>Ceiling</b>	
Purpose of Action	LEVEL 2
Deficiency Photo1

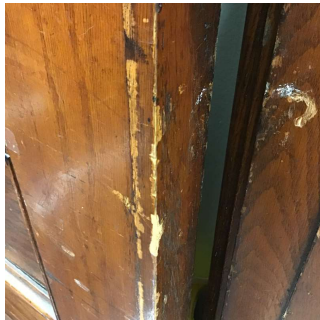
Violations	Corridor near Room 120 No violations recorded.
<b>Door(s)</b>	
Condition	Inspected 5 - Poor
Deficiency	WOOD: DETERIORATED DOOR
Deficiency Location/Instance	Rooms 101,103,105, Main Entrance Lobby, Exit H8 - Vestibule and others
Deficiency Quantity	34
Quantity Uom	EACH
Potential Action	MAINTENANCE
Urgency of Action	PRIORITY 3
Purpose of Action	LEVEL 2
Deficiency Photo1

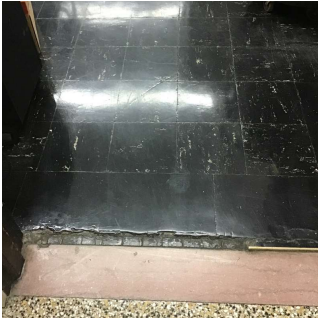
Question	Response
<b>INTERIOR</b>	
<b>CLASSROOMS/CORRIDORS/ADMIN SPACES</b>	
<b>Floor Finish</b>	
Deficiency	VINYL TILES: BROKEN/DETERIORATED/MISSING TILES
Deficiency Location/Instance	Rooms 101,359,431,433,460 and others
Deficiency Quantity	2,500
Quantity Uom	S.F.
Potential Action	REPLACE
Urgency of Action	PRIORITY 3
Purpose of Action	LEVEL 2
Deficiency Photo1

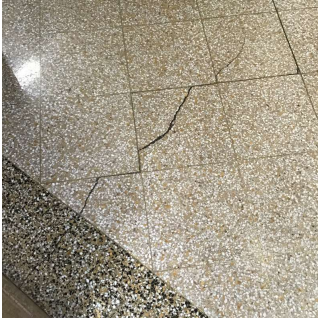
Violations	Room 101 No violations recorded.
Deficiency	TERRAZZO: CRACKS
Deficiency Location/Instance	Main Entrance Vestibule, Corridor near Auditorium, By Rooms 101,153, Next to Stair EF/1 and others
Deficiency Quantity	80
Quantity Uom	S.F.
Potential Action	REPLACE
Urgency of Action	PRIORITY 3
Purpose of Action	LEVEL 2
Deficiency Photo1

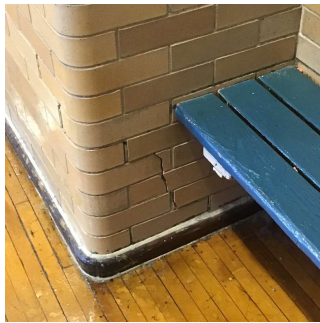
Question	Response
<b>INTERIOR</b>	
<b>GYMNASIUM</b>	
<b>Walls</b>	
Deficiency Photo1

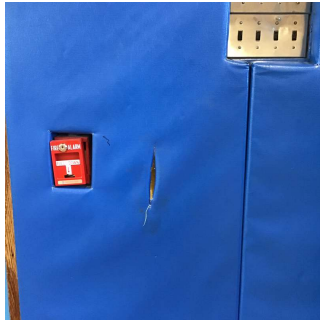
Violations	Right Side No violations recorded.
Deficiency	<b>WALL PADDING: DETERIORATED</b>
Deficiency Location/Instance	Near Room 352, By Entrance
Deficiency Quantity	160
Quantity Uom	S.F.
Potential Action	REPLACE
Urgency of Action	PRIORITY 3
Purpose of Action	LEVEL 2
Deficiency Photo1

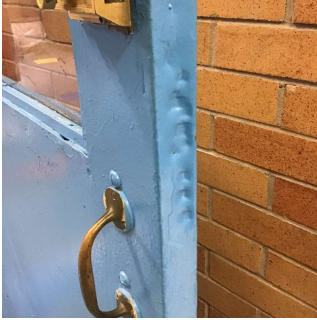
Violations	Stair EF/3 No violations recorded.
<b>KITCHEN</b>	Inspected
Instance on 1st Floor	Inspected
<b>Ceiling</b>	
Instance on 1st Floor	Inspected
Condition	2 - Between Good and Fair
Deficiency	No deficiencies recorded
<b>Door(s)</b>	
Instance on 1st Floor	Inspected
Condition	5 - Poor
Deficiency	METAL: DETERIORATED DOOR
Deficiency Location/Instance	Entrance
Deficiency Quantity	1
Quantity Uom	EACH
Potential Action	MAINTENANCE
Urgency of Action	PRIORITY 3
Purpose of Action	LEVEL 2
Deficiency Photo1

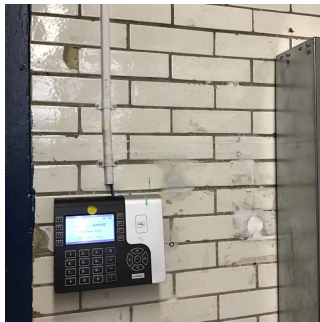
Office Room
Violations	No violations recorded.
<b>Walls</b>	
Instance on 1st Floor	Inspected
Condition	2 - Between Good and Fair
Deficiency	BRICK: CRACKS/SPALLING
Deficiency Location/Instance	Near Entrance
Deficiency Quantity	10
Quantity Uom	S.F.
Potential Action	REPLACE
Urgency of Action	PRIORITY 3
Purpose of Action	LEVEL 2
Deficiency Photo1

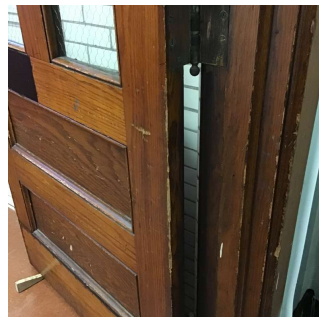
Violations	Exit 9 - Vestibule No violations recorded.
Deficiency	WOOD: DETERIORATED DOOR
Deficiency Location/Instance	Exit 9 - Vestibule
Deficiency Quantity	1
Quantity Uom	EACH
Potential Action	MAINTENANCE
Urgency of Action	PRIORITY 3
Purpose of Action	LEVEL 2
Deficiency Photo1

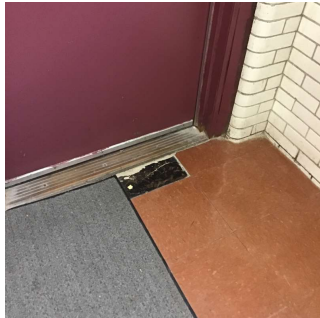
Stair CD/1
Violations	No violations recorded.
<b>Partition</b>	Inspected
Condition	2 - Between Good and Fair
Deficiency	No deficiencies recorded
<b>Railings</b>	Inspected
Condition	2 - Between Good and Fair
Deficiency	No deficiencies recorded
<b>Stairs and Landings</b>	Inspected
Condition	5 - Poor
Deficiency	VINYL TILES: BROKEN/DETERIORATED/MISSING TILES
Deficiency Location/Instance	Exit 9 - Vestibule, Stair J/1
Deficiency Quantity	20
Quantity Uom	S.F.
Potential Action	REPLACE
Urgency of Action	PRIORITY 3
Purpose of Action	LEVEL 2
Deficiency Photo1

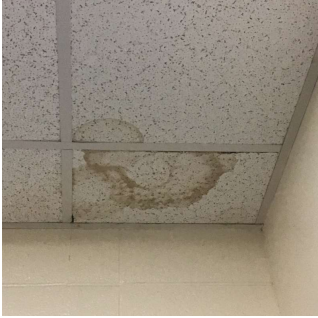
Room 451
Violations	No violations recorded.
Deficiency	ACOUSTIC TILES: DAMAGED/MISSING
Deficiency Location/Instance	Staff Toilet - 1st Floor
Deficiency Quantity	10
Quantity Uom	S.F.
Potential Action	REPLACE
Urgency of Action	PRIORITY 3
Purpose of Action	LEVEL 2
Deficiency Photo1

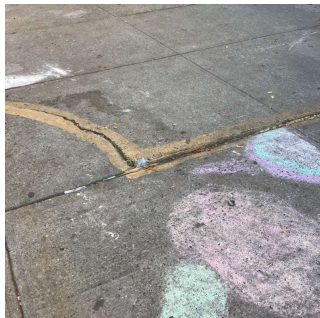
Violations	Dahill Road No violations recorded.
<b>Pavers</b>	Does not Exist
<b>DOT Sidewalk</b>	Inspected
<b>Asphalt</b>	Does not Exist
<b>Concrete</b>	Inspected
Condition	4 - Between Fair and Poor
Deficiency	HEAVING
Deficiency Location/Instance	McDonald Avenue, Dahill Road, Albemarle Road
Deficiency Quantity	600
Quantity Uom	S.F.
Potential Action	REPLACE
Urgency of Action	PRIORITY 3
Purpose of Action	LEVEL 2
Deficiency Photo1

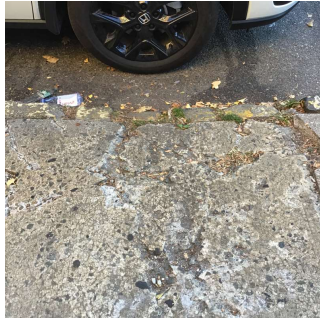
Violations	McDonald Avenue No violations recorded.
Deficiency	DAMAGED CURBS
Deficiency Location/Instance	McDonald Avenue, Albemarle Road, Dahill Road
Deficiency Quantity	200
Quantity Uom	L.F.
Potential Action	REPLACE
Urgency of Action	PRIORITY 3
Purpose of Action	LEVEL 2
Deficiency Photo1
