**NYC Department of Education**  
**Building Condition Assessment Survey 2023 - 2024**

Architectural Inspection

**Asset: P.S. 231 - BROOKLYN, 360 36TH STREET, New York, 11232**

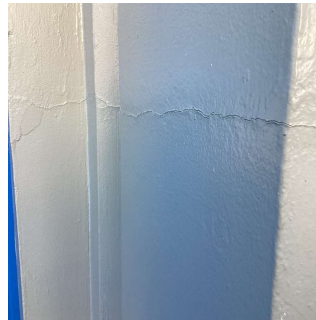
Facade A

CAST IN PLACE / PRE-CAST CONCRETE: MAJOR CRACKS/SPALLING

REPLACE

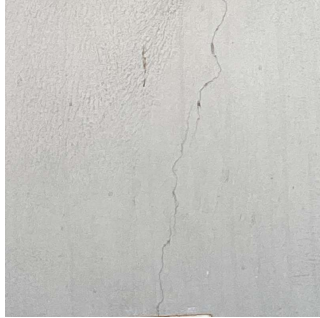
CAST IN PLACE / PRE-CAST CONCRETE: MINOR CRACKS/SPALLING

Question	Response
<b>EXTERIOR</b>	
<b>EXTERIOR WALLS</b>	
Potential Action	REPAIR
Urgency of Action	PRIORITY 3
Purpose of Action	LEVEL 2
Deficiency Photo1

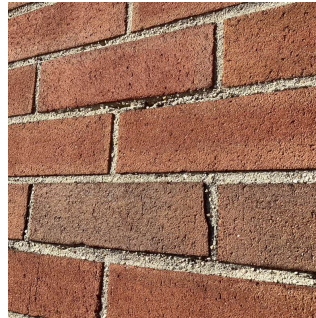
BH1

Question	Response
<b>EXTERIOR</b>	
<b>ROOF</b>	
Specialties	Inspected
<b>BULKHEAD/PENTHOUSE</b>	Inspected
Condition	3 - Fair
Deficiency	<b>BULKHEAD/PENTHOUSE WALLS/EXTERIOR: MAJOR THRU CRACKS</b>
Roof Plan reference	
Deficiency Quantity	30
Quantity Uom	S.F.
Potential Action	REMOVE AND REBUILD
Urgency of Action	PRIORITY 4
Purpose of Action	LEVEL 2
Deficiency Photo1	
Violations	No violations recorded.
Deficiency	<b>BULKHEAD/PENTHOUSE WALLS/EXTERIOR: DETERIORATED JOINTS</b>
Roof Plan reference	
Deficiency Quantity	50
Quantity Uom	S.F.
Potential Action	REPOINT
Urgency of Action	PRIORITY 4
Purpose of Action	LEVEL 2

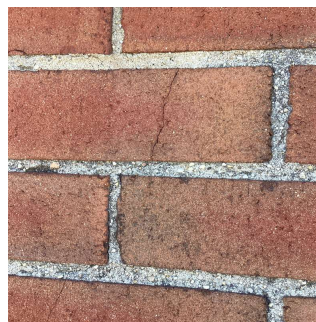
BH1

**BULKHEAD/PENTHOUSE WALLS/EXTERIOR:  
CRACKS/SPALLING - MINOR**

REPAIR

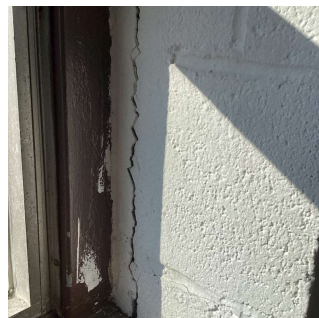
**BULKHEAD/PENTHOUSE WALLS/INTERIOR: CMU  
CRACKS/SPALLING**

Deficiency Quantity	40
Quantity Uom	S.F.
Potential Action	REPLACE
Urgency of Action	PRIORITY 4
Purpose of Action	LEVEL 2
Deficiency Photo1

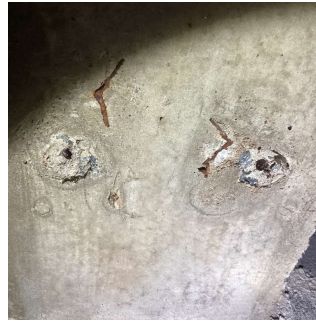
<b>Question</b>	<b>Response</b>
<b>EXTERIOR</b>	
<b>WINDOWS</b>	
<b>WINDOWS</b>	Inspected
Material Type(s)	Aluminum
Instance on Aluminum - Double Hung: All Facades	Inspected
Instance Condition	2 - Between Good and Fair
Instance Quantity	4,000
Instance Quantity Uom	S.F.
Are these windows insulated	Yes
Installation Year	2008
Source of Installation	Custodial Staff
Deficiency	No deficiencies recorded
<b>INTERIOR</b>	Inspected
<b>POOLS</b>	Does not Exist
<b>STRUCTURAL</b>	Inspected
<b>COLUMNS/BEAMS/BEARING WALLS</b>	Inspected
Condition	3 - Fair
Deficiency	STEEL COLUMNS/BEAMS: DETERIORATED MASONRY FIREPROOFING
Deficiency Location/Instance	Sub-cellar - Crawlspace
Deficiency Quantity	10
Quantity Uom	S.F.
Potential Action	REPLACE
Urgency of Action	PRIORITY 4
Purpose of Action	LEVEL 5
Deficiency Photo1	 
	Sub-cellar - Crawlspace
Violations	No violations recorded.
Deficiency	STEEL COLUMNS/BEAMS: DETERIORATED CONCRETE FIREPROOFING

Deficiency Location/Instance	Sub-cellar - Crawlspace
Deficiency Quantity	10
Quantity Uom	S.F.
Potential Action	REPLACE
Urgency of Action	PRIORITY 4
Purpose of Action	LEVEL 5

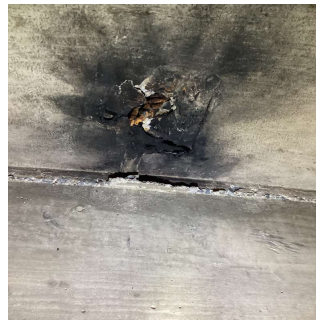
Sub-cellar - Crawlspace

CONCRETE: CRACKS/SPALLED/REINFORCEMENT EXPOSED

Sub-cellar - Crawlspace, Basement - Room B6

REPAIR

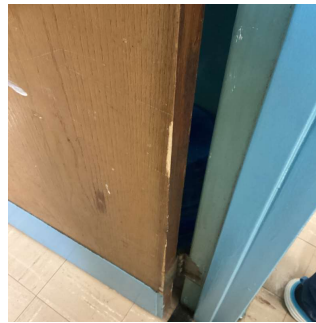
Room 302

Deficiency	WOOD: DETERIORATED DOOR
Deficiency Location/Instance	Rooms 222, 302, 306, 307, 310 and others
Deficiency Quantity	17
Quantity Uom	EACH
Potential Action	MAINTENANCE
Urgency of Action	PRIORITY 3
Purpose of Action	LEVEL 2

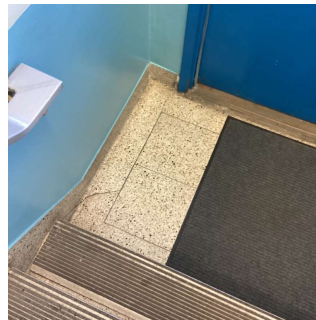
TERRAZZO: CRACKS

Main Entrance - Vestibule

REPLACE

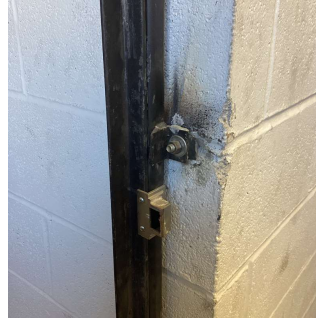
Condition	2 - Between Good and Fair
Deficiency	DETERIORATED/TORN-OUT/MISSING
Deficiency Location/Instance	Stair A/Bulkhead
Deficiency Quantity	20
Quantity Uom	S.F.
Potential Action	REPLACE
Urgency of Action	PRIORITY 3
Purpose of Action	LEVEL 2
Deficiency Photo1

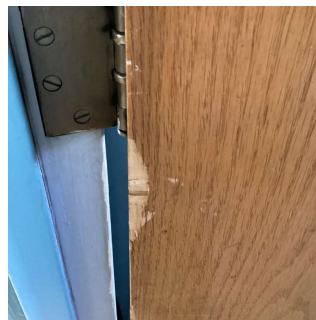
Deficiency	WOOD: DETERIORATED DOOR
------------	-------------------------

Deficiency Location/Instance	Main Entrance
------------------------------	---------------

Potential Action	MAINTENANCE
------------------	-------------

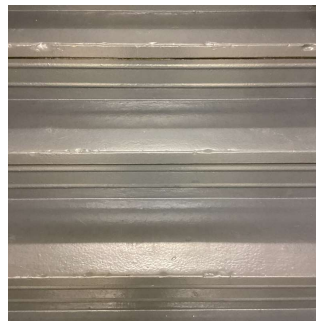
Stair AB/3

STONE: BROKEN/MISSING

Stairs AB/3, 2, 1, Basement

REPLACE

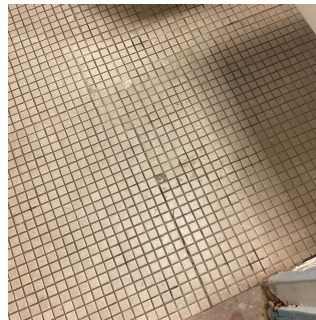
CERAMIC TILE: DETERIORATED SUBSTRATE

Room B9

REPLACE

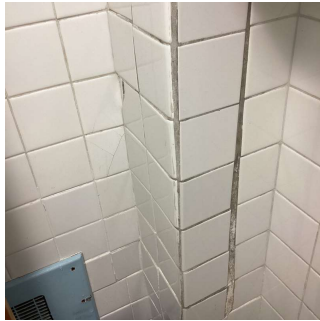
CERAMIC TILE: BROKEN/ MISSING

Rooms B1, B9, 113, 114, 203

REPLACE
