NYC Department of Education
Building Condition Assessment Survey 2023 - 2024

Architectural Inspection

Asset: I.S. 234 - BROOKLYN, 1875 E 17 STREET, New York, 11229

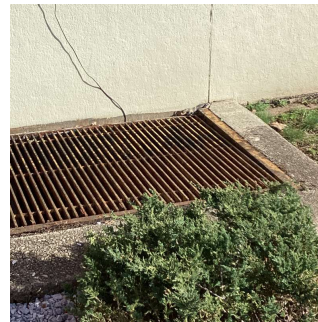
AW3
No violations recorded.

Question	Response
Architectural	
EXTERIOR	Inspected
AREAWAY	Inspected
Instance on AW1-AW4	Inspected
Instance Condition	3 - Fair
Instance Quantity	4
Instance Quantity Uom	EACH
Deficiency	AREAWAY GRATINGS: MAJOR RUSTING AND / OR BROKEN SUPPORTS

35
L.F.
REPLACE
PRIORITY 4
LEVEL 2

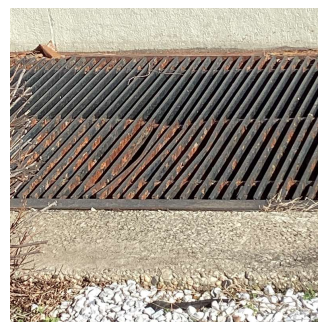
AW2

AREAWAY GRATINGS: MAJOR RUSTING / OR BROKEN

40
S.F.
REPLACE
PRIORITY 4
LEVEL 2

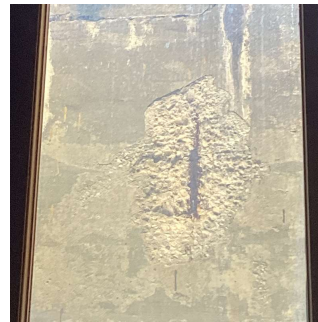
AW2
 No violations recorded.

AREAWAY WALLS: CRACKS AND SPALLING

30
 S.F.
 REPLACE
 PRIORITY 4
 LEVEL 2

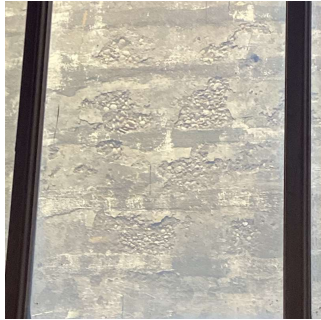
AREAWAY WALLS: CRACKS AND SPALLING

45
 S.F.
 REPAIR
 PRIORITY 3
 LEVEL 2

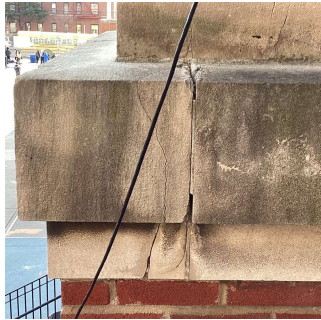
Violations	AW2 No violations recorded.
AWNINGS AND CANOPIES	Does not Exist
CHIMNEY	Inspected
Material Type(s)	Masonry
Condition	5 - Poor
Deficiency	STONE/TERRA COTTA BAND: MAJOR DETERIORATION
Roof Plan reference

Deficiency Quantity	25
Quantity Uom	S.F.
Potential Action	REPLACE
Urgency of Action	PRIORITY 5
Purpose of Action	LEVEL 6
Deficiency Photo1

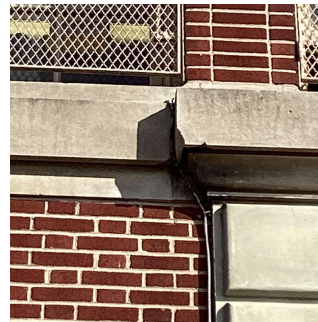
Facade A

Violations	CH1 No violations recorded.
COPING	Inspected
Condition	2 - Between Good and Fair
Deficiency	No deficiencies recorded
CORNICE	Inspected
Condition	3 - Fair
Deficiency	STONE: MINOR CRACKS, SPALLING

10
S.F.
REPAIR
PRIORITY 3
LEVEL 2

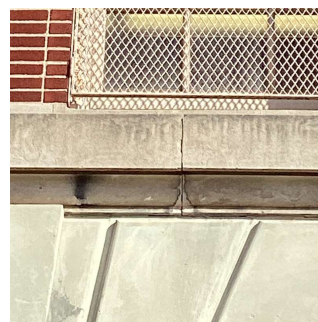
Facade A

STONE: DETERIORATED JOINTS

15
L.F.
REPOINT
PRIORITY 4
LEVEL 2

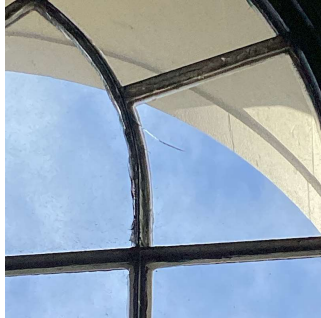
METAL: BROKEN GLASS

Question	Response
EXTERIOR	
DOORS	Inspected
TRANSOM/SIDE LIGHT	
Quantity Uom	S.F.
Potential Action	MAINTENANCE
Urgency of Action	PRIORITY 3
Purpose of Action	LEVEL 2
Deficiency Photo1

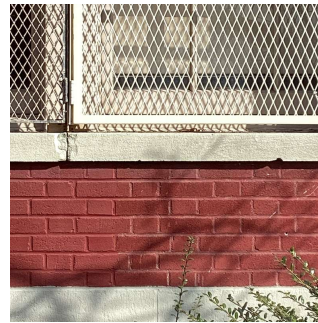
Facade A

BRICK: DETERIORATED MASONRY SILLS - MAJOR

REMOVE AND REPLACE

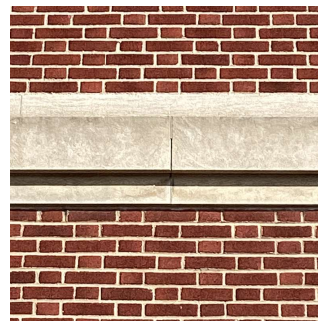
Facade A

STONE: DETERIORATED JOINTS

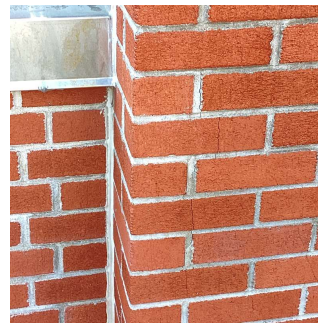
Roof 7

BRICK: MINOR CRACKS, SPALLING

REPAIR

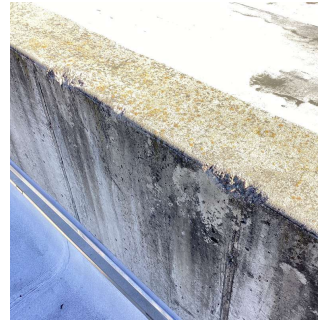
Roof 7

CONCRETE: MINOR CRACKS, SPALLING

REPAIR

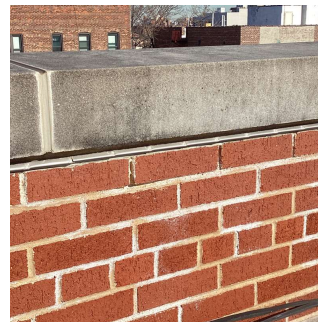
Roof 1

BRICK: DETERIORATED JOINTS

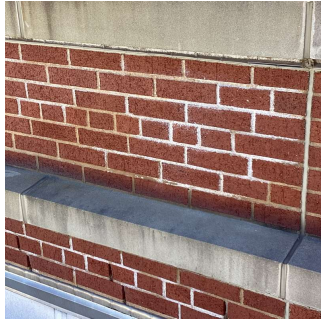
BRICK: EFFLORESCENCE

Question	Response
EXTERIOR	
PARAPETS	
Quantity Uom	S.F.
Potential Action	MAINTENANCE
Urgency of Action	PRIORITY 1
Purpose of Action	LEVEL 1
Deficiency Photo1

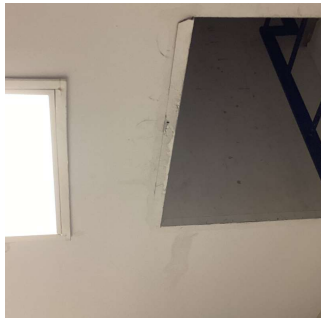
Violations	RH2 - Kitchen Storage Room 130 No violations recorded.

Violations	Roof 1 No violations recorded.
PLAZA DECK	Does not Exist
ROOF	Inspected
Roofing	Inspected
Replacement Quantity	38,500
Replacement Uom	S.F.
ROOF HATCH/SMOKE HATCH	Inspected
Condition	5 - Poor
Deficiency	WATER INFILTRATION
Roof Plan reference

Deficiency Quantity	1
Quantity Uom	EACH
Potential Action	REPAIR
Urgency of Action	PRIORITY 5
Purpose of Action	LEVEL 2
Deficiency Photo1

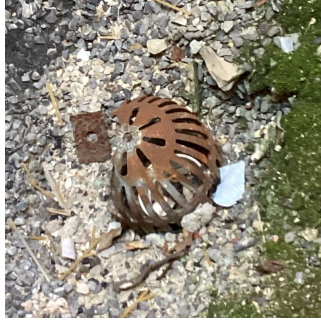
Question	Response
EXTERIOR	
ROOF	
Roofing	
ROOFING DRAINS	
Urgency of Action	PRIORITY 4
Purpose of Action	LEVEL 2
Deficiency Photo1

Roof 9
Violations	No violations recorded.
Specialties	Inspected
BULKHEAD/PENTHOUSE	Inspected
Condition	3 - Fair
Deficiency	BULKHEAD/PENTHOUSE CEILING: PLASTER DAMAGED/DETERIORATED
Roof Plan reference	<p>K234</p>

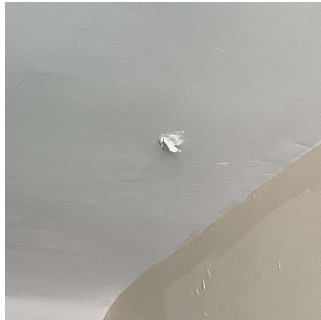
Deficiency Quantity	10
Quantity Uom	S.F.
Potential Action	REPLACE
Urgency of Action	PRIORITY 3
Purpose of Action	LEVEL 2
Deficiency Photo1

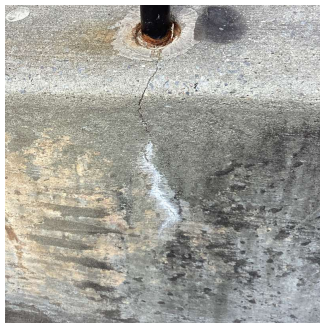
CAST IN PLACE CONCRETE: CRACKS/SPALLING - MINOR

20
S.F.
REPAIR
PRIORITY 3
LEVEL 2

Question	Response
EXTERIOR	
STAIRS/RAMPS: EXTERIOR	
BUILDING CHEEK/FLANK WALLS	
Deficiency Photo1

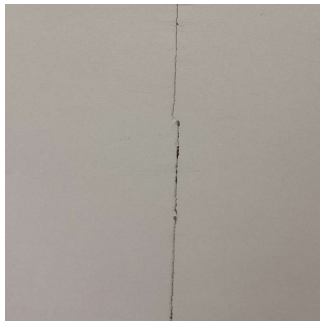
Violations	Gas Meter Room (Basement Storage Area similar) No violations recorded.
ROOF STRUCTURE	
Condition	Inspected 3 - Fair
Deficiency	CONCRETE: CRACKED/SPALLED/REINFORCEMENT EXPOSED
Deficiency Location/Instance	BH2
Deficiency Quantity	35
Quantity Uom	S.F.
Potential Action	REPAIR
Urgency of Action	PRIORITY 3
Purpose of Action	LEVEL 5
Deficiency Photo1

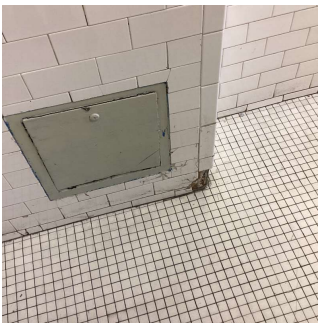
Question	Response
INTERIOR	
TOILET ROOMS - STAFF	
Walls	
Deficiency Photo1

Violations	Room 112 No violations recorded.
TOILET ROOMS - STUDENTS	
Ceiling	Inspected
Condition	4 - Between Fair and Poor
Deficiency	ACOUSTIC TILES: DAMAGED/MISSING - ACTIVE LEAK
Deficiency Location/Instance	Room A314
Deficiency Quantity	200
Quantity Uom	S.F.
Potential Action	REPLACE
Urgency of Action	PRIORITY 5
Purpose of Action	LEVEL 2
Deficiency Photo1
