NYC Department of Education
Building Condition Assessment Survey 2023 - 2024

Architectural Inspection

K237

Asset: LUCRETIA MARCIGLIANO CAMPUS - K, 50 AVENUE P, New York, 11204

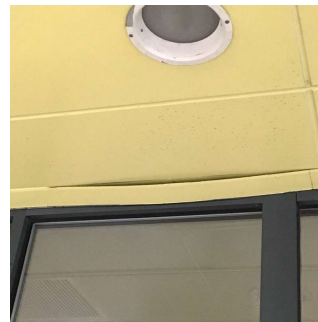
Facade A

Question	Response
Architectural	
EXTERIOR	Inspected
AREAWAY	Does not Exist
AWNINGS AND CANOPIES	Inspected
Condition	3 - Fair
Deficiency	METAL: DETERIORATION/DAMAGED/MISSING PIECES

20
S.F.
REPLACE
PRIORITY 4
LEVEL 2

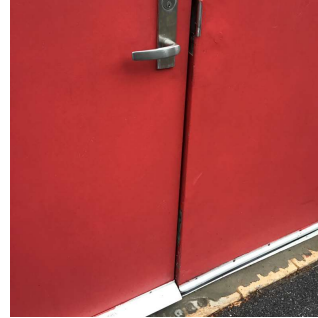
Facade E

Deficiency	METAL: DETERIORATED DOOR - MAJOR DETERIORATION
------------	--

1
EACH
REPLACE

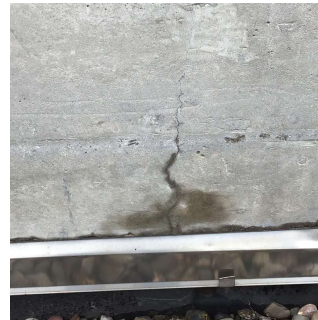
Roof 1
 No violations recorded.

10
 S.F.
 REPAIR
 PRIORITY 3
 LEVEL 2

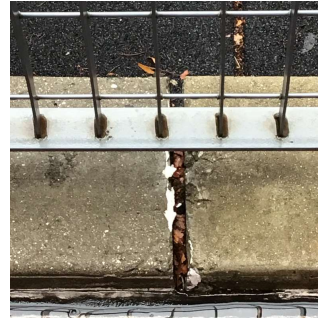
Facade C

ROOF/GRAVITY TANK	Does not Exist
STAIRS/RAMPS: EXTERIOR	Inspected
BUILDING CHEEK/FLANK WALLS	Inspected
Condition	3 - Fair
Deficiency	CAST IN PLACE CONCRETE: DETERIORATED CONTROL/EXPANSION JOINT
Roof Plan reference

L.F.
 REPLACE
 PRIORITY 3
 LEVEL 2

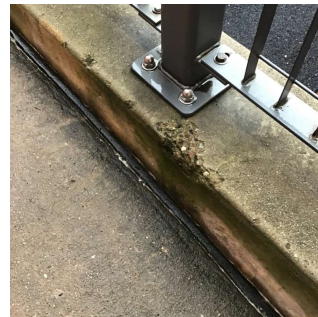
Facade C

CAST IN PLACE CONCRETE: CRACKS/SPALLING - MINOR

10
 S.F.
 REPAIR
 PRIORITY 3
 LEVEL 2

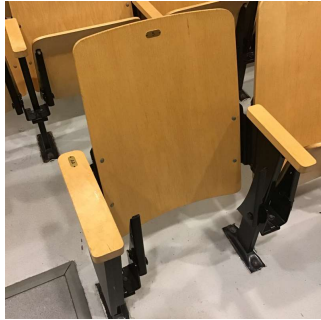
Condition	3 - Fair
Deficiency	DAMAGED/BROKEN/INOPERABLE
Deficiency Location/Instance	Seats AA/5, D/3, E/20, J/5
Deficiency Quantity	4
Quantity Uom	EACH
Potential Action	REPLACE
Urgency of Action	PRIORITY 5
Purpose of Action	LEVEL 6
Deficiency Photo1

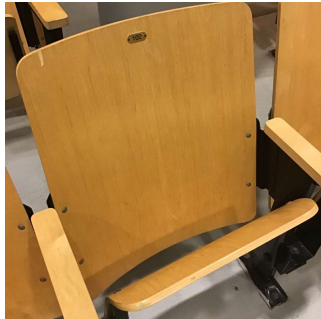
Deficiency	DAMAGED/BROKEN/INOPERABLE
Deficiency Location/Instance	Seats C/104, D/104, H/102, J/106,111 and others
Deficiency Quantity	10
Quantity Uom	EACH
Potential Action	REPLACE
Urgency of Action	PRIORITY 3
Purpose of Action	LEVEL 2
Deficiency Photo1

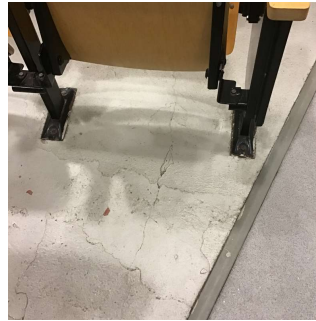
Near Seat B/2

Instance on 1st Floor (344 Seats)	Inspected
Condition	2 - Between Good and Fair
Deficiency	CONCRETE: CRACKS
Deficiency Location/Instance	Near Seats B/2, E/16,102,109
Deficiency Quantity	40
Quantity Uom	S.F.
Potential Action	REPLACE
Urgency of Action	PRIORITY 3
Purpose of Action	LEVEL 2

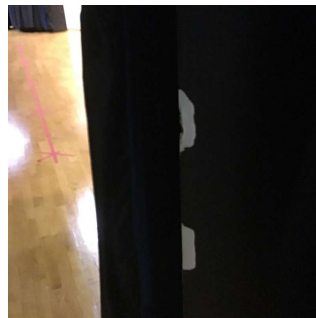
Right Side Stage

GYPSUM BOARD: DETERIORATED

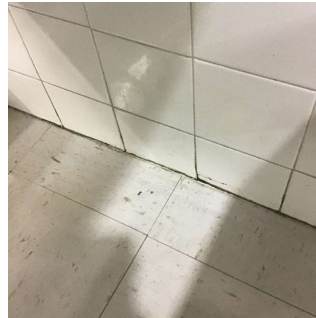
Near Servery

CERAMIC TILE: BROKEN/ MISSING

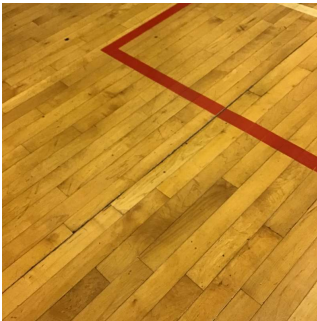
Priority Condition Exist Last Year?	Priority Category	Condition Description	Component Affected	Location Description	Person(s) Notified	Person(s) Title	PhotoImage
Yes	Tripping Hazard	Severely damaged Wood Floor is a potential tripping hazard	INTERIOR GYMNASIUM Floor Finish	Near Sliding Folding Partition	James Mulroy	Fireman

Violations	Near Sliding Folding Partition No violations recorded.
Deficiency	WOOD: DAMAGED/DETERIORATED
Deficiency Location/Instance	East and West Side, Center
Deficiency Quantity	140
Quantity Uom	S.F.
Potential Action	REPLACE
Urgency of Action	PRIORITY 3
Purpose of Action	LEVEL 2
Deficiency Photo1

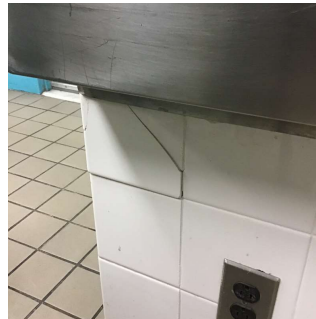
Instance on Basement	Inspected
Condition	2 - Between Good and Fair
Deficiency	CERAMIC TILE: BROKEN/ MISSING
Deficiency Location/Instance	Servery
Deficiency Quantity	10
Quantity Uom	S.F.
Potential Action	REPLACE
Urgency of Action	PRIORITY 3
Purpose of Action	LEVEL 2
Deficiency Photo1

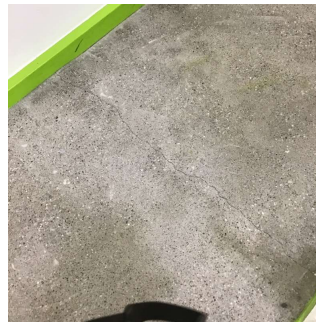
Deficiency	No deficiencies recorded
Partition	Does not Exist
Railings	Inspected
Condition	2 - Between Good and Fair
Deficiency	No deficiencies recorded
Stairs and Landings	Inspected
Condition	2 - Between Good and Fair
Deficiency	CONCRETE: CRACKS/SPALLING - MAJOR
Deficiency Location/Instance	Stair to GreenHouse
Deficiency Quantity	10
Quantity Uom	S.F.
Potential Action	REPLACE
Urgency of Action	PRIORITY 3
Purpose of Action	LEVEL 2

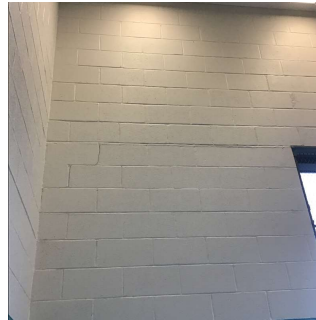
Stair A/3

MASONRY: CRACKS/SPALLING

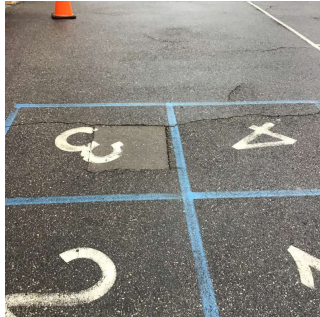
Condition	3 - Fair
Deficiency	CRACKS - MAJOR
Deficiency Location/Instance	Schoolyard
Deficiency Quantity	400
Quantity Uom	S.F.
Potential Action	REPLACE
Urgency of Action	PRIORITY 3
Purpose of Action	LEVEL 2
