NYC Department of Education
Building Condition Assessment Survey 2023 - 2024

Architectural Inspection

Asset: P.S. 238 - BROOKLYN, 1633 EAST 8 STREET, New York, 11223

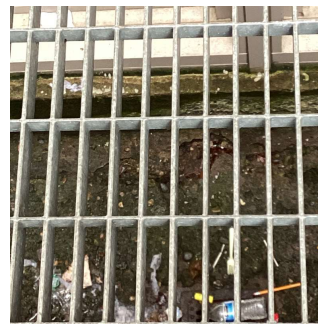
AW5

AREAWAY SLAB: CRACKS AND SPALLING

REPLACE

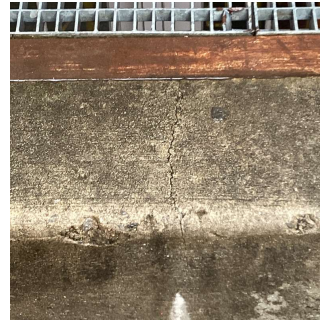
AW5

AREAWAY WALLS: CRACKS AND SPALLING

REPAIR

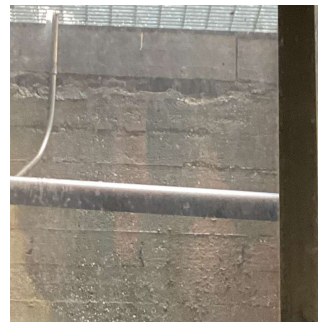
AW1
No violations recorded.

AREAWAY WALLS: CRACKS AND SPALLING

70
S.F.
REPLACE
PRIORITY 4
LEVEL 2

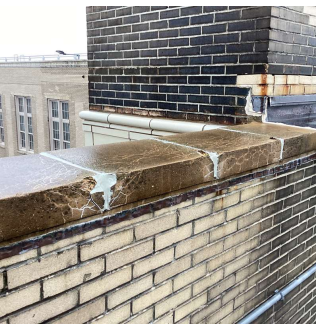
CAST STONE: DISINTEGRATING / FREEZE THAW

REPLACE-IN-KIND

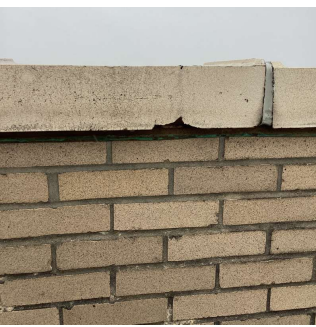
<p>Roof 1</p> <p>No violations recorded.</p>
Deficiency Roof Plan reference Deficiency Quantity Quantity Uom Potential Action Urgency of Action Purpose of Action Deficiency Photo1	<p>TERRA COTTA: CRACKED/BROKEN PIECES</p>

<p>135</p> <p>L.F.</p> <p>REPLACE-IN-KIND</p> <p>PRIORITY 4</p> <p>LEVEL 2</p>

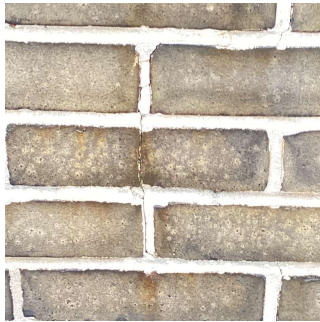
BRICK: MINOR CRACKS, SPALLING

REPAIR

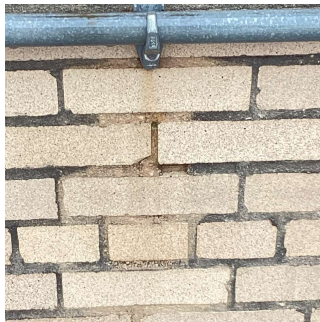
Violations	Roof 1 No violations recorded.
Deficiency	BRICK: DETERIORATED JOINTS
Roof Plan reference	K238

Deficiency Quantity	30
Quantity Uom	S.F.
Potential Action	REPOINT
Urgency of Action	PRIORITY 3
Purpose of Action	LEVEL 2
Deficiency Photo1

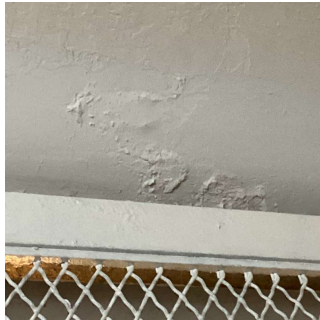
Violations	Roof 1 No violations recorded.
ROOFING DRAINS	Inspected
Condition	2 - Between Good and Fair
Deficiency	No deficiencies recorded
Specialties	Inspected
BULKHEAD/PENTHOUSE	Inspected
Condition	3 - Fair
Deficiency	BULKHEAD/PENTHOUSE CEILING: PLASTER DAMAGED/DETERIORATED
Roof Plan reference	K238

Deficiency Quantity	15
Quantity Uom	S.F.
Potential Action	REPLACE
Urgency of Action	PRIORITY 3
Purpose of Action	LEVEL 2
Deficiency Photo1

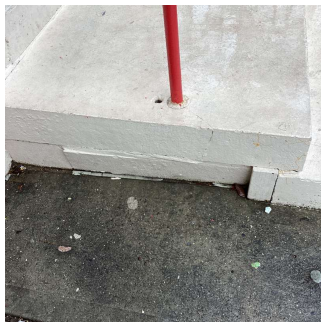
Violations	Facade H No violations recorded.

Violations	BH No violations recorded.
CUPOLA/ SPIRES/ TOWERS	Does not Exist
DORMER	Does not Exist
DUNNAGE STEEL	Does not Exist
SKYLIGHT/ROOF VENT	Does not Exist
ROOF/GRAVITY TANK	Does not Exist
STAIRS/RAMPS: EXTERIOR	Inspected
BUILDING CHEEK/FLANK WALLS	Inspected
Condition	5 - Poor
Deficiency	STONE: BULGING/DISPLACED
Roof Plan reference	K238

E. 9th Street Avenue P E. 8th Street N
Deficiency Quantity	10
Quantity Uom	S.F.
Potential Action	REPLACE
Urgency of Action	PRIORITY 4
Purpose of Action	LEVEL 2
Deficiency Photo1

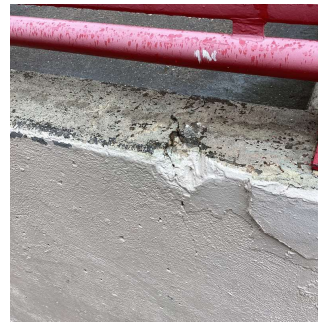
Facade C

CAST IN PLACE CONCRETE: CRACKS/SPALLING - MAJOR

REPLACE

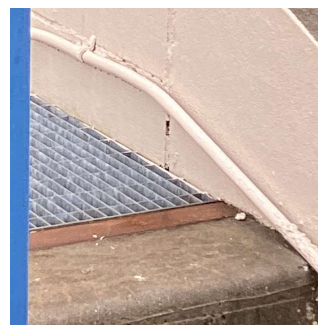
Facade A

STONE: DETERIORATED JOINTS

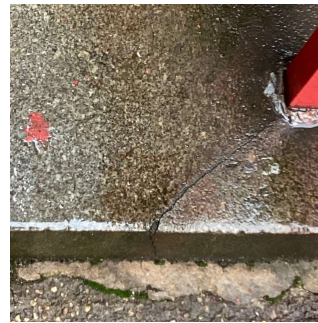
Facade E

STONE: CRACKS/SPALLING - MINOR

30
S.F.
REPAIR
PRIORITY 3
LEVEL 2

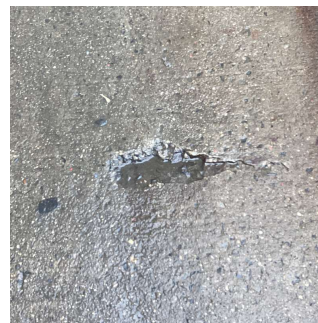
Facade C

CONCRETE: CRACKS/SPALLING - MAJOR

REPLACE

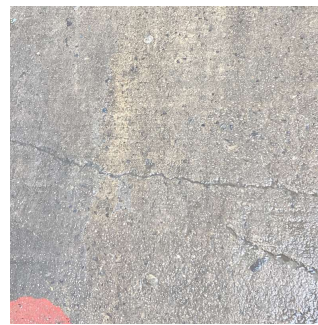
Facade C

CONCRETE: CRACKS/SPALLING - MINOR

20
S.F.
REPAIR
PRIORITY 3
LEVEL 2

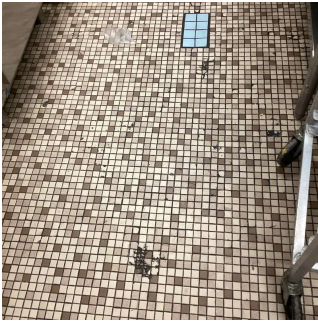
Violations	Room 163 No violations recorded.
Floor Finish	
Instance on 1st Floor	Inspected
Condition	2 - Between Good and Fair
Deficiency	CERAMIC TILE: BROKEN/MISSING TILES
Deficiency Location/Instance	Food Prep, Sink
Deficiency Quantity	20
Quantity Uom	S.F.
Potential Action	REPLACE
Urgency of Action	PRIORITY 3
Purpose of Action	LEVEL 2
Deficiency Photo1
