**NYC Department of Education**  
**Building Condition Assessment Survey 2023 - 2024**

Architectural Inspection

**Asset: P.S. 243 - BROOKLYN, 1580 DEAN STREET, New York, 11213**

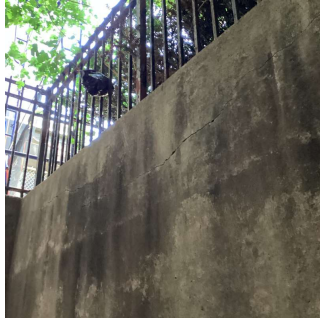
AREAWAY WALLS: CRACKS AND SPALLING

REPLACE

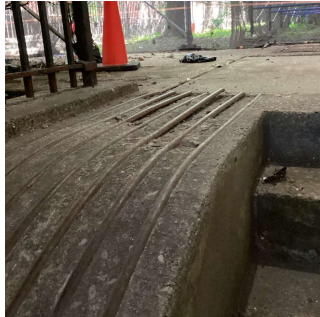
AW1
Violations	No violations recorded.
Deficiency	<b>AREAWAY STAIRS: DETERIORATED MATERIAL SLIDE</b>
Roof Plan reference

Deficiency Quantity	20
Quantity Uom	S.F.
Potential Action	REPLACE
Urgency of Action	PRIORITY 3
Purpose of Action	LEVEL 2
Deficiency Photo1

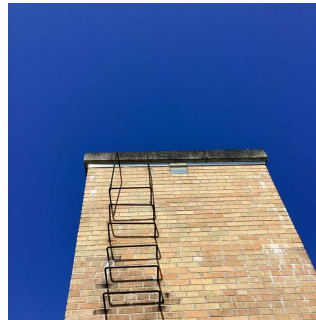
AW1
Violations	No violations recorded.
Instance on AW2	Inaccessible
Instance Quantity	1
Instance Quantity Uom	EACH
<b>AWNINGS AND CANOPIES</b>	Inaccessible
<b>CHIMNEY</b>	Inspected
Material Type(s)	Masonry
Condition	3 - Fair
Deficiency	BRICK: DETERIORATED LADDER

1  
EACH  
REPLACE  
PRIORITY 3  
LEVEL 2

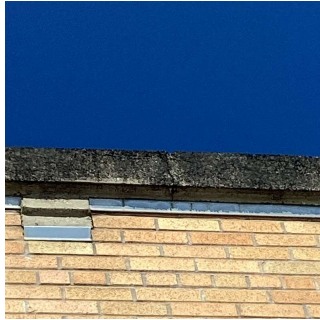
BRICK: DETERIORATED CAP

10  
L.F.  
REPLACE  
PRIORITY 4  
LEVEL 2

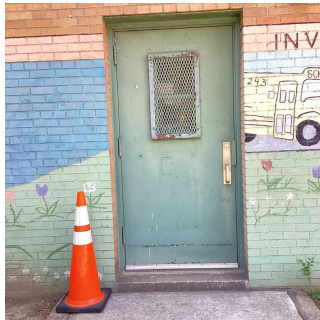
CH
Violations	No violations recorded.
<b>COPING</b>	Inspected
Condition	2 - Between Good and Fair
Deficiency	No deficiencies recorded
<b>CORNICE</b>	Does not Exist
<b>DOORS</b>	Inspected
<b>DOORS AND FRAMES</b>	Inspected
Condition	5 - Poor
Deficiency	METAL: DETERIORATED DOOR - MAJOR DETERIORATION
Roof Plan reference

Deficiency Quantity	1
Quantity Uom	EACH
Potential Action	REPLACE
Urgency of Action	PRIORITY 4
Purpose of Action	LEVEL 2
Deficiency Photo1

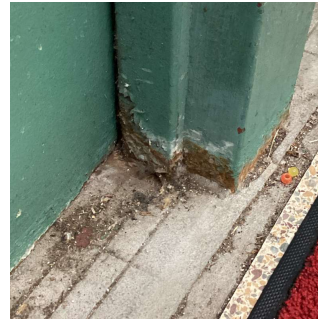
Facade A
Violations	No violations recorded.
Deficiency	METAL: DETERIORATED DOOR AND FRAME - MINOR DETERIORATION

7  
EACH  
MAINTENANCE  
PRIORITY 3  
LEVEL 2

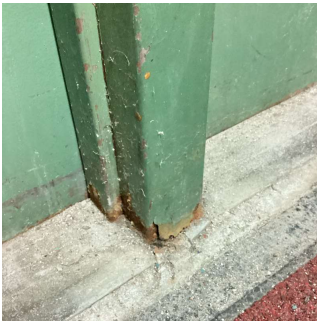
**METAL: DETERIORATED DOOR AND FRAME - MAJOR DETERIORATION**

6  
EACH  
REPLACE  
PRIORITY 4  
LEVEL 2

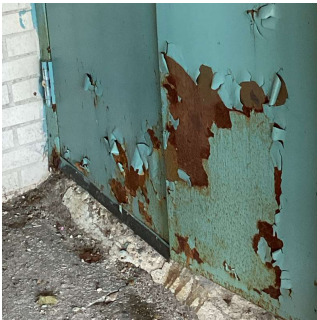
Violations	Facade C No violations recorded.
Deficiency	METAL CLAD: DETERIORATED DOOR AND FRAME - MAJOR DETERIORATION
Roof Plan reference

Deficiency Quantity	4
Quantity Uom	EACH
Potential Action	REPLACE
Urgency of Action	PRIORITY 4
Purpose of Action	LEVEL 2
Deficiency Photo1

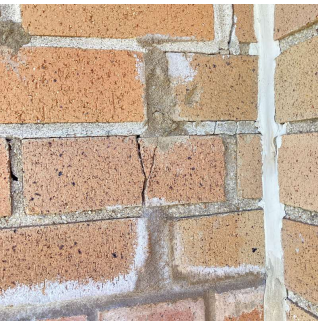
Question	Response
<b>EXTERIOR</b>	
<b>EXTERIOR WALLS</b>	Inspected
Material Type(s)	Masonry
Replacement Quantity	27,000
Replacement Uom	S.F.
Instance on All Facades	Inaccessible
Instance Quantity	27,000
Instance Quantity Uom	S.F.
<b>EXTERIOR SOFFITS</b>	Inspected
Condition	2 - Between Good and Fair
Deficiency	No deficiencies recorded
<b>LOADING DOCK</b>	Does not Exist
<b>LOUVER</b>	Inaccessible
<b>PARAPETS</b>	Inspected
Material Type(s)	Masonry
Replacement Quantity	3,000
Replacement Uom	C.F.
Instance on Roofs 2, 5, 6	Inspected
Instance Condition	3 - Fair
Instance Quantity	3,000
Instance Quantity Uom	C.F.
Deficiency	BRICK: MAJOR DETERIORATION/CRACKS
Roof Plan reference

Deficiency Quantity	10
Quantity Uom	S.F.
Potential Action	REMOVE AND REBUILD
Urgency of Action	PRIORITY 4
Purpose of Action	LEVEL 2
Deficiency Photo1

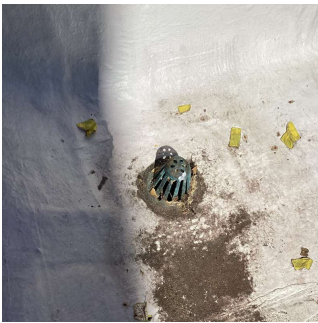
Roof 1
Instance Quantity	44,000
Instance Quantity Uom	S.F.
Does the roof have major mechanical equipment sitting on Dunnage Steel less than 18" above the Roofing?	No
Does this roof instance have a Sustainable Roof System?	Yes
Sustainable Roof Type	White Roof
Sustainable Roof Location (Roof Number)	All Roofs
Do solar panels exist on these roofs?	No
Is/Are the roof(s) suitable for Solar Panel installation?	Yes
Installation Year	2024
Source of Installation	Custodial Staff
Deficiency	No deficiencies recorded
<b>ROOFING DRAINS</b>	
	Inspected
Condition	3 - Fair
Deficiency	DETERIORATED
Roof Plan reference

Deficiency Quantity	1
Quantity Uom	EACH
Potential Action	REPLACE
Urgency of Action	PRIORITY 4
Purpose of Action	LEVEL 2
Deficiency Photo1

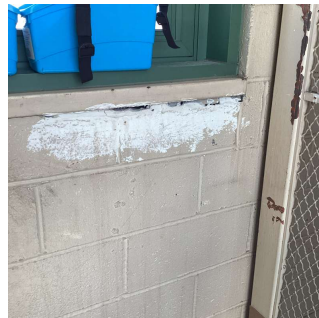
Question	Response
<b>EXTERIOR</b>	
<b>ROOF</b>	
<b>Specialties</b>	
<b>BULKHEAD/PENTHOUSE</b>	
Deficiency	BULKHEAD/PENTHOUSE WALLS/INTERIOR: CMU CRACKS/SPALLING
Roof Plan reference

Deficiency Quantity	55
Quantity Uom	S.F.
Potential Action	REPLACE
Urgency of Action	PRIORITY 3
Purpose of Action	LEVEL 2
Deficiency Photo1

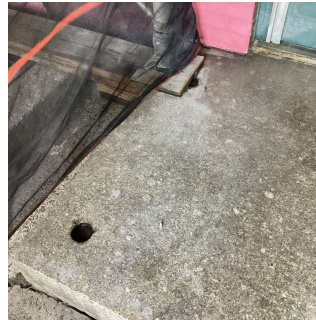
Facade C  
No violations recorded.

Violations	BH1 No violations recorded.
<b>CUPOLA/ SPIRES/ TOWERS</b>	Does not Exist
<b>DORMER</b>	Does not Exist
<b>DUNNAGE STEEL</b>	Does not Exist
<b>SKYLIGHT/ROOF VENT</b>	Does not Exist
<b>ROOF/GRAVITY TANK</b>	Does not Exist
<b>STAIRS/RAMPS: EXTERIOR</b>	Inspected
<b>BUILDING CHEEK/FLANK WALLS</b>	Does not Exist
<b>RAILINGS</b>	Inspected
Condition	3 - Fair
Deficiency	MISSING RAILING

20  
L.F.  
REPLACE  
PRIORITY 5  
LEVEL 6

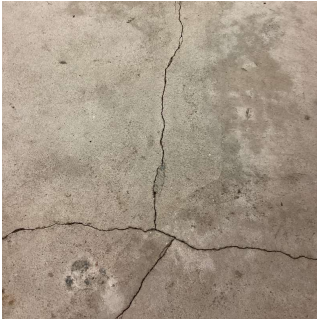
Question	Response
<b>INTERIOR</b>	
<b>STRUCTURAL</b>	
<b>FLOOR STRUCTURE</b>	
Deficiency Photo1	 
Violations	Basement - Gas Meter Room No violations recorded.
Deficiency	CONCRETE SLAB ON GRADE: THRU CRACKS
Deficiency Location/Instance	Basement - Fan Room, Electrical Room, Corridor, Oil Tank Room, Boiler Room Pit
Deficiency Quantity	70
Quantity Uom	S.F.
Potential Action	REPLACE
Urgency of Action	PRIORITY 4
Purpose of Action	LEVEL 5
Deficiency Photo1

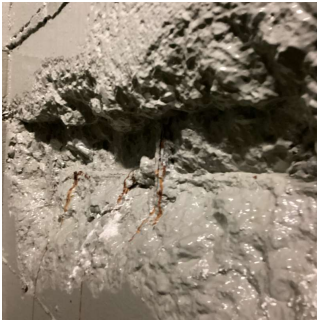
Violations	Basement - Boiler Room Pit No violations recorded.
Deficiency	CONCRETE: CRACKED/SPALLED/REINFORCEMENT EXPOSED
Deficiency Location/Instance	Basement - Oil Tank Room
Deficiency Quantity	35
Quantity Uom	S.F.
Potential Action	REPAIR
Urgency of Action	PRIORITY 4
Purpose of Action	LEVEL 5
Deficiency Photo1

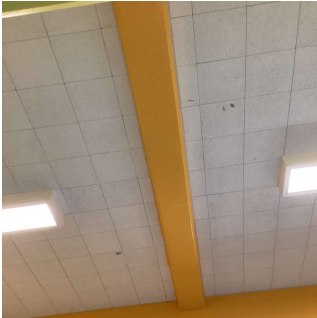
Question	Response
<b>INTERIOR</b>	
<b>CAFETERIA</b>	
<b>Ceiling</b>	
Deficiency	ACOUSTIC TILES ON PLASTER: DAMAGED/MISSING
Deficiency Location/Instance	Near Entrance, Center
Deficiency Quantity	20
Quantity Uom	S.F.
Potential Action	REPLACE
Urgency of Action	PRIORITY 3
Purpose of Action	LEVEL 2
Deficiency Photo1

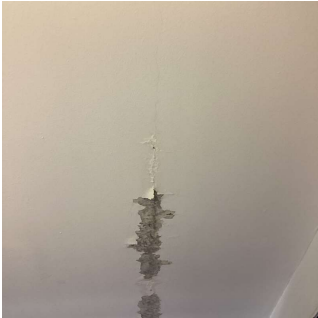
Violations	Near Entrance No violations recorded.
<b>Window Curtains/Shades/Blinds</b>	
Instance on 1st Floor	Does not Exist
<b>CLASSROOMS/CORRIDORS/ADMIN SPACES</b>	
<b>Ceiling</b>	Inspected
Condition	2 - Between Good and Fair
Deficiency	PLASTER: CRACKS/SPALLING

Deficiency Location/Instance	Rooms 304, 222, 122

Question	Response
<b>INTERIOR</b>	
<b>CLASSROOMS/CORRIDORS/ADMIN SPACES</b>	
<b>Ceiling</b>	
Deficiency Quantity	30
Quantity Uom	S.F.
Potential Action	REPLACE
Urgency of Action	PRIORITY 3
Purpose of Action	LEVEL 2
Deficiency Photo1

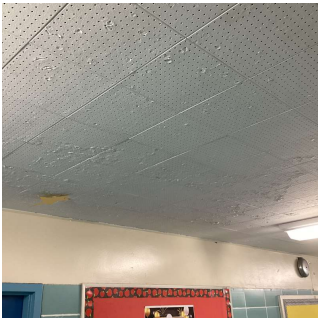
Violations	Room 304 No violations recorded.
Deficiency	ACOUSTIC TILES ON PLASTER: DAMAGED/MISSING
Deficiency Location/Instance	Corridor near Rooms 304, 302, 244, 133, 106 and others
Deficiency Quantity	100
Quantity Uom	S.F.
Potential Action	REPLACE
Urgency of Action	PRIORITY 3
Purpose of Action	LEVEL 2
Deficiency Photo1

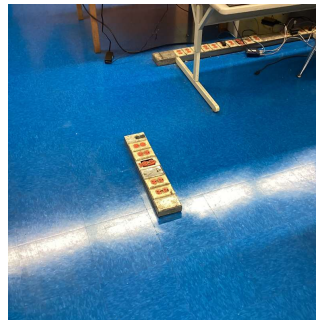
Room 213

VINYL TILES: TRIPPING HAZARD - ELECTRICAL OUTLET

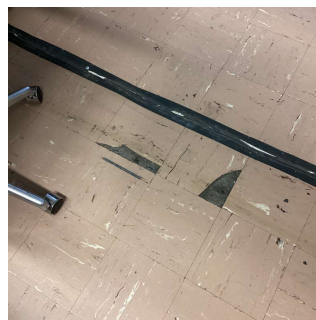
VINYL TILES: BROKEN/DETERIORATED/MISSING TILES

REPLACE

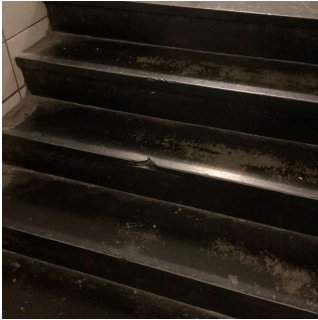
No	Tripping Hazard	Severely damaged stair tread is a potential tripping hazard.	INTERIOR   STAIRS/RAMP S: INTERIOR   Stairs and Landings	Right Side Near Auditorium	Gerald Phillippe	Fireman

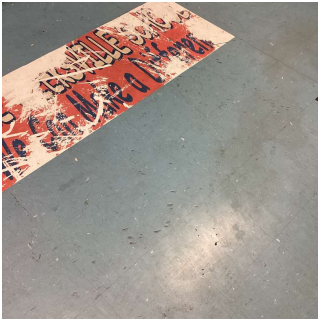
Violations	Right Side Near Auditorium No violations recorded.
Deficiency	VINYL TILES: BROKEN/DETERIORATED/MISSING TILES
Deficiency Location/Instance	Stair GH/1
Deficiency Quantity	20
Quantity Uom	S.F.
Potential Action	REPLACE
Urgency of Action	PRIORITY 3
Purpose of Action	LEVEL 2
Deficiency Photo1

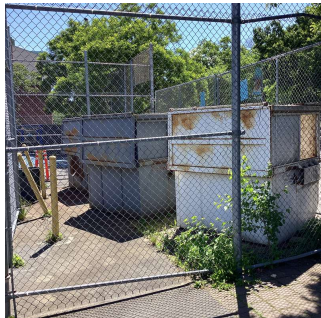
Violations	Bergen Street No violations recorded.
Deficiency	CONTAINER DAMAGED
Deficiency Location/Instance	Bergen Street
Deficiency Quantity	1
Quantity Uom	EACH
Potential Action	REPLACE
Urgency of Action	PRIORITY 3
Purpose of Action	LEVEL 2
Deficiency Photo1

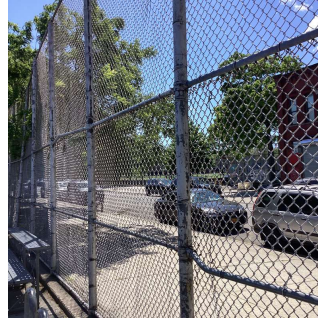
Violations	Bergen Street No violations recorded.
Deficiency	CHAIN LINK: DAMAGED/DETERIORATED
Deficiency Location/Instance	Bergen Street
Deficiency Quantity	400
Quantity Uom	S.F.
Potential Action	REPLACE
Urgency of Action	PRIORITY 3
Purpose of Action	LEVEL 2
