**NYC Department of Education**  
**Building Condition Assessment Survey 2023 - 2024**

Architectural Inspection

**Asset: I.S. 246 - BROOKLYN, 72 VERONICA PLACE, New York, 11226**

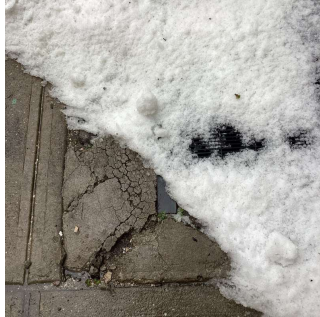
| Question | Response |
|---|--|
| Deficiency | AREAWAY WALLS: CRACKS AND SPALLING |

| Question | Response |
|---|--|
| Urgency of Action | PRIORITY 4 |

| Question | Response |
|---|--|
| Potential Action | REPLACE |

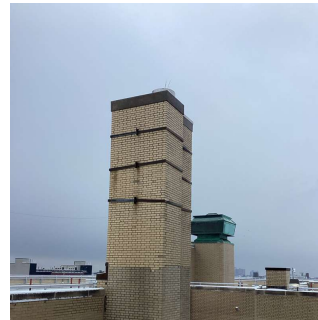
CHI

| Question | Response |
|---|--|
| Deficiency | BRICK: DETERIORATED STRAPPING |

REPLACE

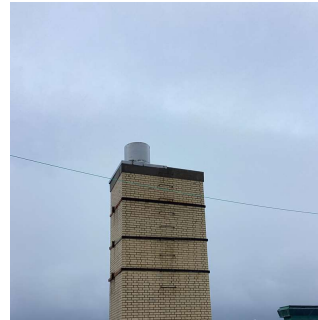
CHI

**BRICK: DETERIORATED CAP**

REPLACE

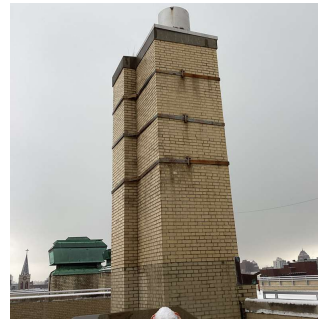
CHI

**BRICK: DETERIORATED JOINTS**

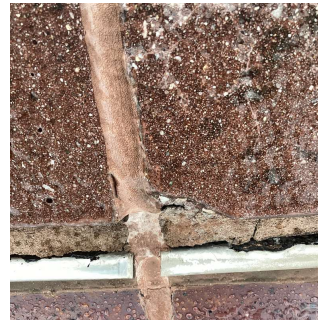
Roof 7

CAST STONE: CRACKED/BROKEN PIECES

REPLACE-IN-KIND

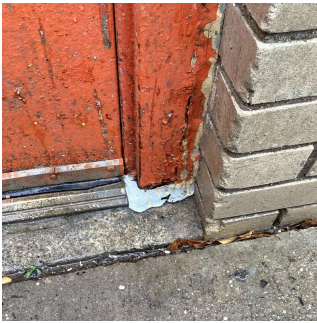
| Question | Response |
|---|---|
| Violations | Facade B<br>No violations recorded. |

METAL: DETERIORATED DOOR AND FRAME - MINOR DETERIORATION

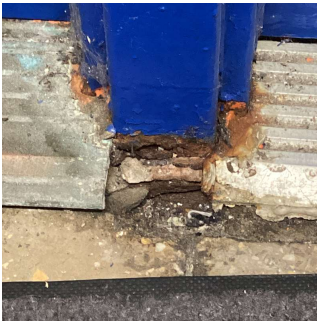
| Question | Response |
|---|---|
| Violations | Facade B<br>No violations recorded. |

| Question | Response |
|---|---|
| Deficiency | METAL: DETERIORATED DOOR AND FRAME - MAJOR DETERIORATION |

| Question | Response |
|---|---|
| Potential Action | REPLACE |

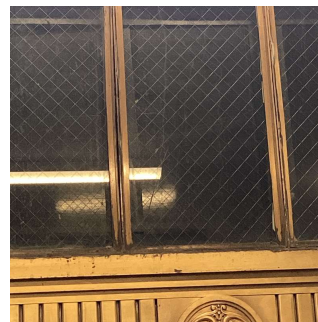
Facade A

**METAL: BROKEN GLASS**

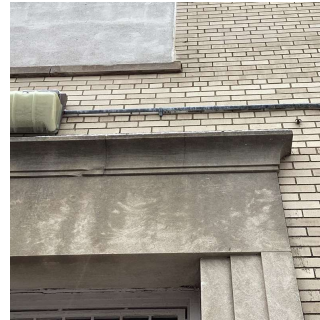
Facade A

STONE: CHIPPED/SPALLED/BROKEN PIECES - MINOR

REPAIR

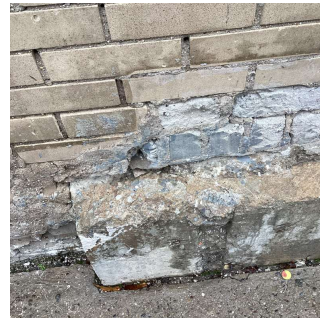
Facade B

**BRICK: MAJOR / THRU CRACKS**

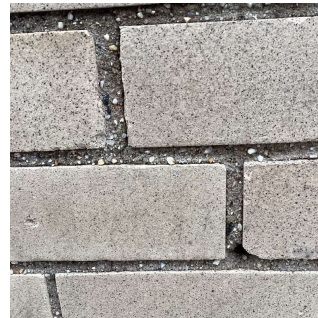
Facade B

BRICK: DETERIORATED JOINTS

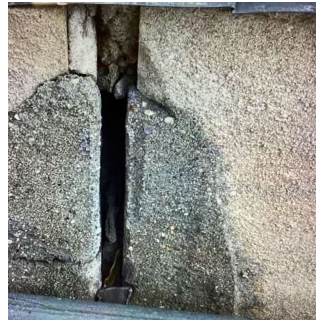
Roof 7

CONCRETE: DETERIORATED CONTROL/EXPANSION JOINT

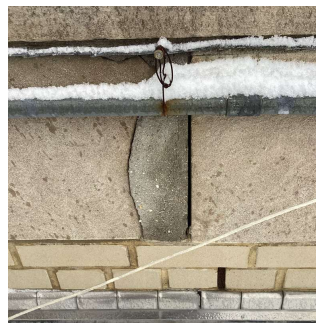
Roof 7

**STONE: MAJOR DETERIORATION/CRACKS**

20  
S.F.  
REMOVE AND REBUILD  
PRIORITY 4  
LEVEL 2

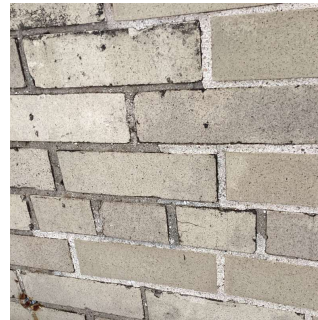
Roof 6

**BRICK: DETERIORATED JOINTS**

30  
S.F.  
REPOINT  
PRIORITY 4  
LEVEL 2

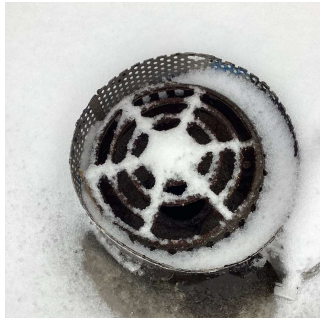
Roof 6

| Deficiency | DETERIORATED |

| Potential Action | REPLACE |

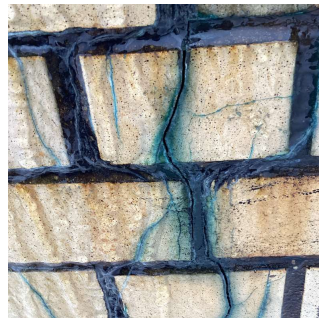
| Question | Response |
|---|--|
| Violations | SK1 |

| Question | Response |
|---|--|
| Deficiency | <b>BULKHEAD/PENTHOUSE WALLS/EXTERIOR: MAJOR THRU CRACKS</b> |

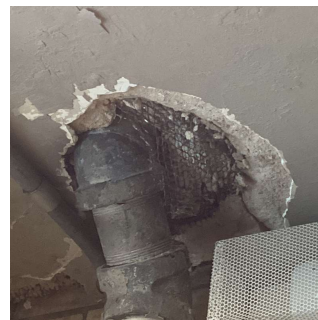
BH2  
No violations recorded.

| Question | Response |
|---|--|
| Deficiency | <b>BULKHEAD/PENTHOUSE CEILING: PLASTER<br/>DAMAGED/DETERIORATED</b> |

10  
S.F.  
REPLACE  
PRIORITY 4  
LEVEL 2

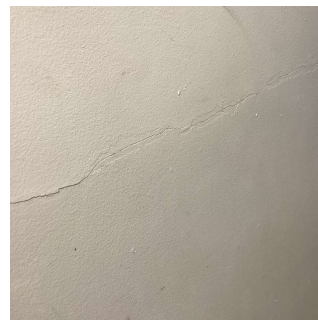
BH3  
No violations recorded.

**BULKHEAD/PENTHOUSE WALLS/INTERIOR: PLASTER  
CRACKS/SPALLING**

10  
S.F.  
REPLACE  
PRIORITY 4  
LEVEL 2

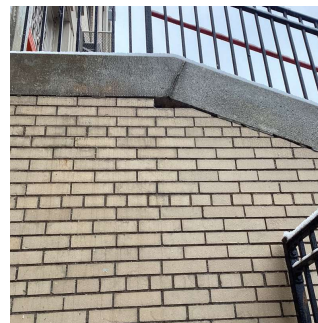
Facade B  
No violations recorded.

| Deficiency | CAST IN PLACE CONCRETE: CRACKS/SPALLING - MINOR |

30  
S.F.  
REPAIR  
PRIORITY 3  
LEVEL 2

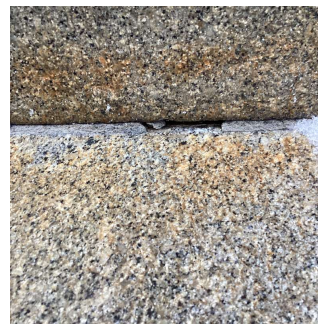
Facade B

**STONE: DETERIORATED JOINTS**

30  
 L.F.  
 REPOINT  
 PRIORITY 4  
 LEVEL 2

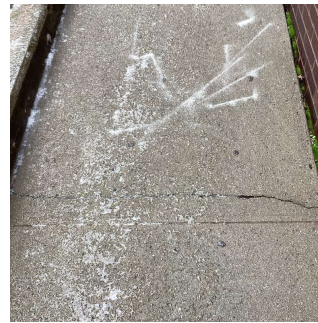
Facade E

**CONCRETE: CRACKS/SPALLING - MAJOR**

30  
 S.F.  
 REPLACE  
 PRIORITY 4  
 LEVEL 2

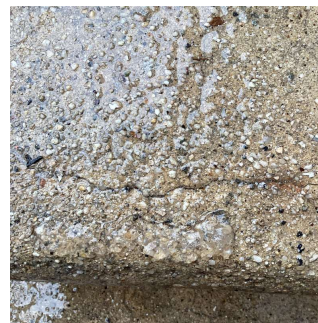
Facade E

**CONCRETE: CRACKS/SPALLING - MINOR**

REPAIR

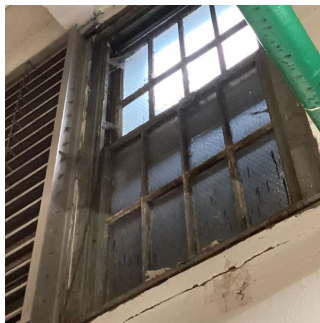
| Question | Response |
|---|--|
| | Basement - Boiler Room |

WOOD: DETERIORATED

60  
S.F.  
REPLACE WINDOW  
PRIORITY 4  
LEVEL 2

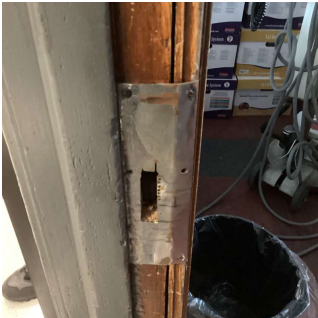
| Question | Response |
|--|--|
| Violations | Room 317<br>No violations recorded. |

| Question | Response |
|--|--|
| Deficiency | WOOD: DETERIORATED DOOR AND FRAME |

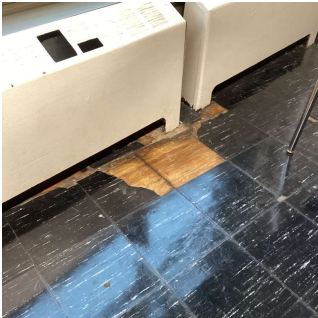
| Question | Response |
|--|--|
| Violations | Room 217<br>No violations recorded. |

| Question | Response |
|--|--|
| Deficiency | VINYL TILES: BROKEN/DETERIORATED/MISSING TILES |

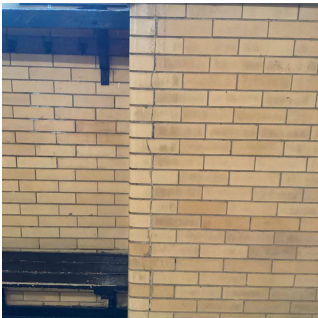
| Question | Response |
|---|--|
| Violations | Right Side<br>No violations recorded. |

| Question | Response |
|---|--|
| Deficiency | SALT GLAZED BRICK: CRACKS/SPALLING |

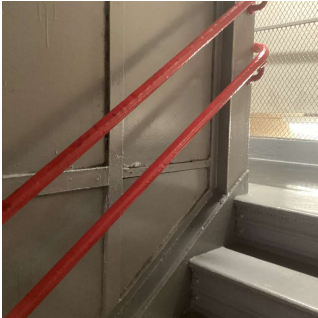
| Question | Response |
|---|--|
| Violations | Stair CD/Basement<br>No violations recorded. |

| Question | Response |
|---|--|
| Deficiency | METAL FRAME: DAMAGED/DETERIORATED |

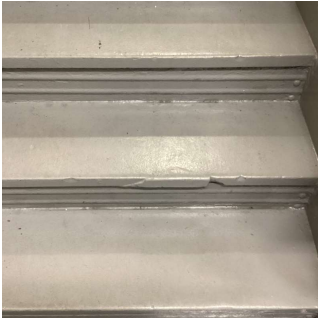
| Question | Response |
|---|--|
| Violations | Stair EF/1<br>No violations recorded. |

| Question | Response |
|---|--|
| Deficiency | STONE: BROKEN/MISSING |
