NYC Department of Education
Building Condition Assessment Survey 2023 - 2024

Architectural Inspection

Asset: P.S. 247 - BROOKLYN, 7000 21 AVENUE, New York, 11204

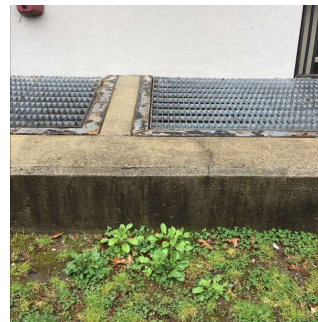
AW9
No violations recorded.

Question	Response
Architectural	
EXTERIOR	Inspected
AREAWAY	Inspected
Instance on AW1-AW10	Inspected
Instance Condition	3 - Fair
Instance Quantity	10
Instance Quantity Uom	EACH
Deficiency	AREAWAY WALLS: CRACKS AND SPALLING

20
S.F.
REPAIR
PRIORITY 3
LEVEL 2

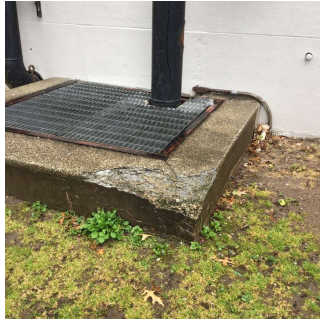
AREAWAY WALLS: CRACKS AND SPALLING

40
S.F.
REPLACE
PRIORITY 4
LEVEL 2

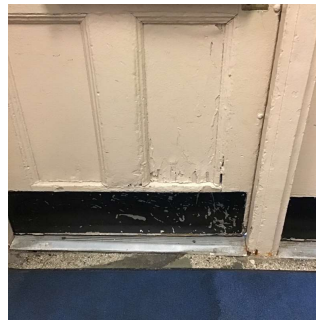
Facade A

METAL CLAD: DETERIORATED DOOR AND FRAME - MAJOR DETERIORATION

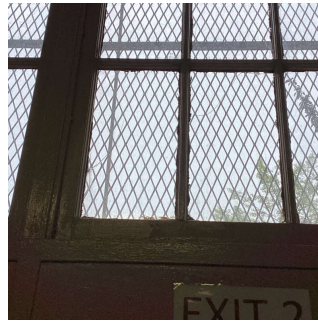
Facade A - Exit 2

WOOD: BROKEN GLASS

Deficiency Quantity	10
Quantity Uom	S.F.
Potential Action	MAINTENANCE
Urgency of Action	PRIORITY 3
Purpose of Action	LEVEL 2
Deficiency Photo1

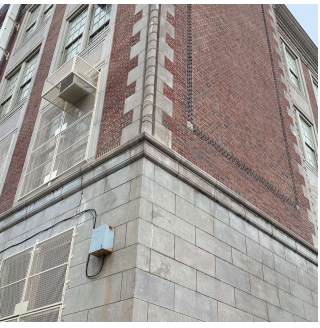
Question	Response
EXTERIOR	
EXTERIOR WALLS	
Instance on All Facades	Inspected
Instance Condition	3 - Fair
Instance Quantity	31,000
Instance Quantity Uom	S.F.
Deficiency	STONE: CRACKS AT BUILDING CORNERS
Roof Plan reference	<p>K247</p>

Deficiency Quantity	20
Quantity Uom	S.F.
Potential Action	REPLACE
Urgency of Action	PRIORITY 4
Purpose of Action	LEVEL 2
Deficiency Photo1

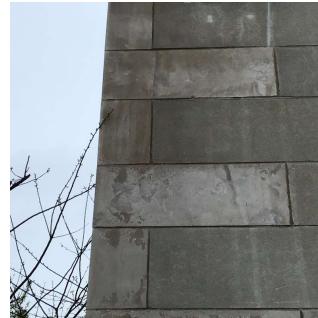
Facade H

STONE: CHIPPED/SPALLED/BROKEN PIECES - MINOR

PRIORITY 3
LEVEL 2

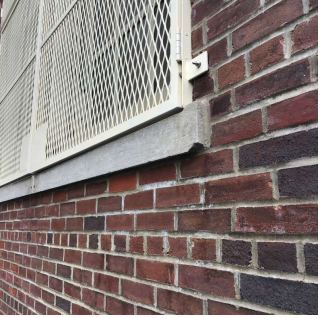
Question	Response
EXTERIOR	
EXTERIOR WALLS	
Violations	No violations recorded.
Deficiency	BRICK: DETERIORATED MASONRY SILLS - MINOR
Roof Plan reference	K247

Deficiency Quantity	20
Quantity Uom	L.F.
Potential Action	REPAIR
Urgency of Action	PRIORITY 3
Purpose of Action	LEVEL 2
Deficiency Photo1

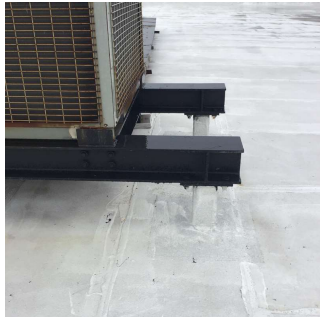
Roof 1
Instance Quantity	14,000
Instance Quantity Uom	S.F.
Does the roof have major mechanical equipment sitting on Dunnage Steel less than 18" above the Roofing?	Yes
Does this roof instance have a Sustainable Roof System?	Yes
Sustainable Roof Type	White Roof
Sustainable Roof Location (Roof Number)	Roof 1
Do solar panels exist on these roofs?	No
Is/Are the roof(s) suitable for Solar Panel installation?	Yes
Installation Year	2022
Source of Installation	Custodial Staff
Deficiency	No deficiencies recorded
ROOFING DRAINS	
	Inspected
Condition	2 - Between Good and Fair
Deficiency	No deficiencies recorded
Specialties	
	Inspected
BULKHEAD/PENTHOUSE	
	Inspected
Condition	2 - Between Good and Fair
Deficiency	No deficiencies recorded
CUPOLA/ SPIRES/ TOWERS	
	Does not Exist
DORMER	
	Does not Exist
DUNNAGE STEEL	
	Inspected
Condition	3 - Fair
Deficiency	HEIGHT LESS THAN 18"

Deficiency Quantity	50
Quantity Uom	L.F.
Potential Action	REPLACE
Urgency of Action	PRIORITY 3
Purpose of Action	LEVEL 2

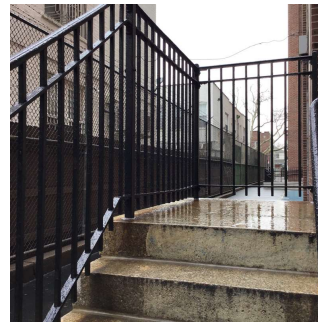
Facade C

MISSING RAILING

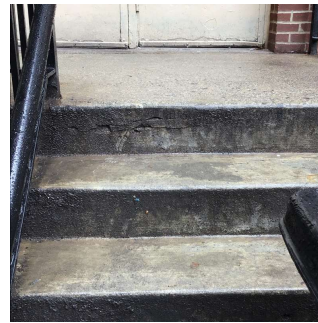
Facade E

CONCRETE: CRACKS/SPALLING - MAJOR

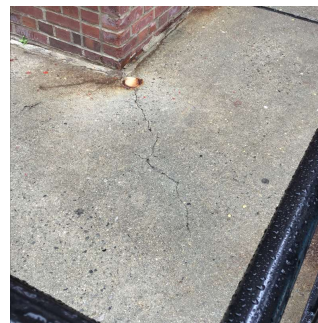
Facade G

CONCRETE: CRACKS/SPALLING - MINOR

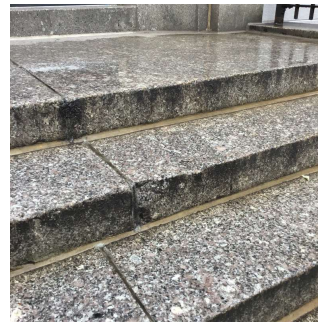
STONE: CRACKS/SPALLING - MINOR

15
S.F.
REPAIR
PRIORITY 3
LEVEL 2

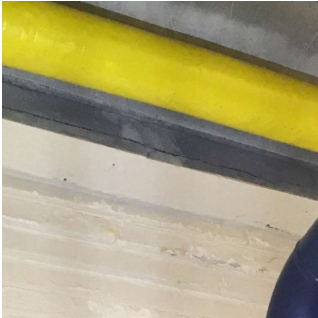
STEEL COLUMNS/BEAMS: DETERIORATED
Basement
20
S.F.
REPAIR
PRIORITY 3
LEVEL 5

Question	Response
INTERIOR	
STRUCTURAL	
COLUMNS/BEAMS/BEARING WALLS	
Violations	No violations recorded.
Deficiency	STEEL COLUMNS/BEAMS: DETERIORATED CONCRETE FIREPROOFING
Deficiency Location/Instance	Basement Gas Meter Room, Boiler Room
Deficiency Quantity	60
Quantity Uom	S.F.
Potential Action	REPLACE
Urgency of Action	PRIORITY 3
Purpose of Action	LEVEL 5
Deficiency Photo1

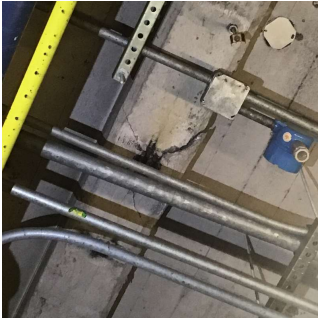
Violations	Gas Meter Room No violations recorded.
Deficiency	STEEL COLUMNS/BEAMS: DETERIORATED CONCRETE FIREPROOFING
Deficiency Location/Instance	Basement
Deficiency Quantity	50
Quantity Uom	S.F.
Potential Action	REPLACE
Urgency of Action	PRIORITY 4
Purpose of Action	LEVEL 5
Deficiency Photo1

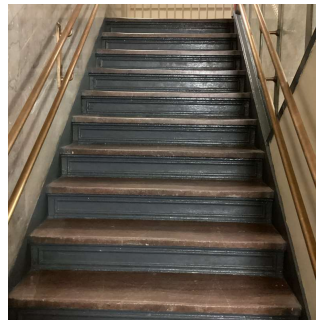
Stair EF/1

STONE: WORN-OUT TREAD/NOSINGS
Stairs EF/1, 2
140
S.F.
REPLACE
PRIORITY 3
LEVEL 2

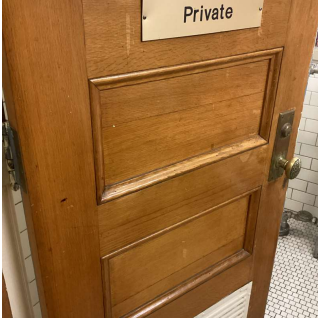
Question	Response
INTERIOR	
TOILET ROOMS - STAFF	
Door(s)	
Deficiency	WOOD: DETERIORATED DOOR
Deficiency Location/Instance	Room 257
Deficiency Quantity	1
Quantity Uom	EACH
Potential Action	MAINTENANCE
Urgency of Action	PRIORITY 3
Purpose of Action	LEVEL 2
Deficiency Photo1

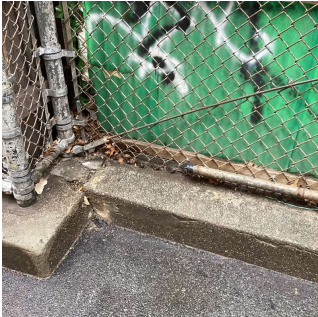
Violations	21st Avenue No violations recorded.
Deficiency	CHAIN LINK: DAMAGED POST/RAIL

Question	Response
SITE	
FENCES	
Deficiency Location/Instance	Schoolyard
Deficiency Quantity	20
Quantity Uom	L.F.
Potential Action	REPLACE
Urgency of Action	PRIORITY 3
Purpose of Action	LEVEL 2
Deficiency Photo1
