NYC Department of Education
Building Condition Assessment Survey 2023 - 2024

Architectural Inspection

Asset: P.S. 250 - BROOKLYN, 108 MONTROSE AVENUE, New York, 11206

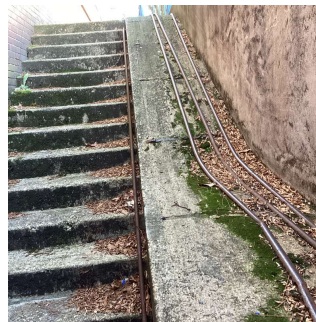
AW2
No violations recorded.

Deficiency	AREAWAY STAIRS: DETERIORATED MATERIAL SLIDE
------------	---

50
S.F.
REPLACE
PRIORITY 3
LEVEL 2

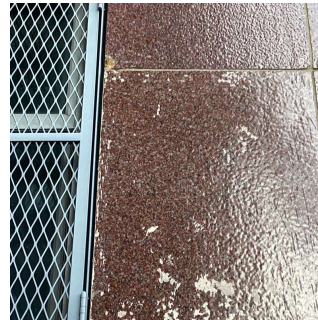
Facade C

CERAMIC TILE: CHIPPED, SPALLED, BROKEN PIECES

REPLACE

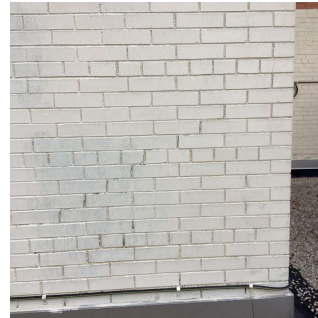
Facade F

BRICK: MINOR CRACKS AND SPALLING

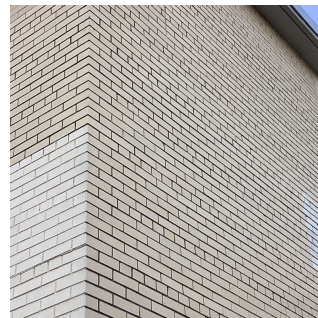
Facades B, F

BRICK: DETERIORATED JOINTS

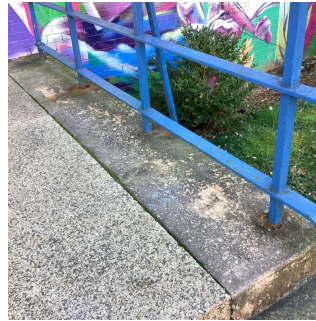
Main Entrance

Violations	Facade A No violations recorded.
RAILINGS	Inspected
Condition	4 - Between Fair and Poor
Deficiency	DAMAGED
Roof Plan reference

<p>This diagram is identical to the one above, showing the floor plan of the K250 building. A red box highlights a different section of the facade, labeled 'A' near the Main Entrance, indicating the location of the damaged railing.</p>
Deficiency Quantity	15
Quantity Uom	L.F.
Potential Action	REPLACE
Urgency of Action	PRIORITY 4
Purpose of Action	LEVEL 2

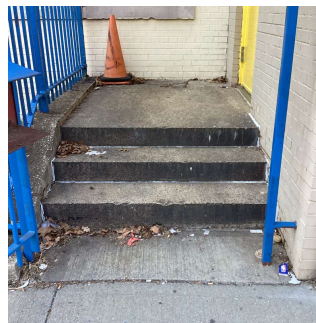
Facade B

MISSING RAILING

REPLACE

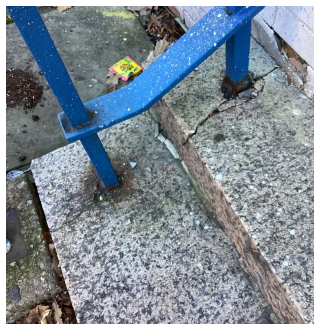
Main Entrance

STONE: CRACKS/SPALLING - MAJOR

10
 S.F.
 REPLACE
 PRIORITY 4
 LEVEL 2

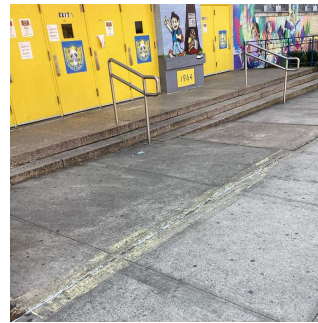
Main Entrance

STONE: DETERIORATED JOINTS

150
 L.F.
 REPOINT
 PRIORITY 3
 LEVEL 2

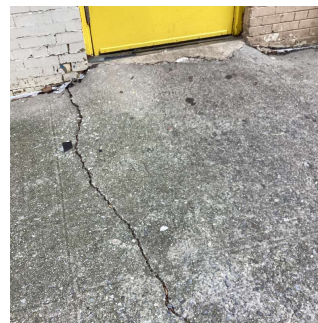
Facade C

CONCRETE: CRACKS/SPALLING - MAJOR

REPLACE

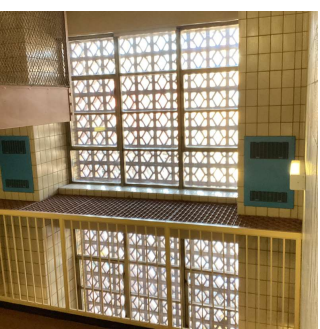
Instance on Aluminum - Other: Facade A	Inspected
Instance Condition	5 - Poor
Instance Quantity	500
Instance Quantity Uom	S.F.
Are these windows insulated	No
Installation Year	1964
Source of Installation	Custodial Staff
Deficiency	ALUMINUM - OTHER: DETERIORATED

Deficiency Quantity	180
Quantity Uom	S.F.
Potential Action	REPLACE WINDOW
Urgency of Action	PRIORITY 4
Purpose of Action	LEVEL 2
Deficiency Photo1

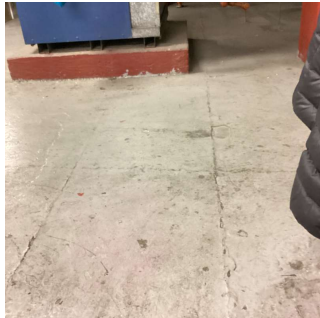
Room B13
Violations	No violations recorded.
Deficiency	CONCRETE SLAB ON GRADE: THRU CRACKS
Deficiency Location/Instance	Boiler Room
Deficiency Quantity	30
Quantity Uom	S.F.
Potential Action	REPAIR
Urgency of Action	PRIORITY 3
Purpose of Action	LEVEL 5
Deficiency Photo1

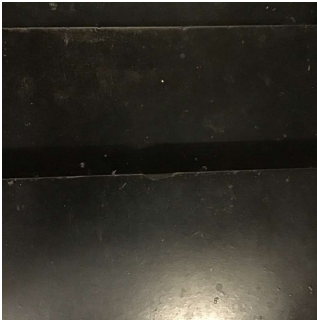
Violations	Stair EF/1 No violations recorded.

Violations	Stair CD/basement No violations recorded.
Deficiency	CONCRETE: CRACKS/SPALLING - MAJOR
Deficiency Location/Instance	Stair AB/Basement,2,3,EF/1,2, and others
Deficiency Quantity	40
Quantity Uom	S.F.
Potential Action	REPLACE
Urgency of Action	PRIORITY 3
Purpose of Action	LEVEL 2
Deficiency Photo1

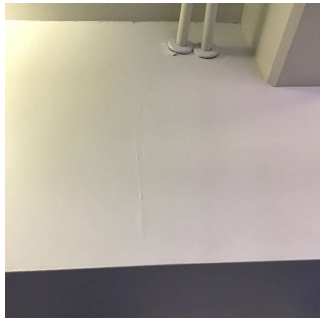
Violations	Main Entrance Lobby No violations recorded.
Walls	Inspected
Condition	2 - Between Good and Fair
Deficiency	GYPSUM BOARD: DETERIORATED
Deficiency Location/Instance	Stair AB/3
Deficiency Quantity	10
Quantity Uom	S.F.
Potential Action	REPLACE
Urgency of Action	PRIORITY 3
Purpose of Action	LEVEL 2
Deficiency Photo1

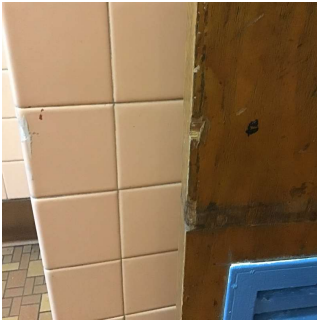
Room 215
Violations	No violations recorded.
Door(s)	Inspected
Condition	5 - Poor
Deficiency	WOOD: DETERIORATED DOOR
Deficiency Location/Instance	Room 315,309,215,209,115, and others
Deficiency Quantity	6
Quantity Uom	EACH
Potential Action	MAINTENANCE
Urgency of Action	PRIORITY 3
Purpose of Action	LEVEL 2
Deficiency Photo1

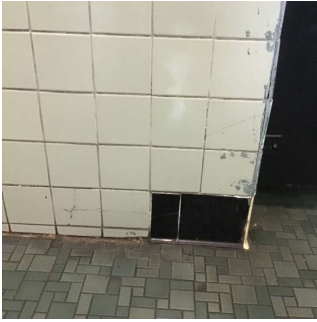
Question	Response
INTERIOR	
TOILET ROOMS - STUDENTS	
Floor Finish	
Deficiency Photo1	 
	Room 315
Violations	No violations recorded.
Stalls	Inspected
Condition	2 - Between Good and Fair
Deficiency	No deficiencies recorded
Walls	Inspected
Condition	2 - Between Good and Fair
Deficiency	CERAMIC TILE: BROKEN/ MISSING
Deficiency Location/Instance	Room 315,309,215,209,115, and others
Deficiency Quantity	30
Quantity Uom	S.F.
Potential Action	REPLACE
Urgency of Action	PRIORITY 3
Purpose of Action	LEVEL 2
Deficiency Photo1

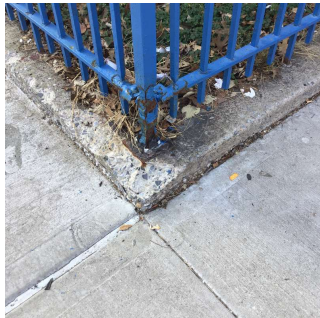
Question	Response
SITE	
FENCES	
Condition	5 - Poor
Deficiency	CONCRETE CURB: DAMAGED/DETERIORATED
Deficiency Location/Instance	Along Montrose Avenue, Leonard Street, Manhattan Avenue
Deficiency Quantity	85
Quantity Uom	S.F.
Potential Action	REPLACE
Urgency of Action	PRIORITY 3
Purpose of Action	LEVEL 2
Deficiency Photo1

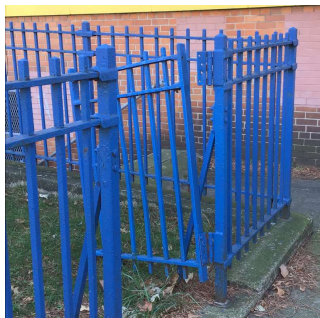
Violations	Along Montrose Avenue No violations recorded.
Deficiency	WROUGHT IRON: DAMAGED/DETERIORATED
Deficiency Location/Instance	Along Montrose Avenue
Deficiency Quantity	80
Quantity Uom	S.F.
Potential Action	REPLACE
Urgency of Action	PRIORITY 3
Purpose of Action	LEVEL 2
Deficiency Photo1

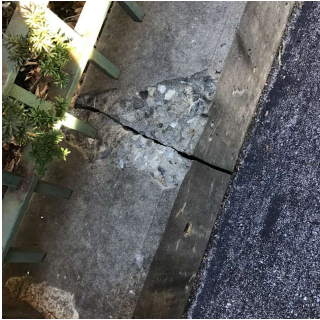
Schoolyard
Violations	No violations recorded.
Deficiency	CONCRETE CURB: DAMAGED/DETERIORATED
Deficiency Location/Instance	Schoolyard
Deficiency Quantity	60
Quantity Uom	S.F.
Potential Action	REPLACE
Urgency of Action	PRIORITY 3
Purpose of Action	LEVEL 2
Deficiency Photo1
