NYC Department of Education
Building Condition Assessment Survey 2023 - 2024

Architectural Inspection

Asset: I.S. 252 - BROOKLYN, 1084 LENOX ROAD, New York, 11212

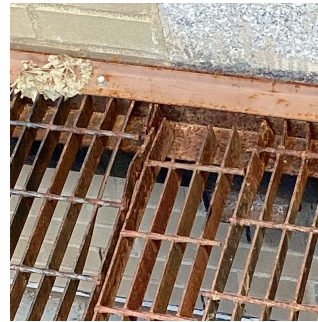
AW7
No violations recorded.

Question	Response
Architectural	
EXTERIOR	Inspected
AREAWAY	Inspected
Instance on AW1, AW7-AW8	Inspected
Instance Condition	3 - Fair
Instance Quantity	3
Instance Quantity Uom	EACH
Deficiency	AREAWAY GRATINGS: MAJOR RUSTING / OR BROKEN

20
S.F.
REPLACE
PRIORITY 4
LEVEL 2

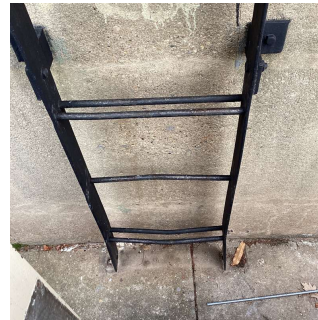
AW11

AREAWAY LADDER: DETERIORATED

1
EACH
MAINTENANCE
PRIORITY 3
LEVEL 2

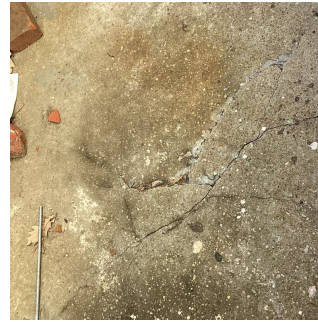
AW11

AREAWAY SLAB: CRACKS AND SPALLING

250
S.F.
REPLACE
PRIORITY 4
LEVEL 2

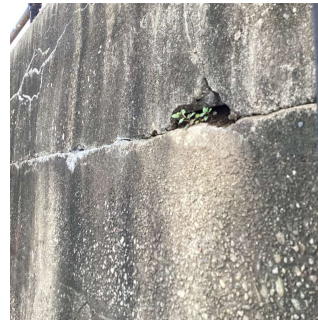
AW11

AREAWAY WALLS: CRACKS AND SPALLING

55
S.F.
REPAIR
PRIORITY 3
LEVEL 2

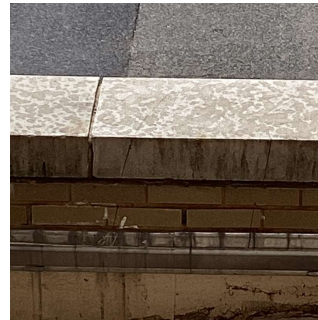
Roof 6

Violations	Chimney No violations recorded.
COPING	
Condition	Inspected 3 - Fair
Deficiency	CAST STONE: CRACKED/BROKEN PIECES

10
L.F.
REPLACE-IN-KIND
PRIORITY 4
LEVEL 2

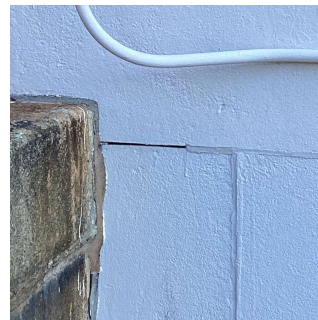
Facade A

Violations	Facade F - Exit 6 No violations recorded.
DOOR HARDWARE	Inspected
Condition	3 - Fair
Deficiency	No deficiencies recorded
LINTELS	Inspected
Condition	2 - Between Good and Fair
Deficiency	No deficiencies recorded
TRANSOM/SIDE LIGHT	Inspected
Condition	2 - Between Good and Fair
Deficiency	No deficiencies recorded
EXTERIOR WALLS	Inspected
Material Type(s)	Masonry
Replacement Quantity	37,000
Replacement Uom	S.F.
Instance on All Facades	Inspected
Instance Condition	3 - Fair
Instance Quantity	37,000
Instance Quantity Uom	S.F.
Deficiency	STONE: DETERIORATED JOINTS

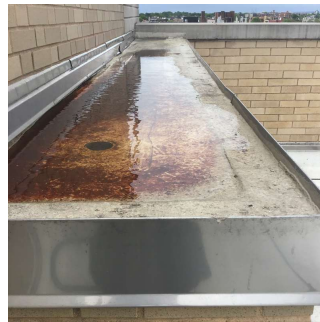
Roof 1
No violations recorded.

Deficiency	CLOGGED
Roof Plan reference	K252

Deficiency Quantity	1
Quantity Uom	EACH
Potential Action	MAINTENANCE
Urgency of Action	PRIORITY 5
Purpose of Action	LEVEL 2
Deficiency Photo1

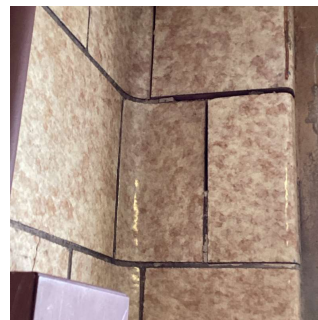
BH2

BULKHEAD/PENTHOUSE WALLS/INTERIOR: GLASS BLOCK DETERIORATED JOINTS

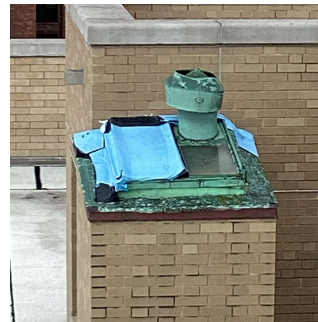
SK

DAMAGED GUARDS

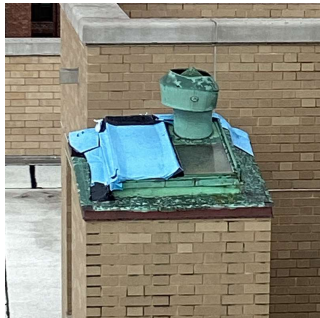
Violations	SK No violations recorded.
Deficiency	BROKEN GLASS
Roof Plan reference	K252

Deficiency Quantity	20
Quantity Uom	S.F.
Potential Action	MAINTENANCE
Urgency of Action	PRIORITY 3
Purpose of Action	LEVEL 2
Deficiency Photo1

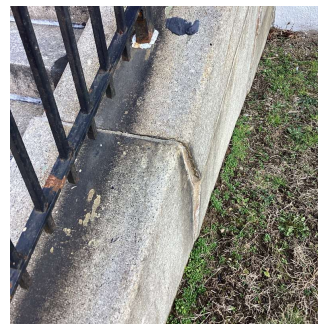
Facade A

Violations	SK No violations recorded.
ROOF/GRAVITY TANK	Does not Exist
STAIRS/RAMPS: EXTERIOR	Inspected
BUILDING CHEEK/FLANK WALLS	Inspected
Condition	4 - Between Fair and Poor
Deficiency	STONE: BULGING/DISPLACED

10
S.F.
REPLACE
PRIORITY 4
LEVEL 2

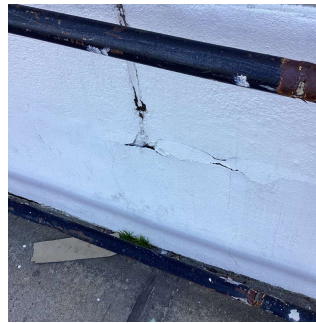
Facade C

CAST IN PLACE CONCRETE: CRACKS/SPALLING - MAJOR

10
S.F.
REPLACE
PRIORITY 4
LEVEL 2

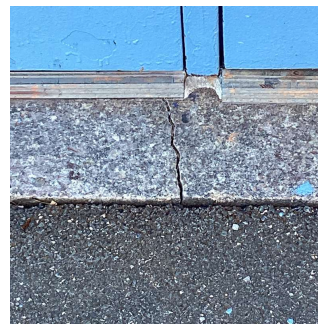
Facade F
No violations recorded.

STONE: CRACKS/SPALLING - MINOR

20
S.F.
REPAIR
PRIORITY 3
LEVEL 2

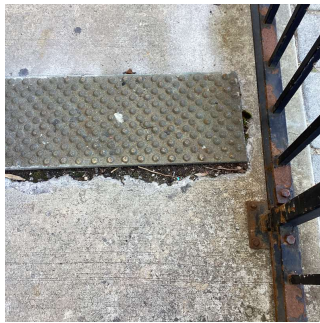
CONCRETE: CRACKS/SPALLING - MAJOR

10
S.F.
REPLACE
PRIORITY 4
LEVEL 2

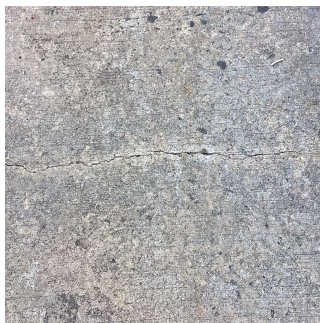
Violations	Facade C No violations recorded.
Deficiency	CONCRETE: CRACKS/SPALLING - MINOR
Roof Plan reference	K252

Deficiency Quantity	60
Quantity Uom	S.F.
Potential Action	REPAIR
Urgency of Action	PRIORITY 3
Purpose of Action	LEVEL 2
Deficiency Photo1

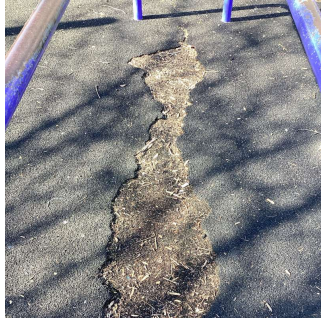
Priority Condition Exist Last Year?	Priority Category	Condition Description	Component Affected	Location Description	Person(s) Notified	Person(s) Title	PhotoImage
Yes	Tripping Hazard	Severely damaged safety surface resulting in potential tripping hazard	SITE PLAYGROUN DS Safety Surfacing	Near Entrance	Scott Mirsky	Custodian

Question	Response
SITE	
PLAYGROUNDS	
Safety Surfacing	
Deficiency Location/Instance	Near Entrance
Deficiency Quantity	15
Quantity Uom	S.F.
Potential Action	REPLACE
Urgency of Action	PRIORITY 5
Purpose of Action	LEVEL 6
Deficiency Photo1
