NYC Department of Education
Building Condition Assessment Survey 2023 - 2024

Architectural Inspection

K255

Asset: P.S. 255 - BROOKLYN, 1866 EAST 17 STREET, New York, 11229

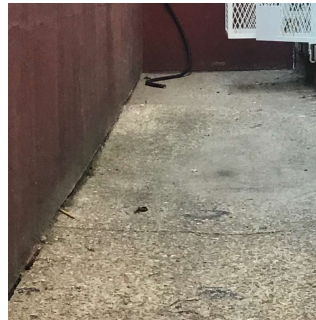
Facade A - AW2

Question	Response
Architectural	
EXTERIOR	Inspected
AREAWAY	Inspected
Instance on AW1-AW5	Inspected
Instance Condition	3 - Fair
Instance Quantity	5
Instance Quantity Uom	EACH
Deficiency	AREAWAY SLAB: DISPLACED

30
S.F.
REPLACE
PRIORITY 4
LEVEL 2

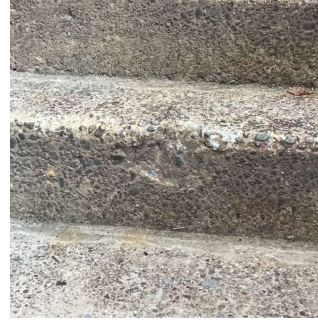
Facade A -AW1

**AREAWAY STAIRS: DETERIORATED
TREADS/RISERS/NOSINGS**

10
S.F.
REPAIR
PRIORITY 3
LEVEL 2

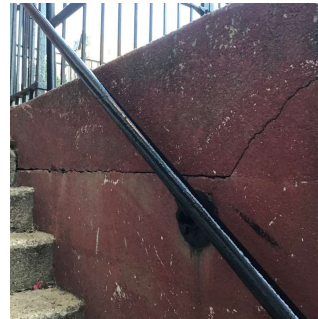
Facade A - AW1

AREAWAY WALLS: CRACKS AND SPALLING

REPAIR

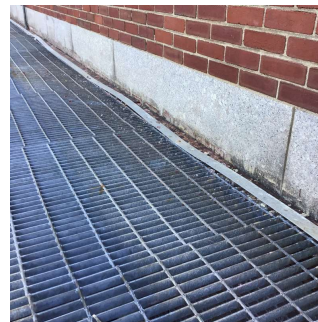
Facade J
No violations recorded.

AREAWAY GRATINGS: MAJOR RUSTING / OR BROKEN

30
S.F.
REPLACE
PRIORITY 4
LEVEL 2

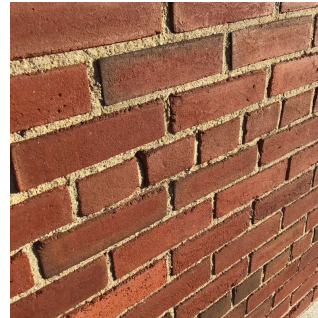
Facade B

BRICK: DETERIORATED JOINTS

PRIORITY 4
LEVEL 2

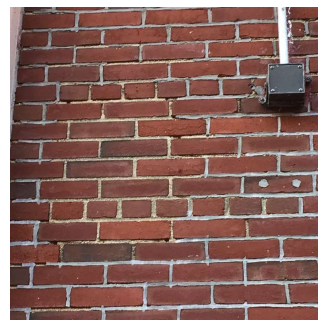
Facade A

BRICK: DETERIORATED JOINTS

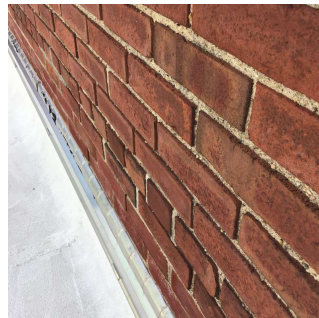
Question	Response
EXTERIOR	
EXTERIOR WALLS	Inspected
Violations	No violations recorded.
EXTERIOR SOFFITS	Inspected
Condition	2 - Between Good and Fair
Deficiency	No deficiencies recorded
LOADING DOCK	Does not Exist
LOUVER	Inspected
Condition	2 - Between Good and Fair
Deficiency	No deficiencies recorded
PARAPETS	Inspected
Material Type(s)	Masonry
Replacement Quantity	8,000
Replacement Uom	C.F.
Instance on All Facades	Inspected
Instance Condition	3 - Fair
Instance Quantity	8,000
Instance Quantity Uom	C.F.
Deficiency	BRICK: DETERIORATED JOINTS
Roof Plan reference

Violations	Roof 1 - Penthouse 2 No violations recorded.
PLAZA DECK	Does not Exist
ROOF	Inspected
Roofing	Inspected
Replacement Quantity	25,500

Deficiency Quantity	200
Quantity Uom	S.F.
Potential Action	REPOINT
Urgency of Action	PRIORITY 3
Purpose of Action	LEVEL 2
Deficiency Photo1

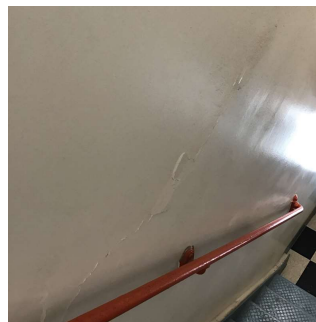
Roof 1 - Bulkhead 3

Deficiency	No deficiencies recorded
ROOFING DRAINS	Inspected
Condition	1 - Good
Deficiency	No deficiencies recorded
Specialties	Inspected
BULKHEAD/PENTHOUSE	Inspected
Condition	3 - Fair
Deficiency	BULKHEAD/PENTHOUSE WALLS/INTERIOR: PLASTER CRACKS/SPALLING

50
 S.F.
 REPLACE
 PRIORITY 3
 LEVEL 2

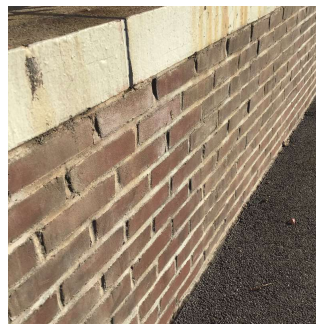
Facade B

Roof 1
Violations	No violations recorded.
ROOF/GRAVITY TANK	Does not Exist
STAIRS/RAMPS: EXTERIOR	Inspected
BUILDING CHEEK/FLANK WALLS	Inspected
Condition	5 - Poor
Deficiency	BRICK: DETERIORATED JOINTS

30
S.F.
REPOINT
PRIORITY 4
LEVEL 2

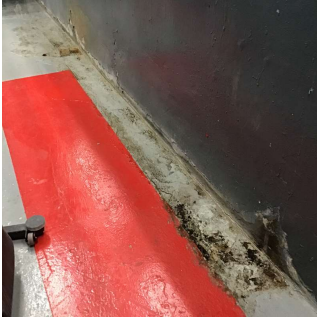
Violations	Basement - Boiler Room Pit No violations recorded.
FOUNDATION WALLS	Inspected
Material Type(s)	Concrete
Condition	4 - Between Fair and Poor
Deficiency	CONCRETE: WATER INFILTRATION IN NON- INSTRUCTIONAL SPACE
Deficiency Location/Instance	Basement - Boiler Room Pit
Deficiency Quantity	100
Quantity Uom	S.F.

Basement - Boiler Room Pit
Violations	No violations recorded.
ROOF STRUCTURE	
	Inspected
Condition	2 - Between Good and Fair
Deficiency	No deficiencies recorded
VAULTS-BUNKERS	
	Inspected
Foundation Walls	
	Inspected
Condition	2 - Between Good and Fair
Deficiency	CRACKS, SPALLING
Deficiency Location/Instance	Basement- Ash Hoist Vault
Deficiency Quantity	10
Quantity Uom	S.F.
Potential Action	REPAIR
Urgency of Action	PRIORITY 3
Purpose of Action	LEVEL 5
Deficiency Photo1

Question	Response
INTERIOR	
STRUCTURAL	
FOUNDATION WALLS	
Potential Action	INSTALL WATERPROOFING
Urgency of Action	PRIORITY 5
Purpose of Action	LEVEL 5
Deficiency Photo1

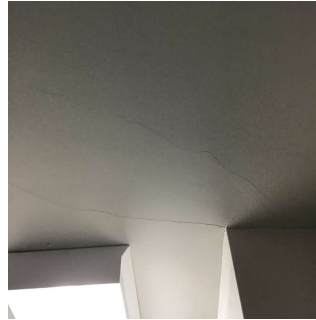
Near Lockers Room/3rd Floor Staff Bathroom

Near Windows
Violations	No violations recorded.
Window Curtains/Shades/Blinds	
Instance on 1st Floor	Does not Exist
CLASSROOMS/CORRIDORS/ADMIN SPACES	
Ceiling	
Condition	2 - Between Good and Fair
Deficiency	PLASTER: CRACKS/SPALLING
Deficiency Location/Instance	Corridor near Lockers Room/3rd Floor - Mezzanine, Room 328

Quantity Uom	S.F.
Potential Action	REPLACE
Urgency of Action	PRIORITY 3
Purpose of Action	LEVEL 2
Deficiency Photo1

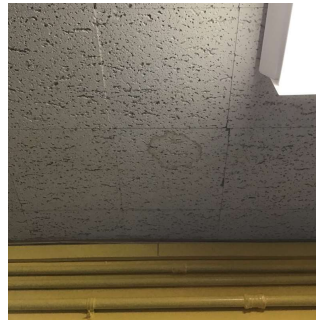
Corridor near Room 320

Deficiency	ACOUSTIC TILES ON PLASTER: DAMAGED/MISSING
Deficiency Location/Instance	Corridor near Room 320, Room 224
Deficiency Quantity	80
Quantity Uom	S.F.
Potential Action	REPLACE
Urgency of Action	PRIORITY 3
Purpose of Action	LEVEL 2
Deficiency Photo1

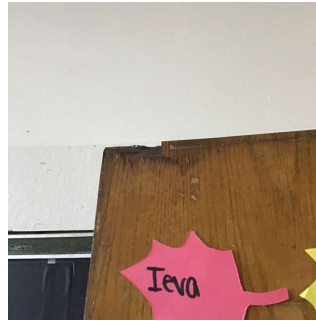
Room 328

Condition	5 - Poor
Deficiency	WOOD: DETERIORATED DOOR
Deficiency Location/Instance	Rooms 330,328,327,129,124
Deficiency Quantity	15
Quantity Uom	EACH
Potential Action	MAINTENANCE
Urgency of Action	PRIORITY 3
Purpose of Action	LEVEL 2

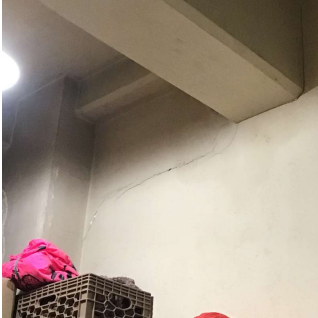
Question	Response
INTERIOR	
GYMNASIUM	
Walls	
Deficiency Location/Instance	Storage Room
Deficiency Quantity	20
Quantity Uom	S.F.
Potential Action	REPLACE
Urgency of Action	PRIORITY 3
Purpose of Action	LEVEL 2
Deficiency Photo1

Violations	Storage Room No violations recorded.
Deficiency	GLAZED BLOCK: CRACKS/SPALLING
Deficiency Location/Instance	Near Storage Room, Next Windows, By Drinking Fountain
Deficiency Quantity	150
Quantity Uom	S.F.
Potential Action	REPLACE
Urgency of Action	PRIORITY 3
Purpose of Action	LEVEL 2
Deficiency Photo1

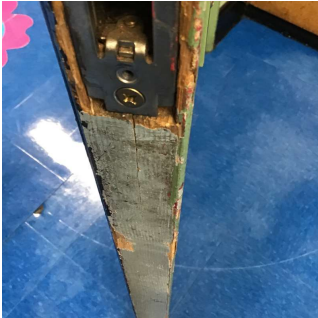
Question	Response
INTERIOR	
KITCHEN	
Floor Finish	
Deficiency Photo1	 
Violations	Severy No violations recorded.
Walls	
Instance on 1st Floor (600 SF)	Inspected
Condition	3 - Fair
Deficiency	CERAMIC TILE: BROKEN/ MISSING
Deficiency Location/Instance	Entrance, Severy, Near Locker Room, By Window
Deficiency Quantity	40
Quantity Uom	S.F.
Potential Action	REPLACE
Urgency of Action	PRIORITY 3
Purpose of Action	LEVEL 2
Deficiency Photo1	 
Violations	Entrance No violations recorded.
LIBRARY	
Instance on Room 227	Inspected
Built-in Furnishing	
Instance on Room 227	Inspected
Condition	2 - Between Good and Fair
Deficiency	No deficiencies recorded
Ceiling	
Instance on Room 227	Inspected
Condition	2 - Between Good and Fair
Deficiency	No deficiencies recorded
Door(s)	
Instance on Room 227	Inspected
Condition	3 - Fair
Deficiency	WOOD: DETERIORATED DOOR
Deficiency Location/Instance	Left Side

Deficiency Quantity	1
Quantity Uom	EACH
Potential Action	MAINTENANCE
Urgency of Action	PRIORITY 3
Purpose of Action	LEVEL 2
Deficiency Photo1
