NYC Department of Education
Building Condition Assessment Survey 2023 - 2024

Architectural Inspection

Asset: P.S. 256 - BROOKLYN, 114 KOSCIUSKO STREET, New York, 11216

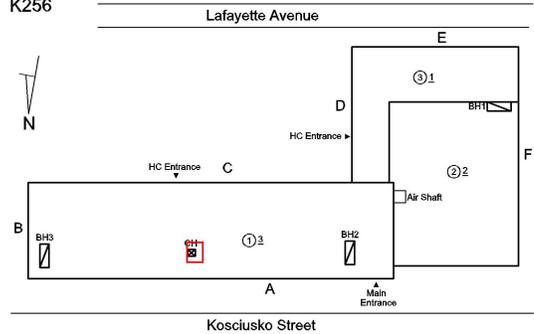
Deficiency	BRICK: MAJOR / THRU CRACKS
Roof Plan reference	K256

Deficiency Quantity	20
Quantity Uom	S.F.
Potential Action	REMOVE AND REBUILD
Urgency of Action	PRIORITY 4
Purpose of Action	LEVEL 2
Deficiency Photo1

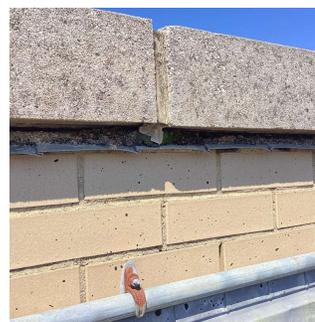
Roof 2
No violations recorded.

CAST STONE: DETERIORATED BED JOINT

K256
80
L.F.
REPOINT
PRIORITY 3
LEVEL 2

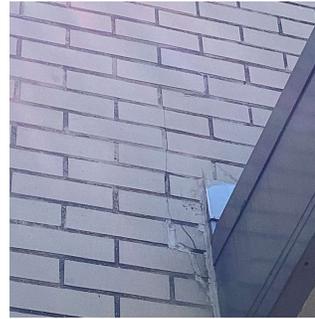
Facade A

BRICK: MINOR CRACKS AND SPALLING

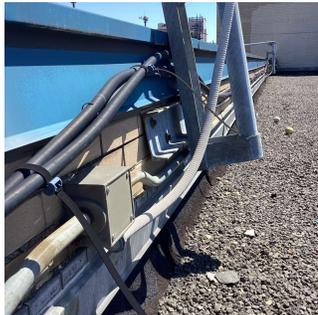
Violations	Roof 2 No violations recorded.
Deficiency	BRICK: DETERIORATED JOINTS

Violations	Facade A No violations recorded.
PARAPETS	Inspected
Material Type(s)	Masonry
Replacement Quantity	4,000
Replacement Uom	C.F.
Instance on All Roofs	Inspected
Instance Condition	4 - Between Fair and Poor
Instance Quantity	4,000
Instance Quantity Uom	C.F.
Deficiency	BRICK: OUT OF PLUMB
Roof Plan reference	K256

Deficiency Quantity	20
Quantity Uom	C.F.
Potential Action	REMOVE AND REBUILD
Urgency of Action	PRIORITY 5
Purpose of Action	LEVEL 6
Deficiency Photo1

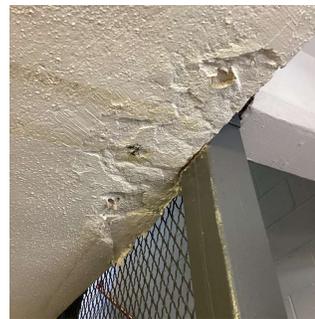
Roof 2 - BH1

BULKHEAD/PENTHOUSE WALLS/EXTERIOR: WATER INFILTRATION

100
S.F.
REPAIR
PRIORITY 5
LEVEL 2

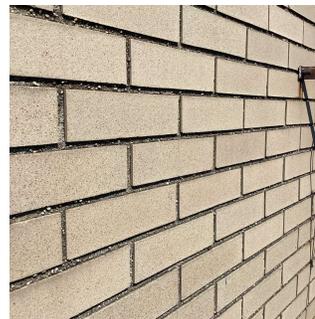
BH2
No violations recorded.

**BULKHEAD/PENTHOUSE WALLS/EXTERIOR: DETERIORATED
JOINTS**

200
S.F.
REPOINT
PRIORITY 3
LEVEL 2

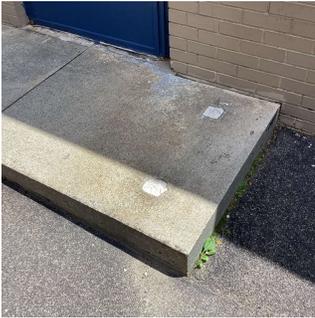
MISSING RAILING

REPLACE

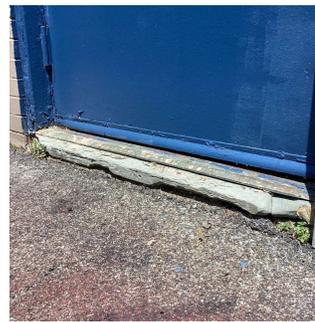
Facade C

Violations	Facade A - Exit 2 No violations recorded.
Deficiency	STONE: WORN-OUT TREAD/RISER/NOSING

20
S.F.
REPLACE
PRIORITY 4
LEVEL 2

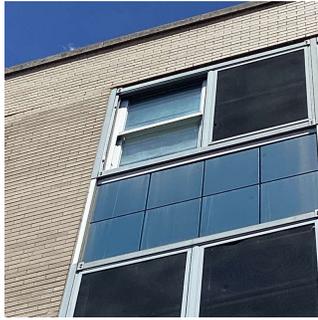
DETERIORATED/TORN-OUT/MISSING

REPLACE

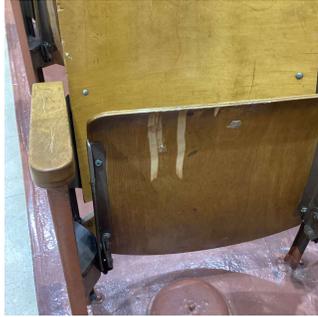
Question	Response
INTERIOR	
AUDITORIUM	
Ceiling	
Instance on Basement (422 Seats)	Inspected
Condition	2 - Between Good and Fair
Deficiency	No deficiencies recorded
Door(s)	
Instance on Basement (422 Seats)	Inspected
Condition	2 - Between Good and Fair
Deficiency	No deficiencies recorded
Fixed H/C Lift	
Instance on Basement (422 Seats)	Does not Exist
Fixed Seating	
Instance on Basement (422 Seats)	Inspected
Condition	4 - Between Fair and Poor
Deficiency	DAMAGED/BROKEN/INOPERABLE
Deficiency Location/Instance	Seats B/3, C/1, D/1,3, 114, and others
Deficiency Quantity	33
Quantity Uom	EACH
Potential Action	REPLACE
Urgency of Action	PRIORITY 3
Purpose of Action	LEVEL 2
Deficiency Photo1

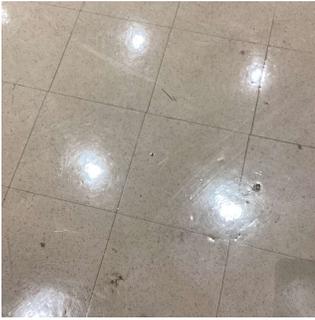
Seat C/1
Violations	No violations recorded.
Floor Finish	
Instance on Basement (422 Seats)	Inspected
Condition	2 - Between Good and Fair
Deficiency	VINYL TILES: BROKEN/DETERIORATED/MISSING TILES
Deficiency Location/Instance	Near Exit 6, Near Entrance

Deficiency Quantity	25
Quantity Uom	S.F.
Potential Action	REPLACE
Urgency of Action	PRIORITY 3
Purpose of Action	LEVEL 2

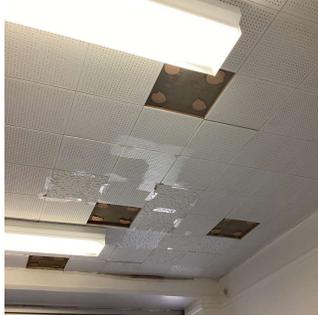
Question	Response
INTERIOR	
CLASSROOMS/CORRIDORS/ADMIN SPACES	
Ceiling	
Deficiency Location/Instance	Main Entrance Vestibule, Corridor near Rooms 211, 304, Rooms B25, 117
Deficiency Quantity	70
Quantity Uom	S.F.
Potential Action	REPLACE
Urgency of Action	PRIORITY 3
Purpose of Action	LEVEL 2
Deficiency Photo1

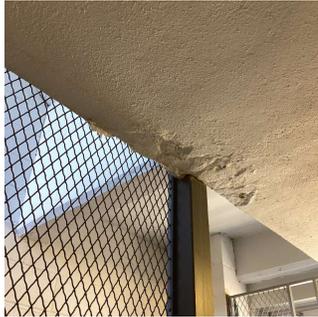
Question	Response
INTERIOR	
STAIRS/RAMPS: INTERIOR	
Do Letter Stair Signs Exist?	Yes
Ceiling	Inspected
Condition	2 - Between Good and Fair
Deficiency	PLASTER: CRACKS/SPALLING
Deficiency Location/Instance	Stair H/1
Deficiency Quantity	10
Quantity Uom	S.F.
Potential Action	REPLACE
Urgency of Action	PRIORITY 3
Purpose of Action	LEVEL 2
Deficiency Photo1

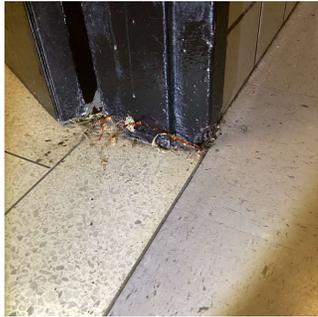
Violations	Stair H/1 No violations recorded.
Door(s)	Inspected
Condition	3 - Fair
Deficiency	METAL: DETERIORATED DOOR AND FRAME
Deficiency Location/Instance	Stair CD/1 Vestibule
Deficiency Quantity	2
Quantity Uom	EACH
Potential Action	MAINTENANCE
Urgency of Action	PRIORITY 3
Purpose of Action	LEVEL 2
Deficiency Photo1

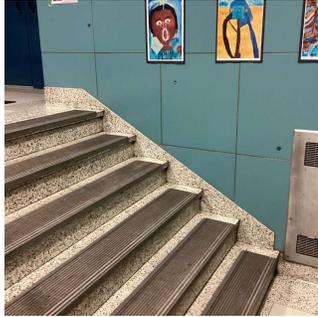
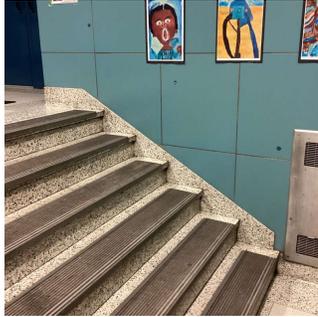
Violations	Stair CD/1 Vestibule No violations recorded.
Partition	Does not Exist
Railings	Inspected
Condition	3 - Fair
Deficiency	METAL: MISSING
Deficiency Location/Instance	Main Entrance Vestibule
Deficiency Quantity	10
Quantity Uom	L.F.

Potential Action	REPLACE
Urgency of Action	PRIORITY 5
Purpose of Action	LEVEL 6
Deficiency Photo1

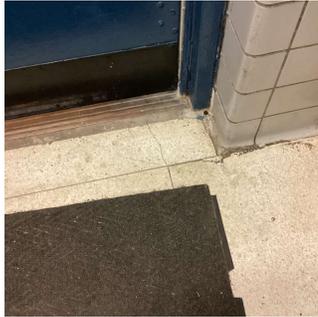
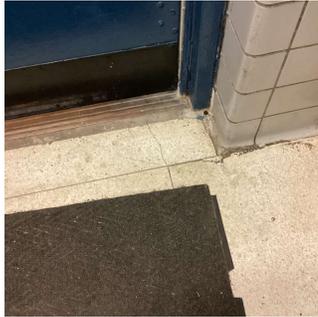
Deficiency	TERRAZZO: CRACKS
Deficiency Location/Instance	Stair CD/1 Vestibule
Deficiency Quantity	10
Quantity Uom	S.F.
Potential Action	REPLACE
Urgency of Action	PRIORITY 3
Purpose of Action	LEVEL 2
Deficiency Photo1

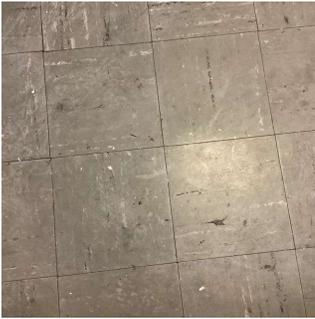
Violations	Stair AB/Basement No violations recorded.
Deficiency	VINYL TILES: BROKEN/DETERIORATED/MISSING TILES
Deficiency Location/Instance	Stairs AB/Bulkhead, CD/1, Bulkhead, E/1
Deficiency Quantity	60
Quantity Uom	S.F.
Potential Action	REPLACE
Urgency of Action	PRIORITY 3
Purpose of Action	LEVEL 2
Deficiency Photo1

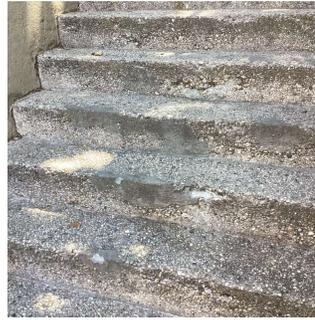
Violations	Playground No violations recorded.
SEATING	Does not Exist
SITE WALLS (NOT RETAINING WALLS)	Does not Exist
STAIRS/RAMPS: EXTERIOR	Inspected
Railings	Inspected
Condition	3 - Fair
Deficiency	MISSING
Deficiency Location/Instance	Stairway Leading to NYC Park
Deficiency Quantity	13
Quantity Uom	L.F.
